**ARBORICULTURAL ASSESSMENT**

**FRIMLEY PARK**

**PAPER STREET TREE COMPANY**

**REPORT DATED:** 26.08.21

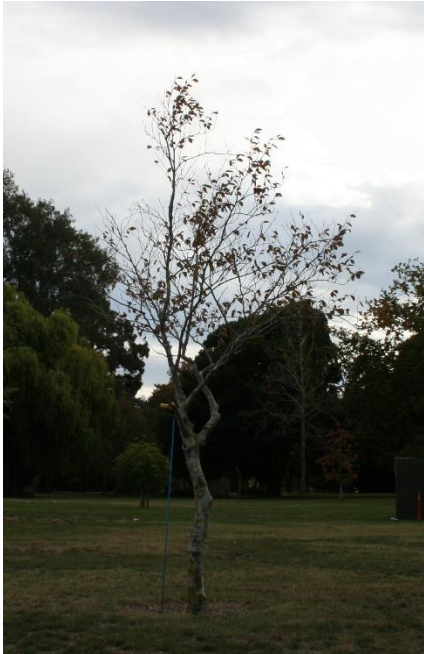
Fig. 3 Tree 31

A Juvenile beech tree (*Fagus sylvatica*) (fig.3). The tree is in decline, and significant mechanical wounding is present at the base. The tree is located adjacent to Frimley Rd and is a good planting location for a feature tree. Remove and replant.

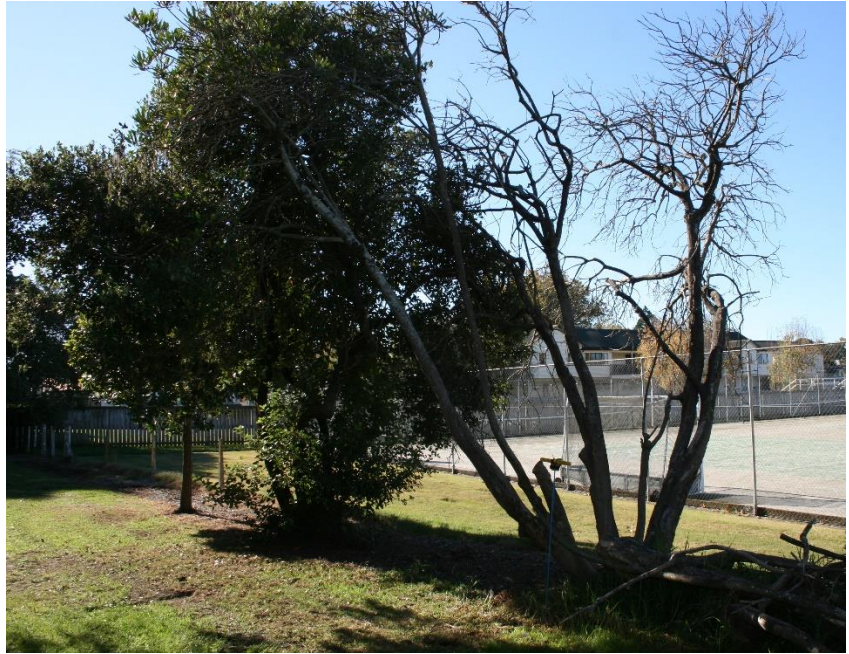
Fig. 4 Tree 107

- **Tree 107**
- Almost dead standing Pseudopanax. The tree is located on the boundary of the school. Remove and replant (fig 4).

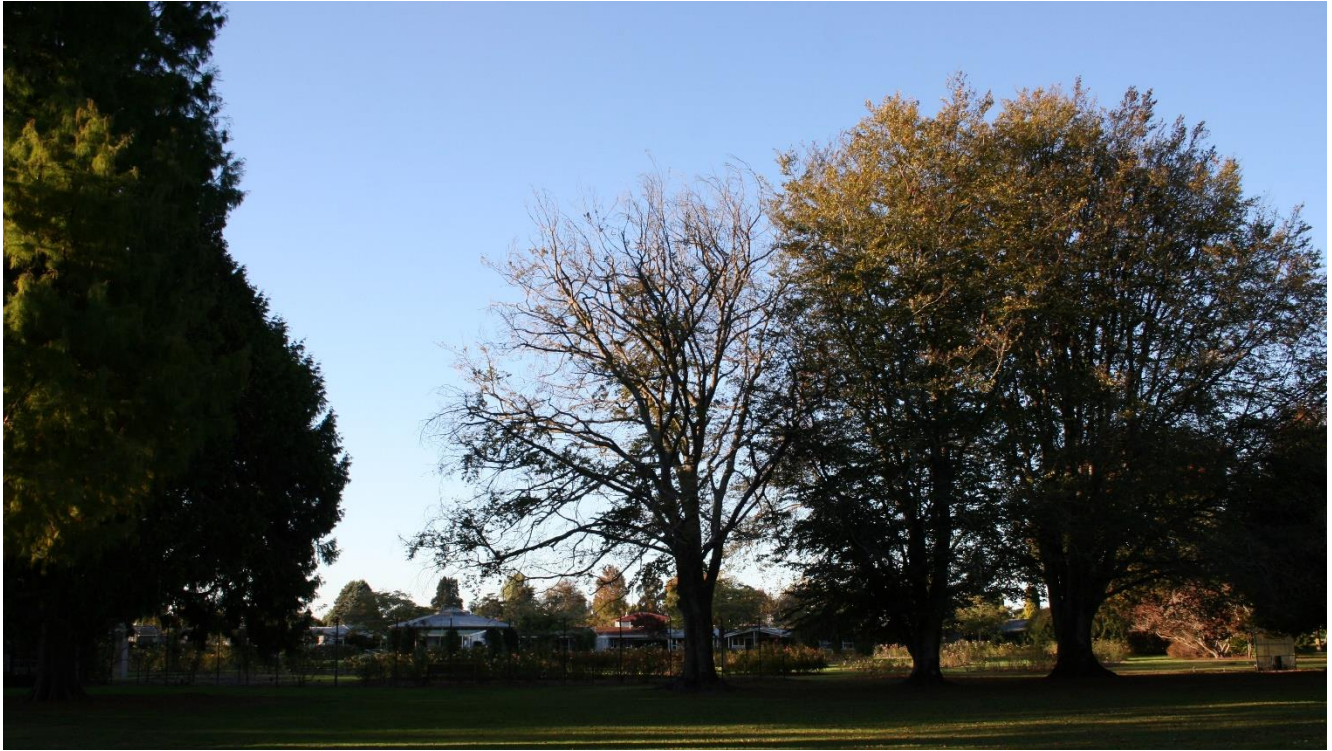
Tree 77 is a fully mature beech tree. Giant meripilus (*Meripilus giganteus*) at the base, a number of fruiting bodies have been removed or sprayed. Dieback throughout the canopy, the recent removal of adjacent beech has also occurred due to decline. *M. giganteus* has a common fungal association with beech. It can act as a parasite and, in most cases, likely signify root disturbance. Probing with the root spear found little to no root activity north of the tree's base and soft roots to the south. Reduction in vitality indicates a significant reduction in tree function that would inhibit adaptation to loss of structural stability at the tree's root plate. However, the tree is of a large girth that has developed a broad buttress root system to provide a degree of stability, and the decreasing canopy would reduce loading at the base. But considering the fungus involved and the tree's condition, a reduction would be required, which would further deplete the tree's ability to react and likely accelerate the speed of deterioration (Figs. 5 & 6).

Fig.5 Note canopy decline in subject tree (pictured centrally) and the beech to the trees to the right

Strategically replant and replace trees to ensure successive canopy coverage. Recommend that the beech tree is left as a high 2m stump for habitat creation. Opportunities should be sought where possible to create habitat creation and allow natural processes to take place whilst providing a learning opportunity for members of the public:

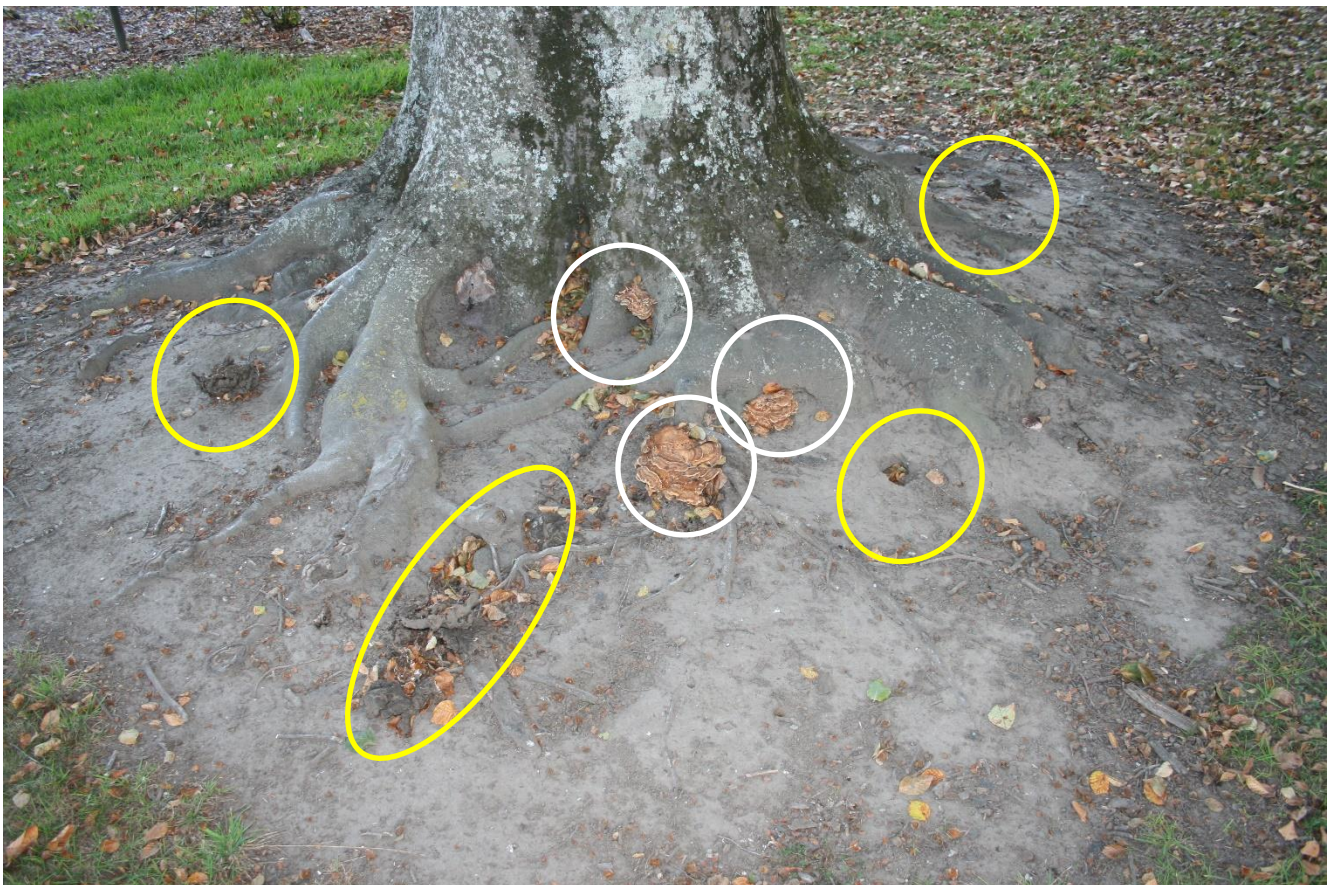
Fig.6 Giant meripilus highlighted in white. Chemical management has resulted in other fruit bodies being killed (highlighted in yellow). Giant meripilus, as its name suggests, has a sizeable fruiting body. If the area was not extensively sprayed, early identification of the fungus would have occurred. As the tree has a large root plate, the tree is fairly stable, but if the root plate was smaller, it would likely have failed.

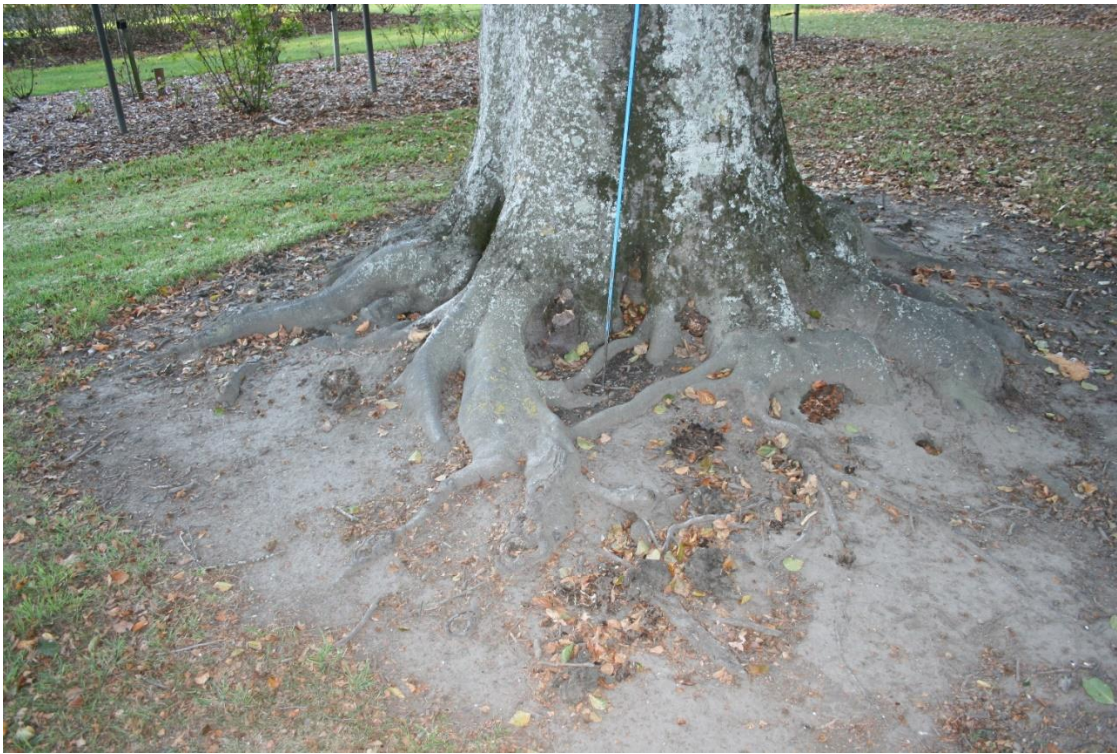
Fig. 7 Area after spraying has occurred, all fruiting bodies killed hiding the significance of the structural loss.

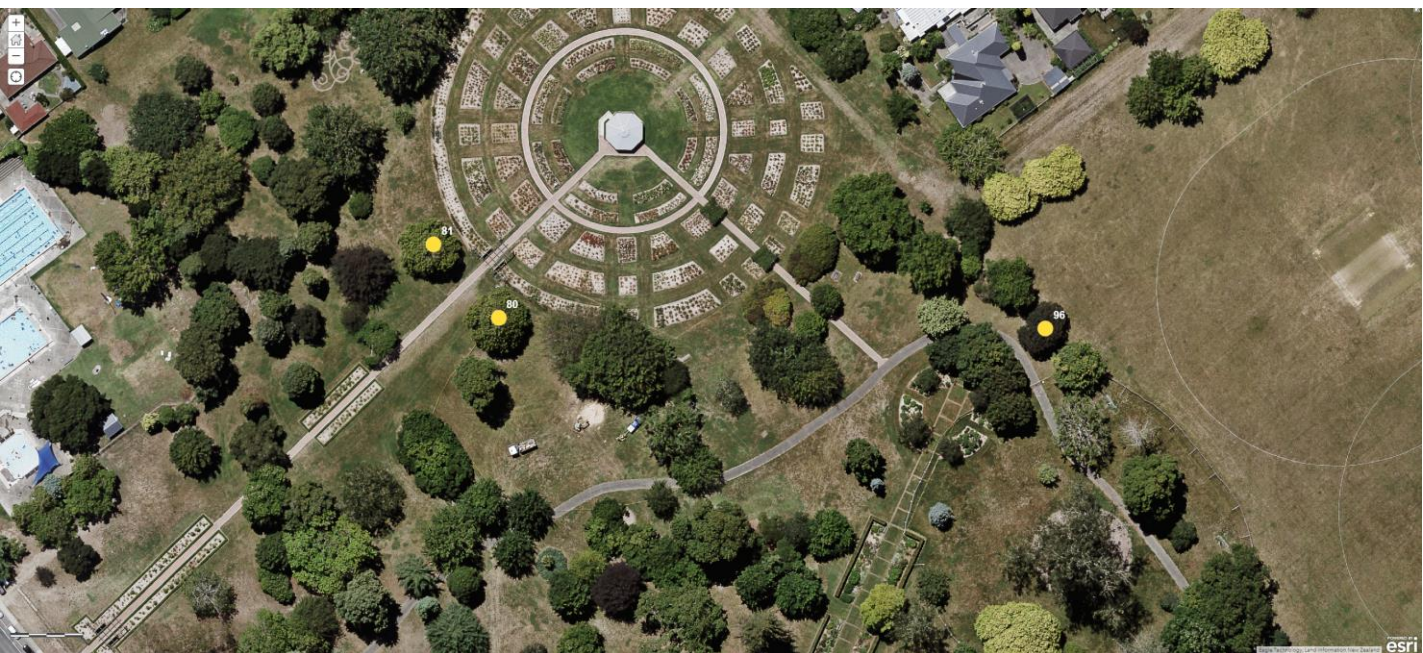
Fig.8 Location of trees 80, 81 and 96

Three trees (Trees 80,81 and 96) are likely to be in a state of irreversible decline due to biotic agents (cypress canker (trees 80 and 81) and phytophthora (Tree 96)). It's likely that these trees will require removal within the next 10yrs years due to their conditions. See below for tree locations.

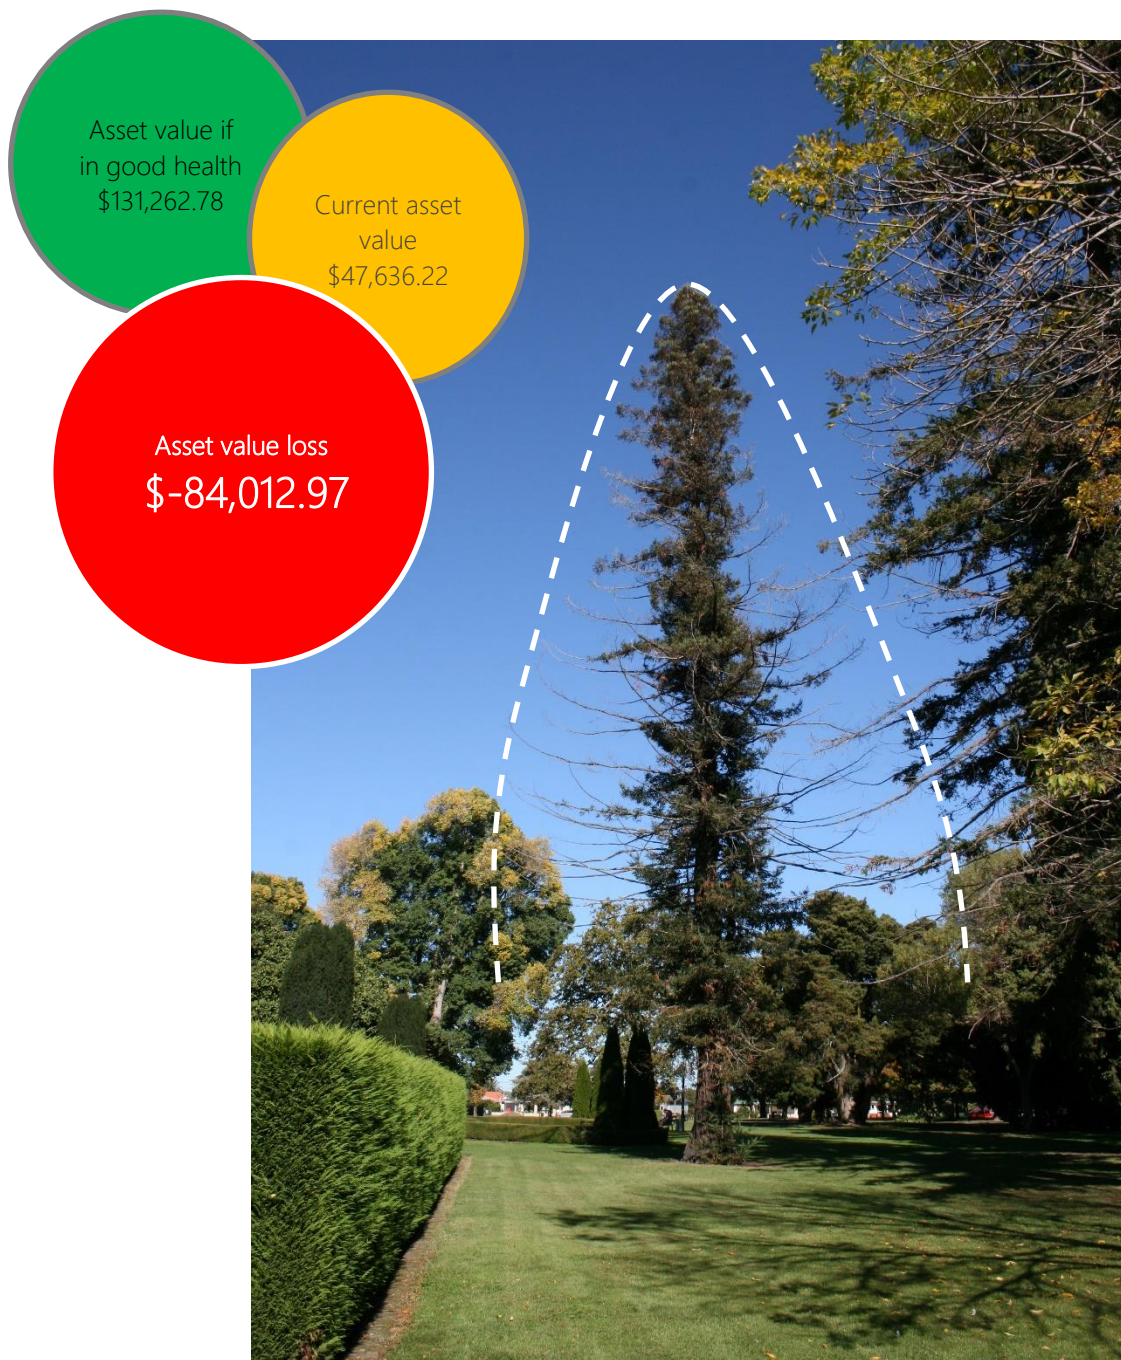
A number of trees within the site show symptoms and conditions likely to be attributed to chemical damage (e.g. dieback, burnt tips, defoliation and deformed leaves/needles). Certain trees are highly susceptible to particular chemical agents, causing reductions in health and can lead to irreversible decline if not controlled. In most cases, the declining condition can be reversed by changing the chemical agent used around these trees. It can take a number of seasons for a tree's physiological condition to improve, providing the damage has not exceeded the trees ability to overcome the stress.

Fig. 9 Highlighting the loss of value from in Coastal redwood. Coastal redwood (*Sequoia sempervirens*) is a species that is sensitive to chemical damage

- Establish and maintain a herbicide register for HDC parks to prevent further avoidable damage to important park assets.
- Increase and establish mulching schedules/specs for the site – this will facilitate natural processes improving soil quality, water holding capacity, and fungal activity.

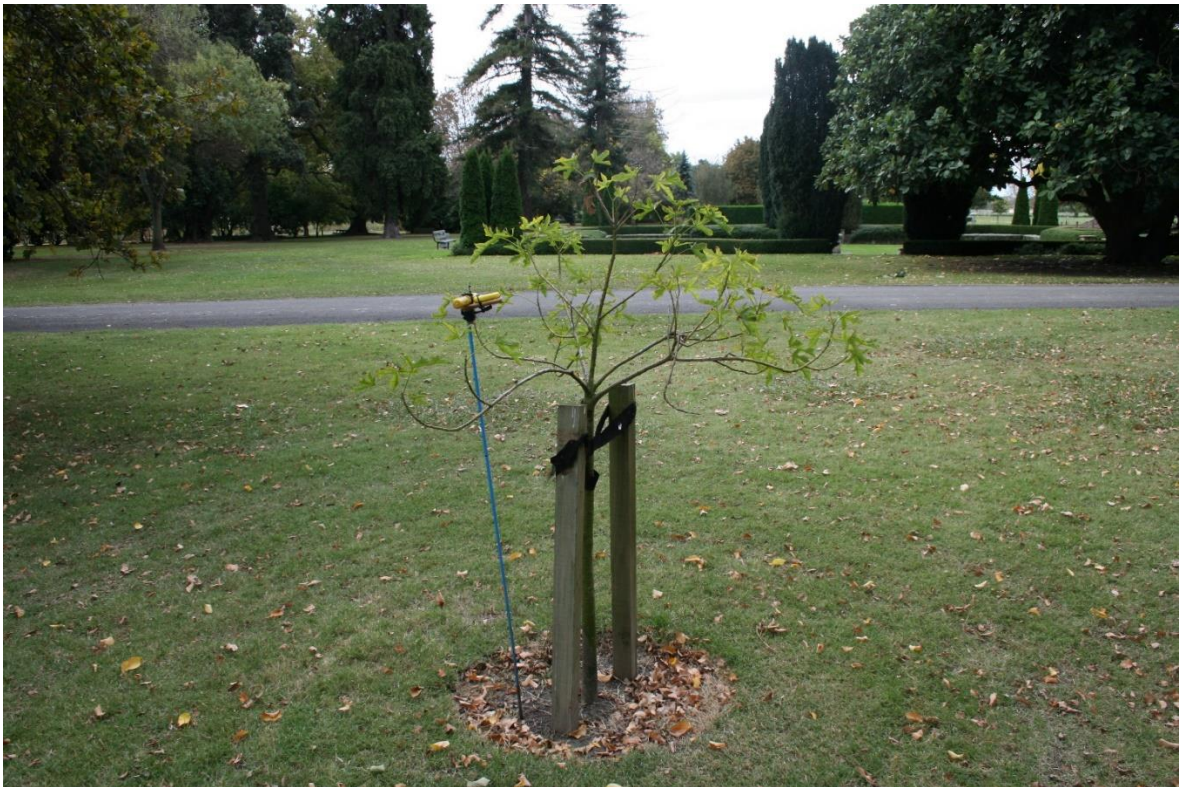
Fig. 10 Illawarra flame tree (*Brachychiton acerifolius*) the root spear is beginning to detect roots at 20cm below ground level.

3.5.2.1 The tree in Fig. 7 has no future potential within the landscape. Aside from lack of water, planting too deep is the most common cause for unsuccessful tree establishment.

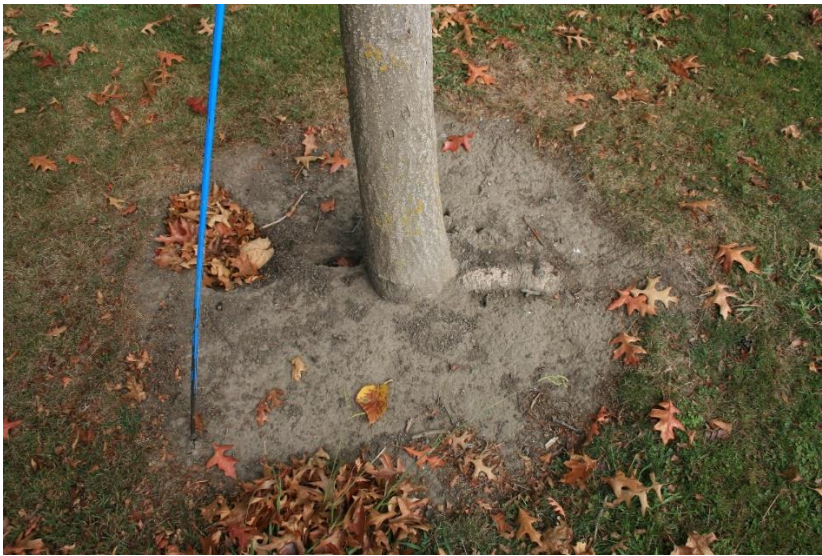
Fig.11 Girdled root on maturing *idesia polycarpa*

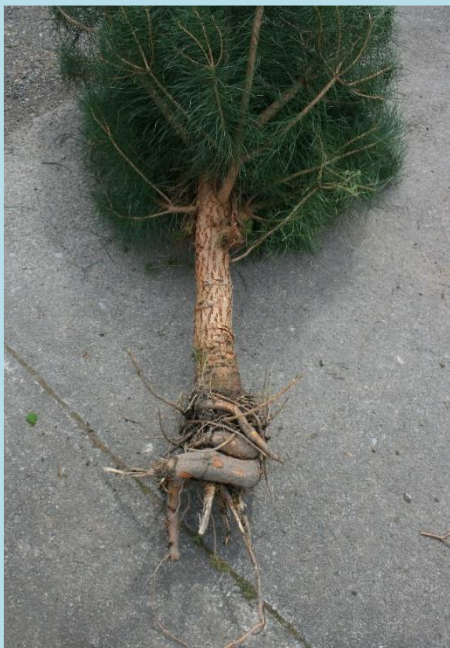
Fig. 12 Image of a girdled root system. These typically form from a tree being containerised to long. Container-grown trees, in most instances, will have gridled roots. But if these roots are not pruned, the above root structure can establish where windthrow is inevitable.

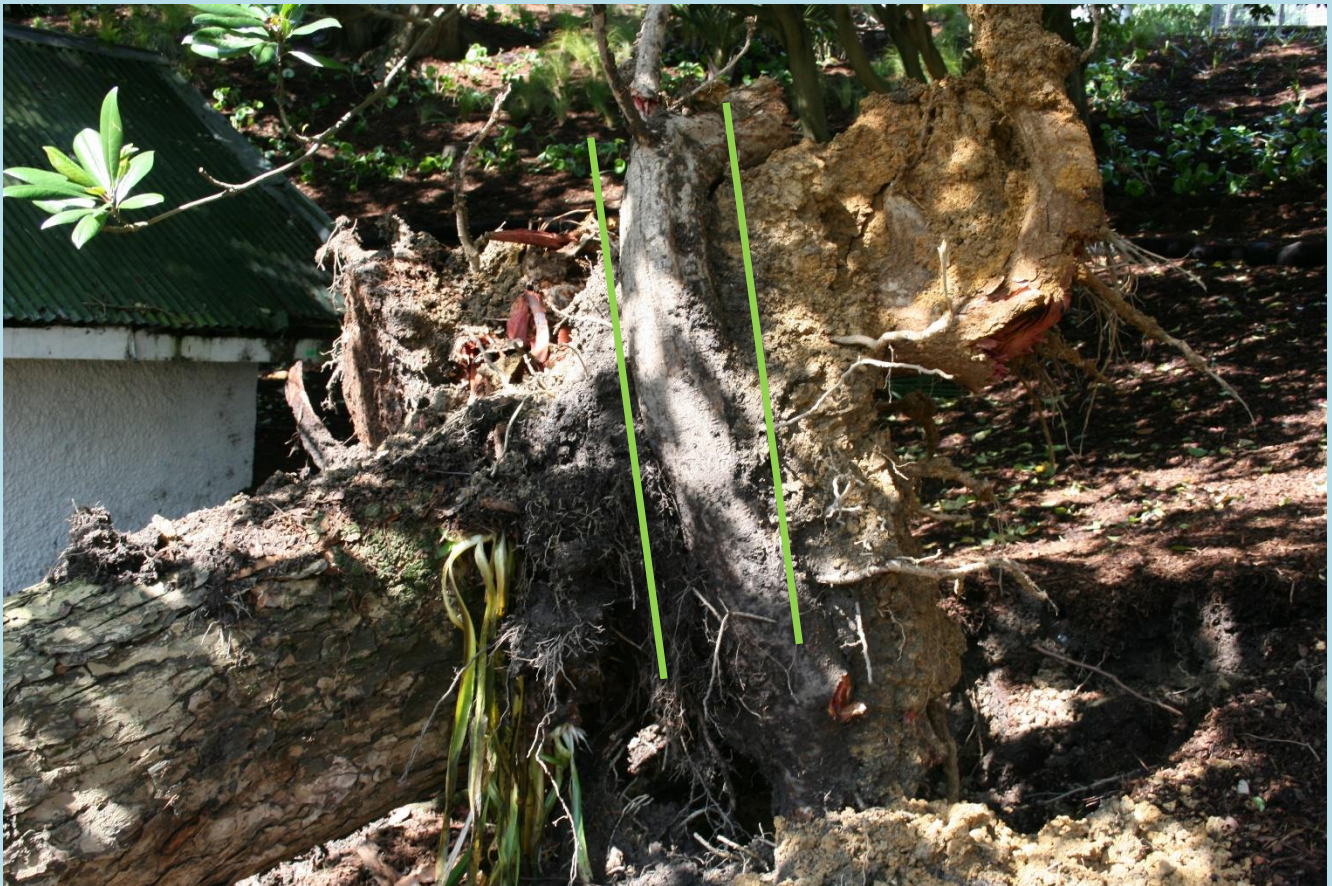
Fig 14, Effect of a girdled root on a mature Western red cedar (*Toona ciliata*) highlighted in green.

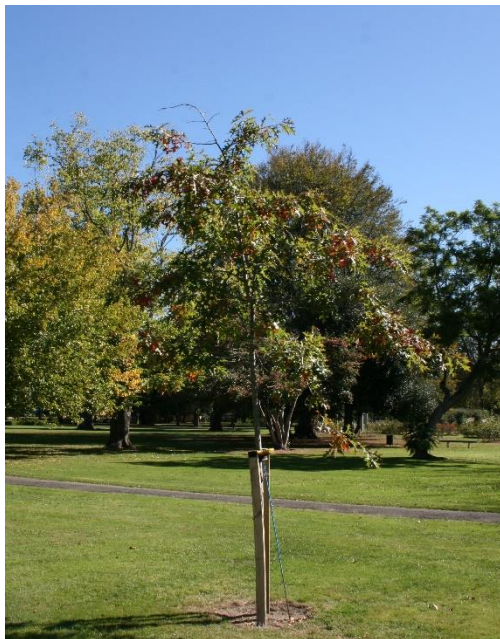
Fig. 15 Tree 69; a young recently planted pin oak (*Quercus palustris*) note the dieback at its apical tip. Dieback is likely a response to transplant shock, but otherwise, the tree is in good health. Apical dominance gives trees their classic conical form; the top bud sends out chemicals to suppress the spread of the lateral limbs. As trees get older, or in certain species, they lose that dominance or have weak apical dominance, and many leaders will form. But when a tree loses its apical dominance during its juvenile stages, then there is nothing to suppress the lower limbs, and poor structures forming. This can be addressed by a few snips of the secateurs and a formative pruning programme during the juvenile stages.

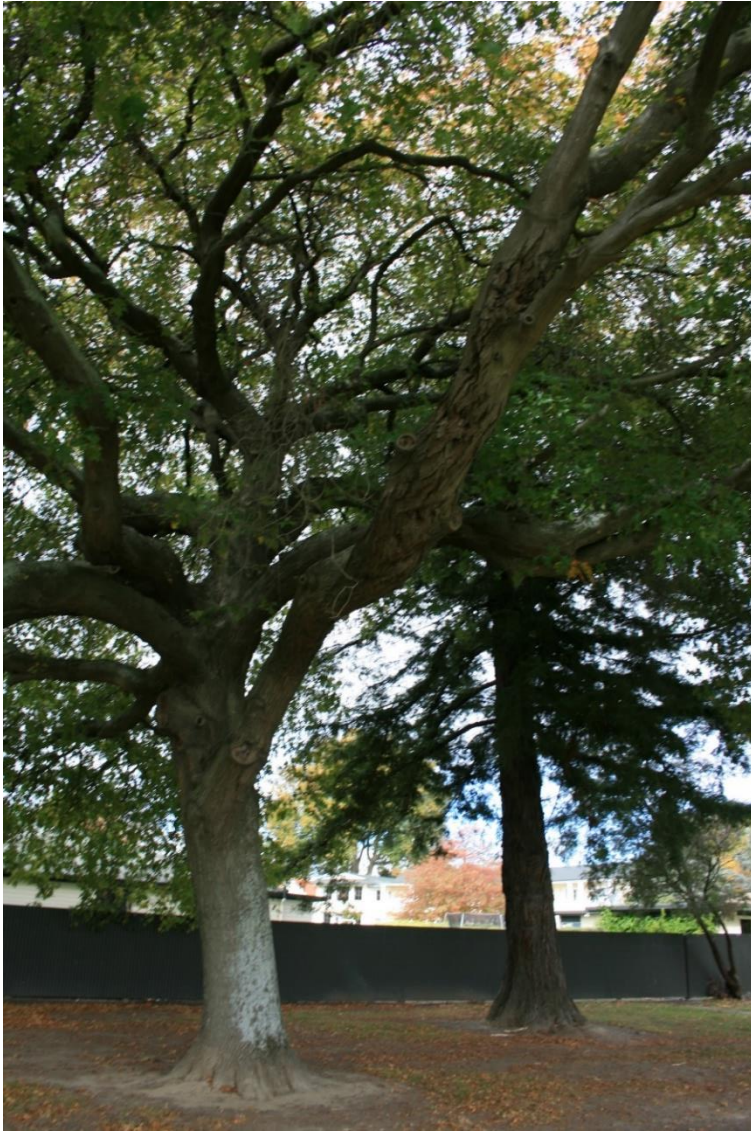
Fig. 16 However, if left, this is a mature pin oak (Tree 90) that has historically lost its apical dominance at a young age, so it has a very broad canopy. The limb in the front spreads over the access road into the park, and as seen on the limb, there is canker and evidence of bulging and reactive growth, which shows there is likely an abated split in the limb forming a mechanical weak point. As the limb extends, the load at this point increases and failure is foreseeable. To remediate this will take three arborists, a truck and a chipper and around 5hrs to prune. Whereas in its juvenile stages, it would have taken one arborist 5mins to prune. This is to highlight that investing in pruning training and establishing formatively pruning specs will lead to greater long term savings and improved trees structures. Additionally, improved structures reduce the likelihood of limb failure.

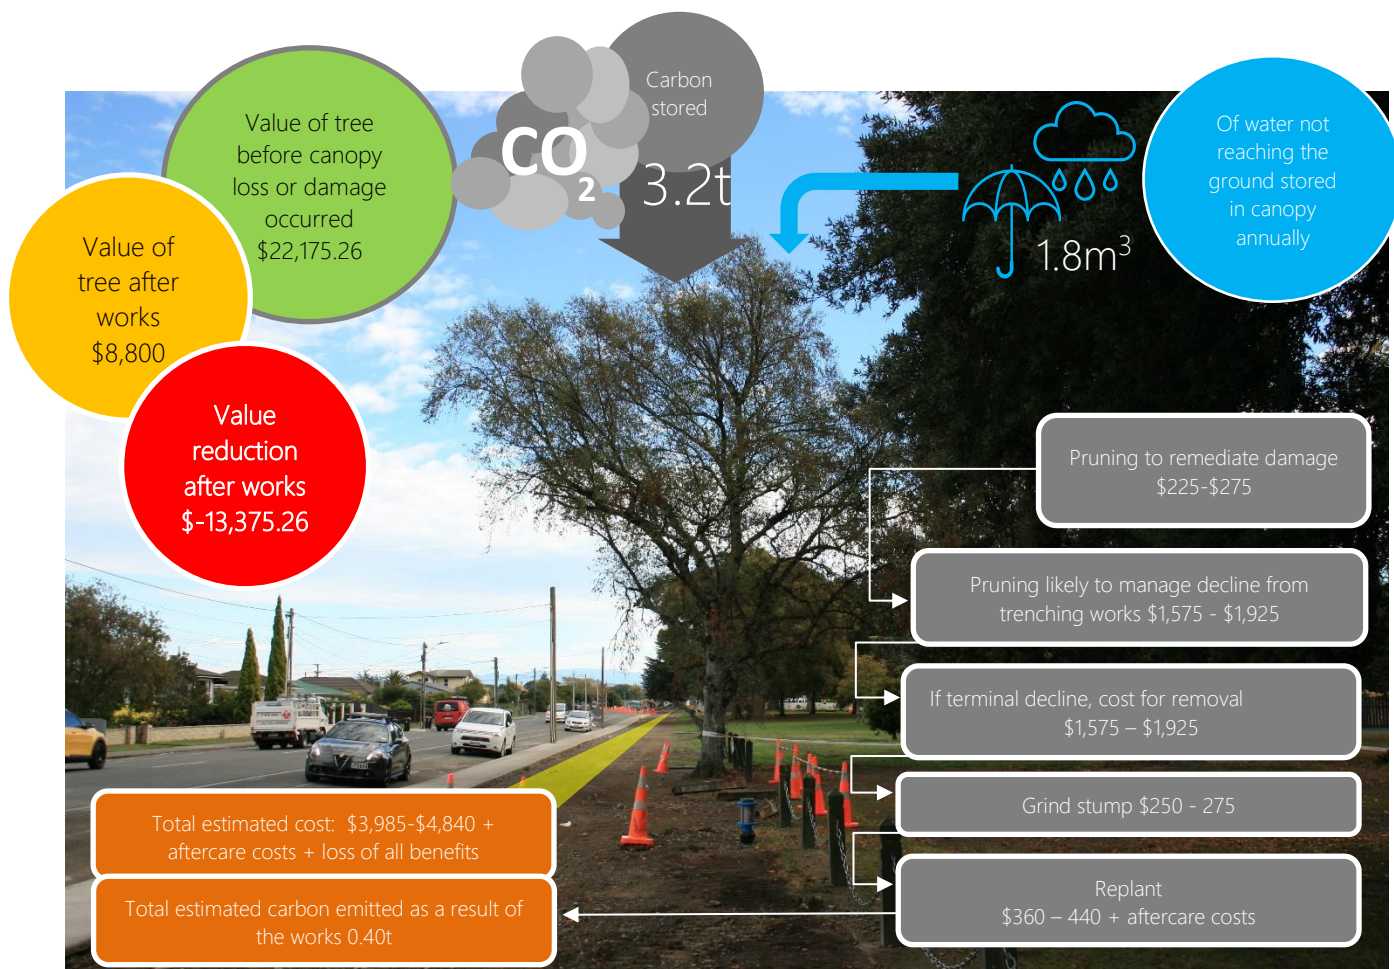
Fig. 17 Shows trenching works (highlighted in yellow) past a silver birch tree (*Betula pendula*).

3.6.2 Fig 13 is a good illustration of the likely creation of additional costs from lack of contractor care. HDC provided clearance for the works, but canopy damage is apparent. This is the visible part of the damage; the root system responsible for nutrient uptake and stability is also likely to have been damaged during the works, which could lead to irreversible effects.

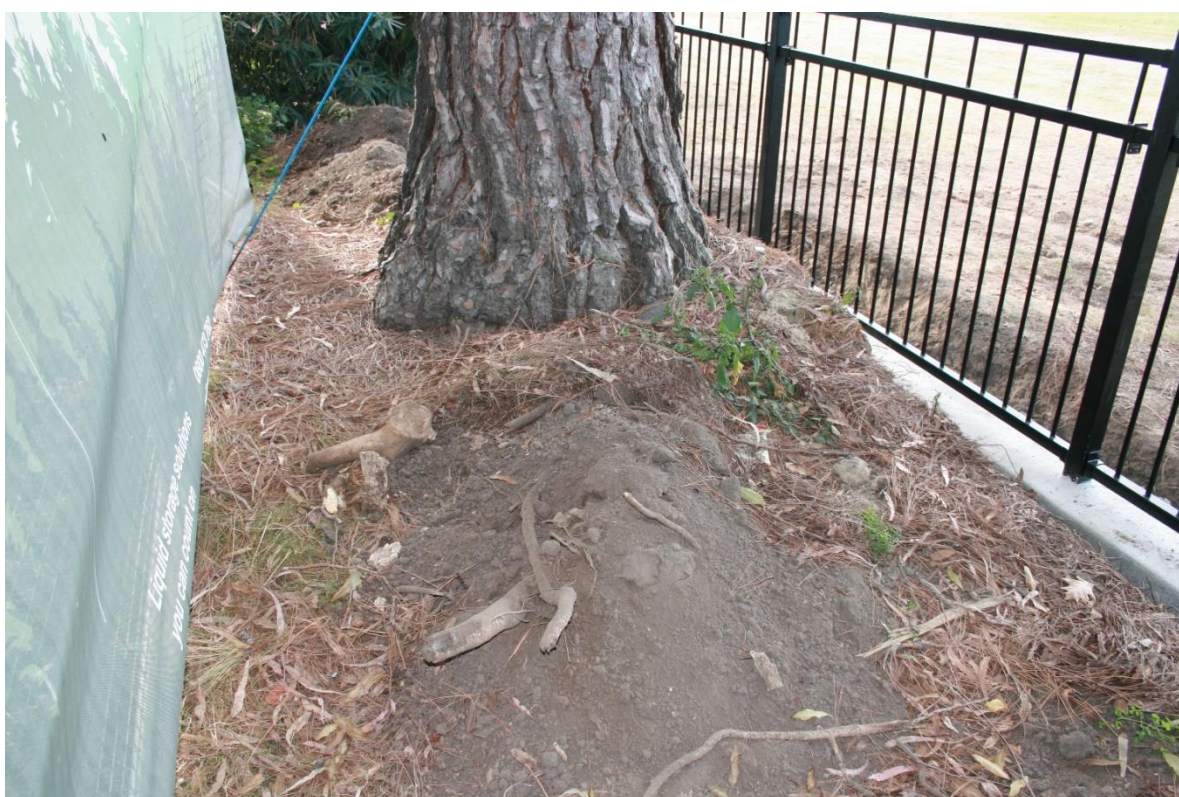
3.6.3 Another example of damage is shown below of contractors working on behalf of the school installing a strip footing along the southern boundary for a fence. The lack of flexibility in design has resulted in damage and loss of roots at the structural root plate for a 30m Ponderosa pine (*Pinus ponderosa*). The pine currently stands in good health, but it is not fully clear the extent of the damage, but as with the example in Fig. 13 it's almost impossible to reverse this sort of damage after the event.

Fig.18 Root damage by contractors installing concrete strip footing adjacent to base of 30m *P. ponderosa*

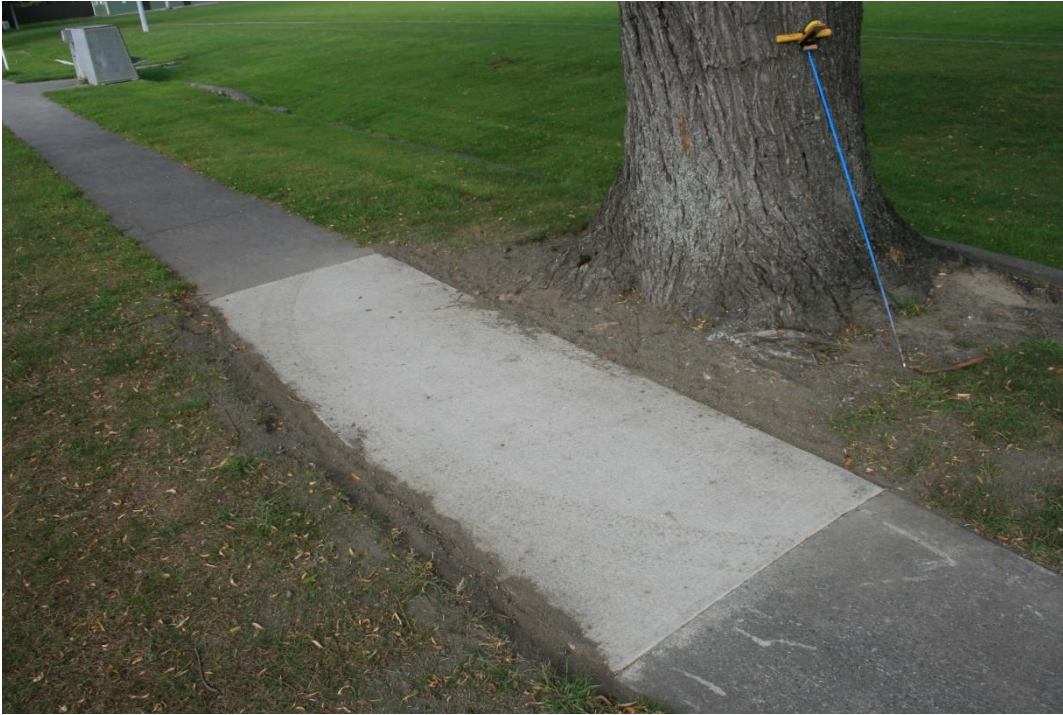
3.6.4 Below is the works to repair the pavement over a willow that stands adjacent to Lyndhurst road. Willow as a species are not effective compartmentalisers. Therefore, any disruption or debarking of its roots will allow entry points for decay and its spread. The tree is currently in good health and is likely to tolerate the disturbance, but solutions are needed to avoid unnecessary damage. Tree mortality for most species occurs due to the environmental stress to which a tree has been subjected. Increasing environmental benefits and often leads to more planting, but it can be more cost-effective to look at processes and solutions to safeguard existing assets, which also protects any new plantings to ensure net environmental gain is achieved for each tree asset.

Fig.19 New section of pavement within root zone of willow

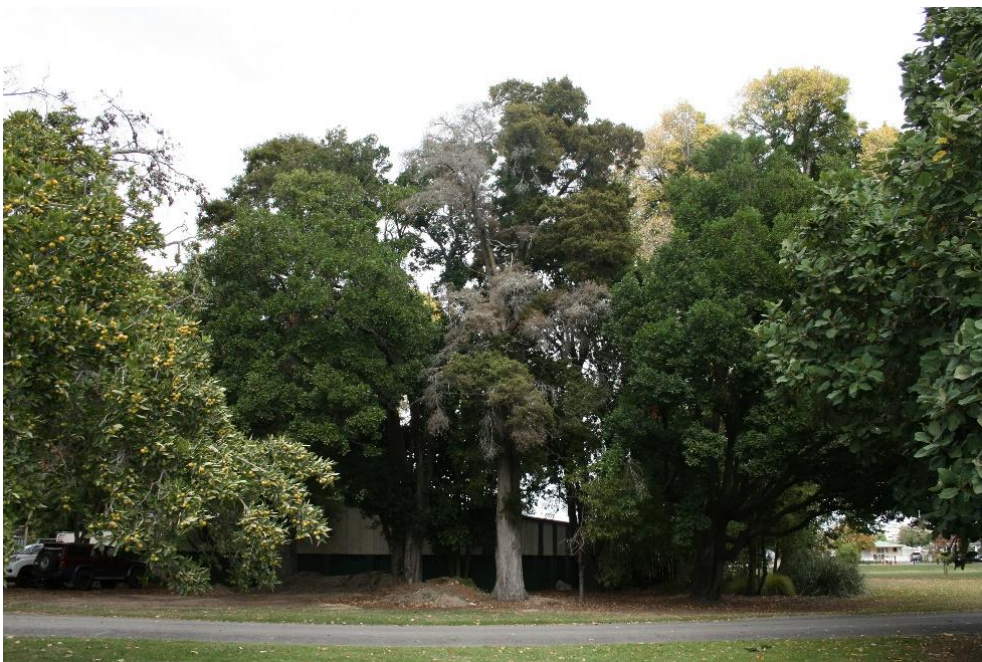
3.6.6 There is also evidence of root disruption from the scrapping and storing of soil within the immediate root zone of a mature totara (fig 16). Totara can be quite fickle in terms of the withstanding tolerances to root disruption. Often root damage can correspond to dieback above/adjacent to the area where root disruption has occurred, as can be seen in fig 16.

Fig.20 Build-up and scraping of soil at the base of totara, corresponding with canopy dieback

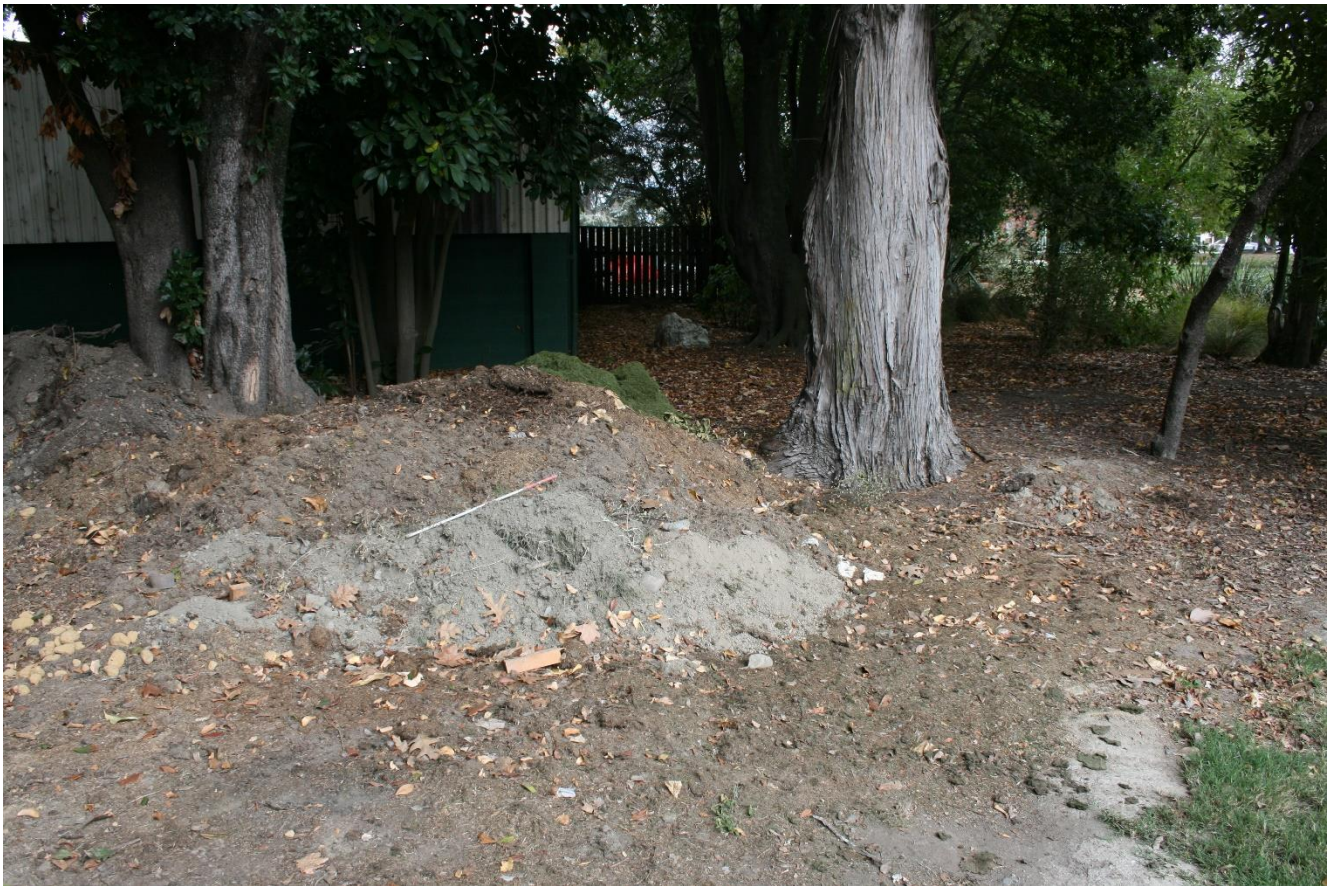
Fig.21 Close up of the damage. The extensive build-up, damage and debarking of a rare *Picconia excelsa* (left of image) by depot.
