Flood Detention Dams

Comprehensive Dam Safety Review

PREPARED FOR HASTINGS DISTRICT COUNCIL | May 2021

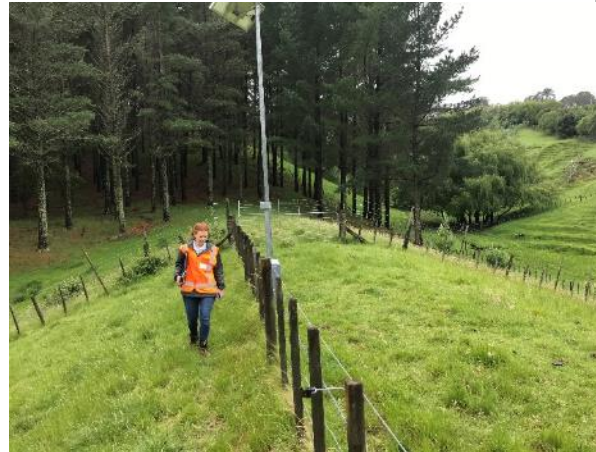
Figure 2: Dam crest with weak fence

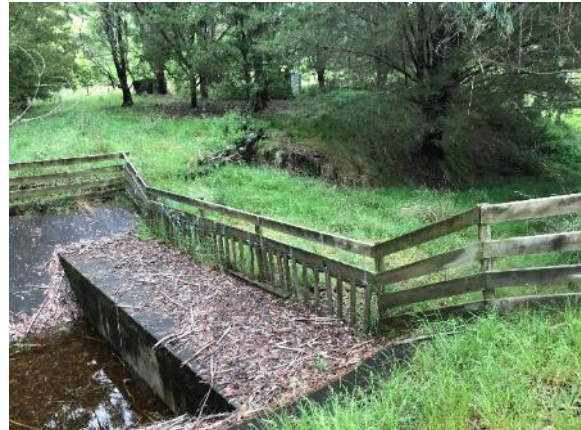
Figure 14: Livestock gate across spillway

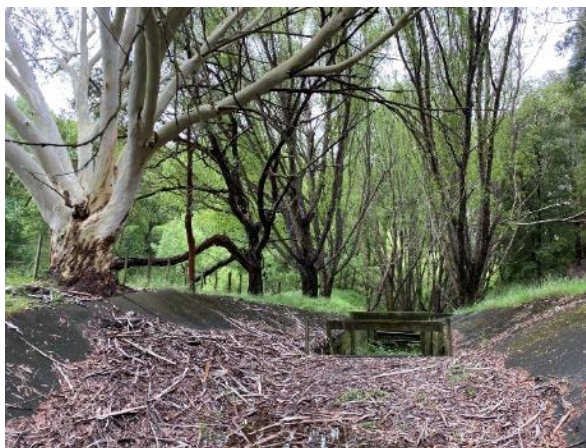
Figure 15: Spillway (showing tree roots probably lifting slab)

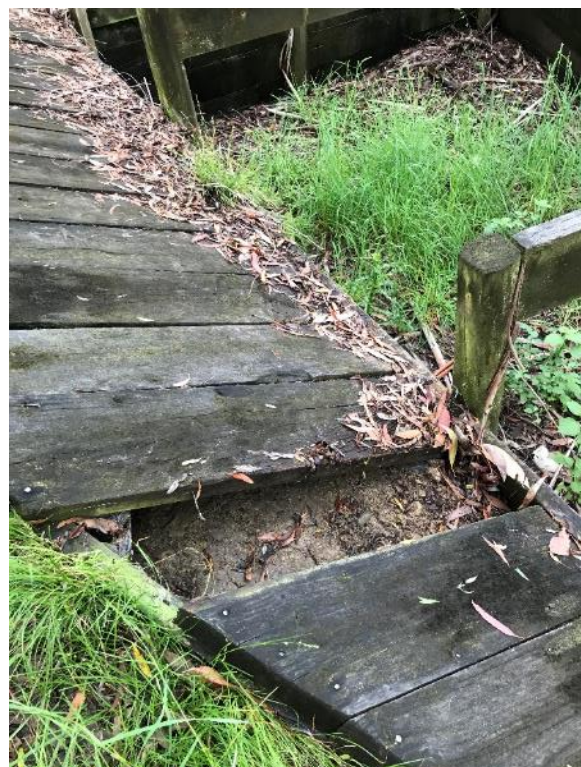
Figure 16: Missing timber on spillway

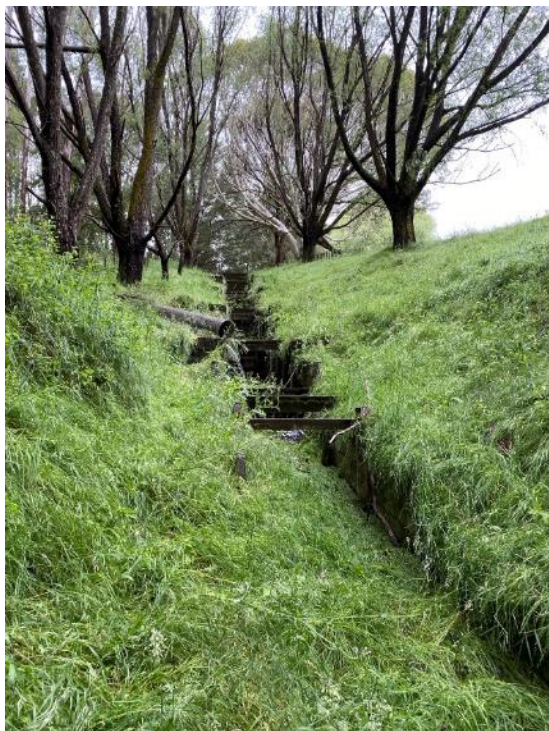
Figure 17: Spillway looking upstream (very long vegetation)

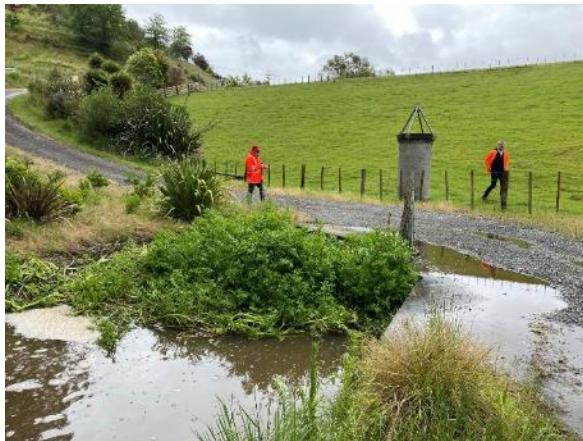
Figure 24: Inlet structure (blocked, subsequently cleared)

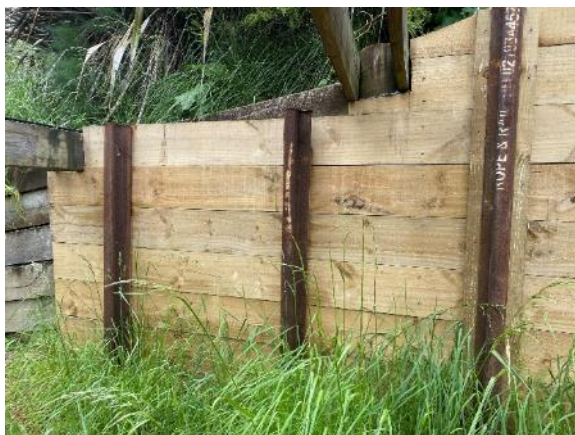
Figure 26: Recent spillway repair at downstream end of channel

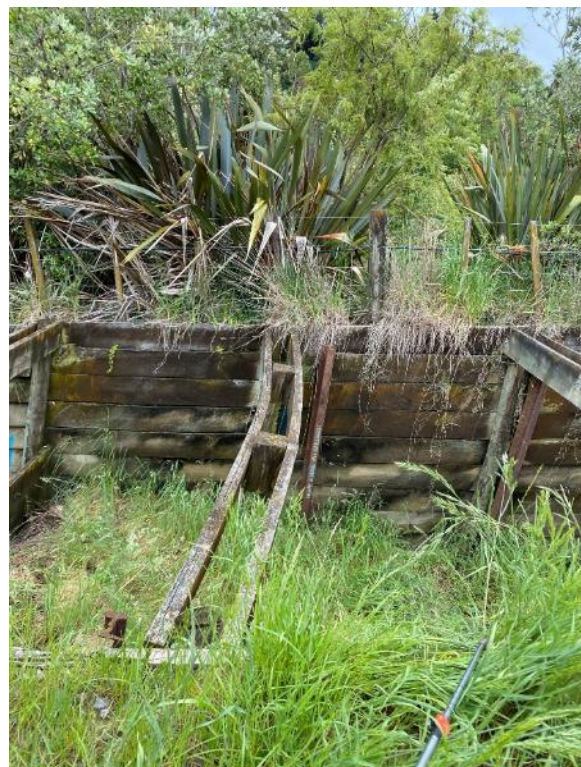
Figure 27: Buckling cross timbers in spillway

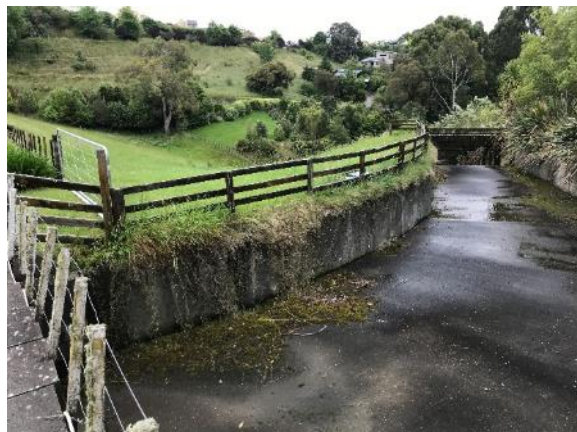
Figure 28: Narrowing of upper spillway channel

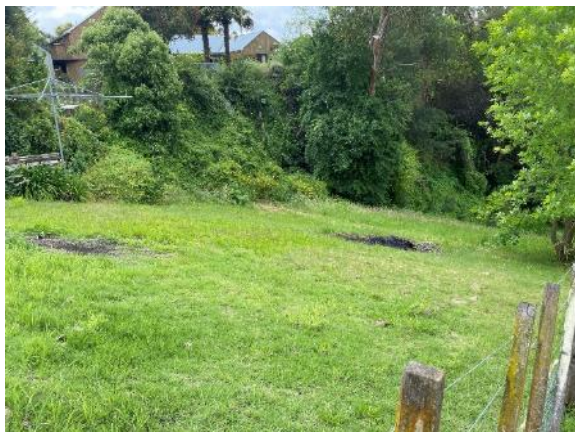
Figure 32: Damage on downstream slope

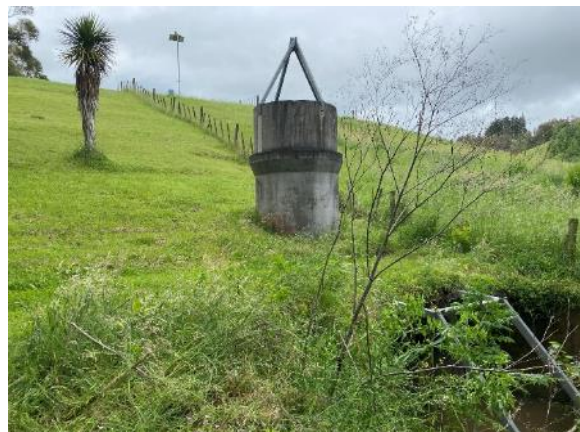
**Figure 33: Auxiliary intake and inlet structure
(blocked with log)**

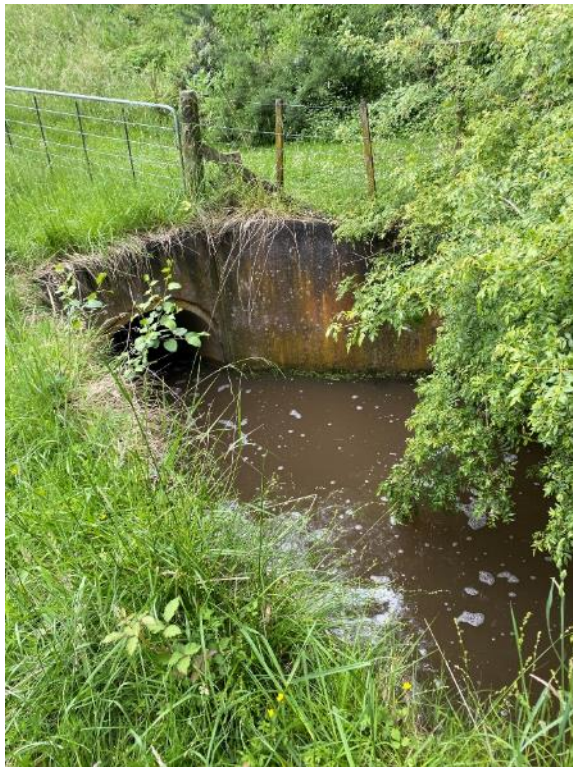
Figure 34: Outlet structure (turbulence heard)

2020-38 /5.5.5	Mangarau - It is recommended that the CCTV survey at Mangarau is prioritised over the other dams due to turbulence heard at the outlet suggesting something is disturbing the flows. (See also 4.1)	B	High	0.5 yr
2020-39 /5.5.6	Mangarau - General debris in the downstream channel at the confluence point of the spillway channel should be cleared.	A	Low	5 yr
2020-40 /5.5.7	Mangarau - The hydraulic capacity of the overflow and channel should be confirmed by calculation and if it is shown to be under capacity or to present a risk to the natural dam abutment, then the spillway should be considered for improvement.	B	High	1 yr
2020-41 /5.6.1	Here Here - It is recommended that gates or stiles are installed to enable safer crossing for inspection and maintenance purposes. Location to suit landowners and HDC.	A	Medium	3 yr
2020-42 /5.6.2	Here Here - Grass on the dam was very long and needs improved maintenance, (machine or sheep).	A&B	Medium	2 yr

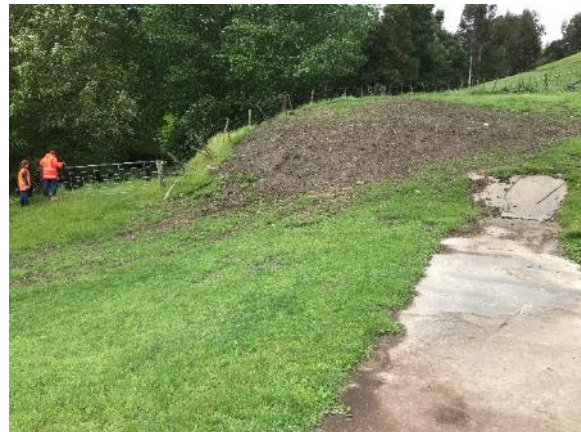
Figure 35: Spillway and recent repair to right hand side

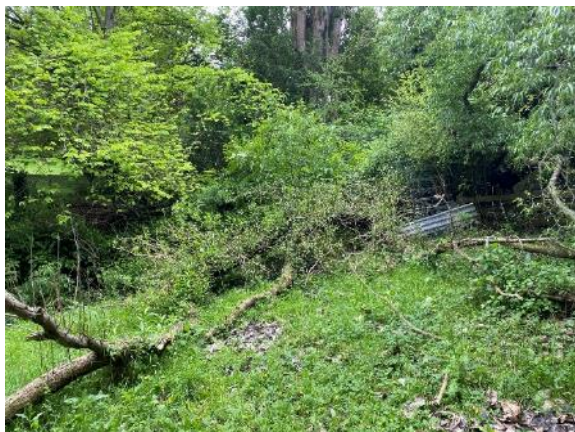
Figure 38: General debris at spillway discharge to downstream channel

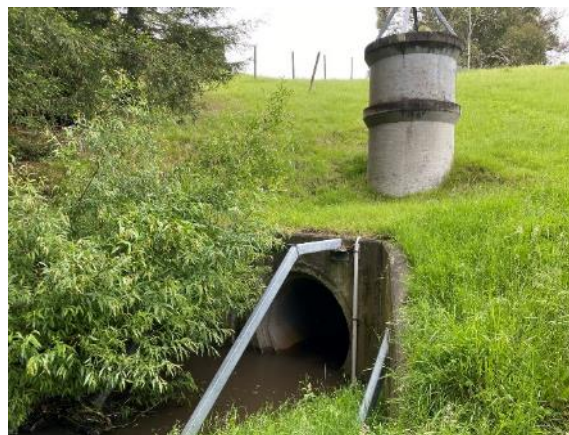
Figure 42: Inlet structure (bush to be removed)

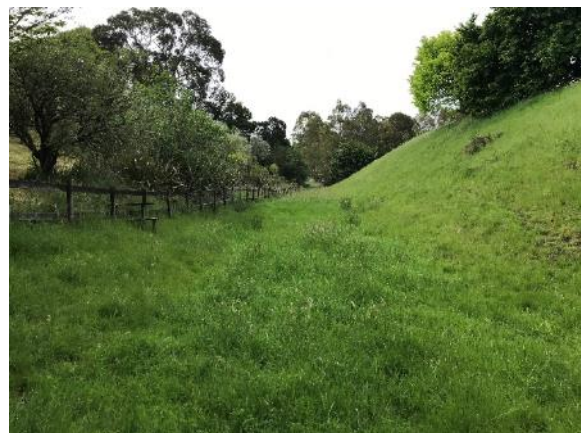
Figure 46: Spillway (undesirable fence / vegetation on the left-hand side and closed gate at the end of the channel)

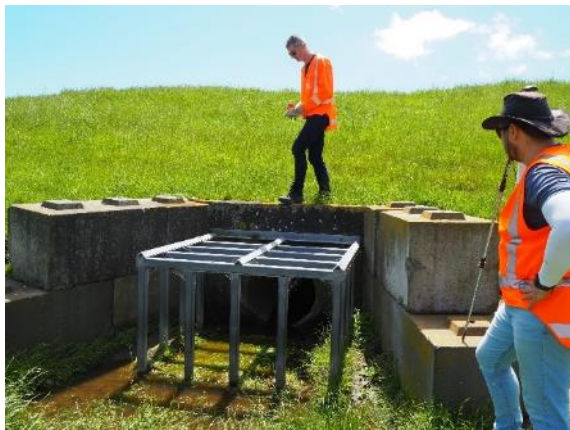
Figure 49: Inlet structure on central dam, noting slight settlement in the vicinity of the pipe.

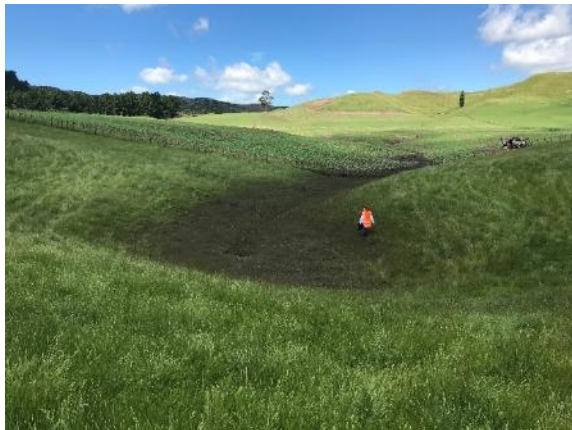
Figure 51: Evidence of recent ponding at east dam inlet pipe

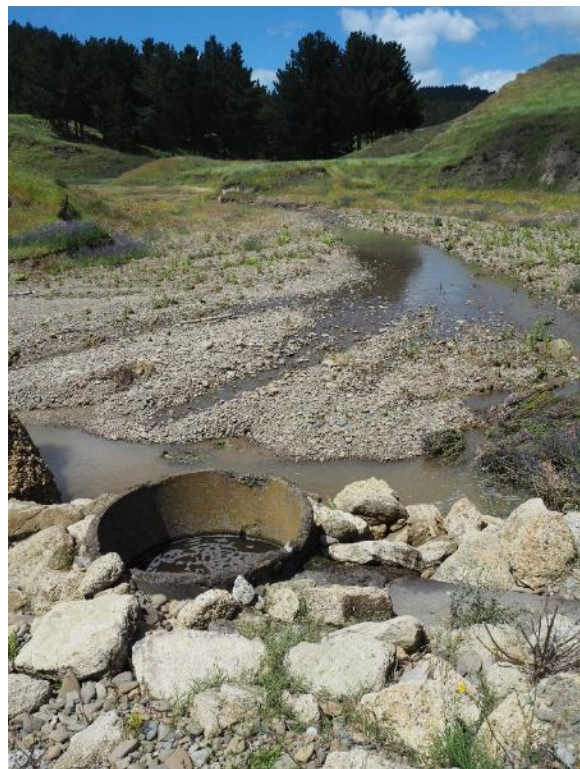
Figure 54: Outlet to Charlton Stream. Screen Required,

2020-50 /5.7.6	Clifton - The hydraulic capacity of the overflows and channels should be checked. The resilience (erosion resistance) of the Lower Central dam overflow should be appraised. (See also 2.2).	B	High	1 yr
2020-51 /5.7.7	Clifton - A webcam or similar means of remote surveillance is recommended if PIC study shows that the dams present a significant risk to the Clifton Motor Camp.	-	Low	5 yr
2020-52 /5.9.1	Te Awanga Upper - A preferred access route to the dam should be agreed with the landowner and defined accurately on a plan of the area.	A	Medium	3 yr
2020-53 /5.9.2	Te Awanga Upper - The outflow characteristics of the on-catchment lakes to the west of the dam should be investigated and incorporated into hydrological studies as this might affect the outputs of existing flood studies at this dam.	B	High	1 yr
2020-54 /5.9.3	Te Awanga Upper - carry out a CCTV survey of the downstream culvert drop shaft structure. This also requires a portable pump. (See also 4.1). Install a safety screen to the Outlet to Charlton Stream.	A	High	0.5 yr

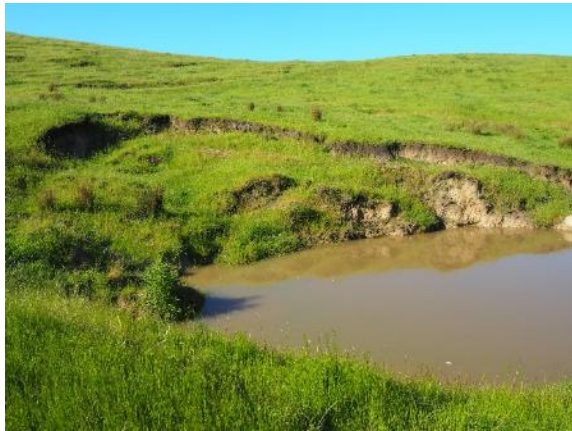
Figure 61: Upstream edge of failing pond (for cattle drinking water) above Western Dam

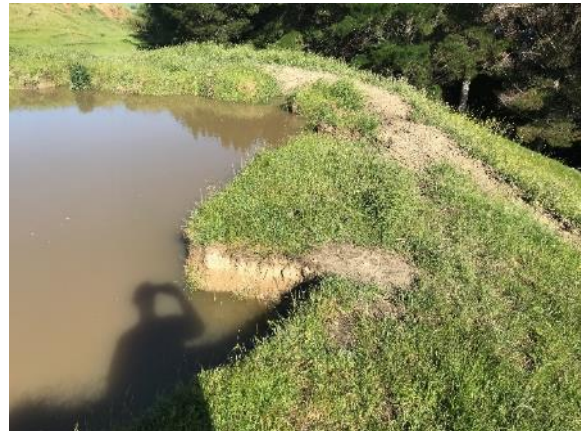
Figure 62: Downstream edge of failing pond (for cattle drinking water) above Western Dam
