**FLOOD DETENTION DAMS - 2023
INTERMEDIATE DAM SAFETY REVIEW**

27 September 2023

Prepared for:
Hastings District Council

Prepared by:
Stantec

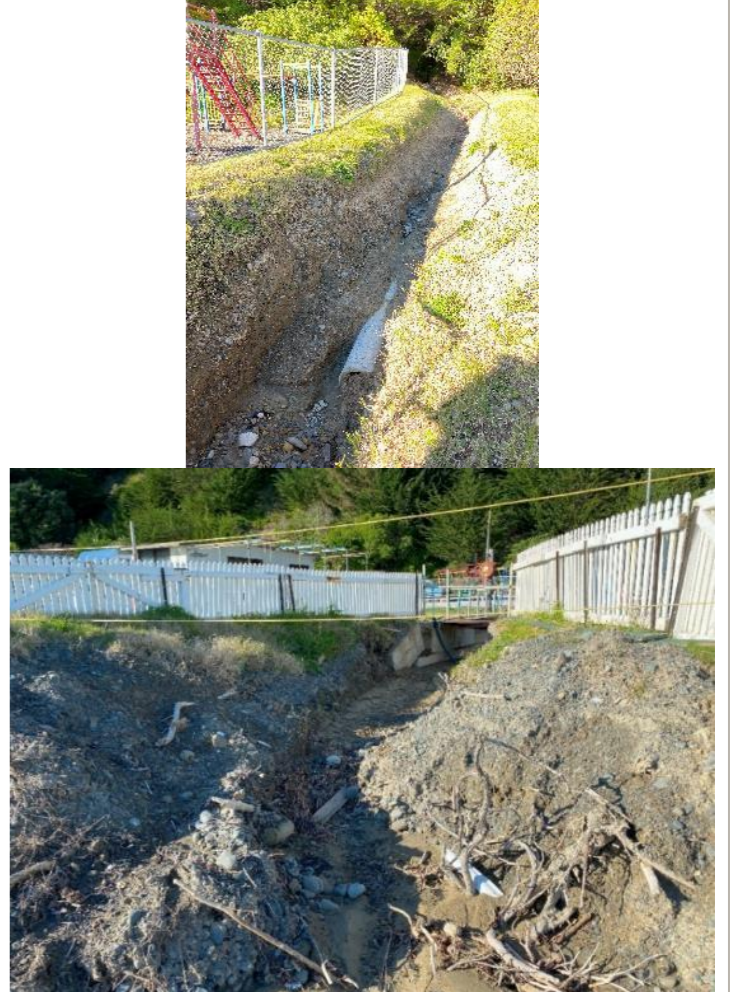
| Dam or Appurtenant Structure | Key Site Inspection Observations | Dam safety issue | Photograph |
|---|--|---|--|
| <p>Clifton Motor Camp Stormwater Gully</p> | <p>Flood flows from the catchment and detention dams flow down the stormwater gully through the Clifton Motor Camp. There is no control over these flows, but the channel is defined through the motor camp to reduce flooding of campsites.</p> <p>The stormwater gully has been scoured out since last year due to heavy rainfall events. The scour has deepened the channel and exposed an unknown concrete pipe section upstream of the road (see top image). The concrete box channel still has some sediment but less than 2022 and is in about the same condition. There is now a picket fence protecting the public from falling into the channel downstream of the concrete box channel which has also been scoured deeper. There is no longer an earth plug at the bottom of the channel where it meets the beach and the boulders placed on the beach as erosion protection from waves have been displaced.</p> <p>The gully was not easily inspected due to fallen trees, overgrown vegetation and wet slippery slopes. Conditions were similar to previous inspections, albeit from limited inspection at the lower section of the slope.</p> | <p>The capacity, make up and remediation of the gully or other stormwater control options should be investigated (previous DSI).</p> <p>Clear the downstream gully stormwater channel upstream of the concrete box section, and within the concrete box section (previous DSI).</p> | |

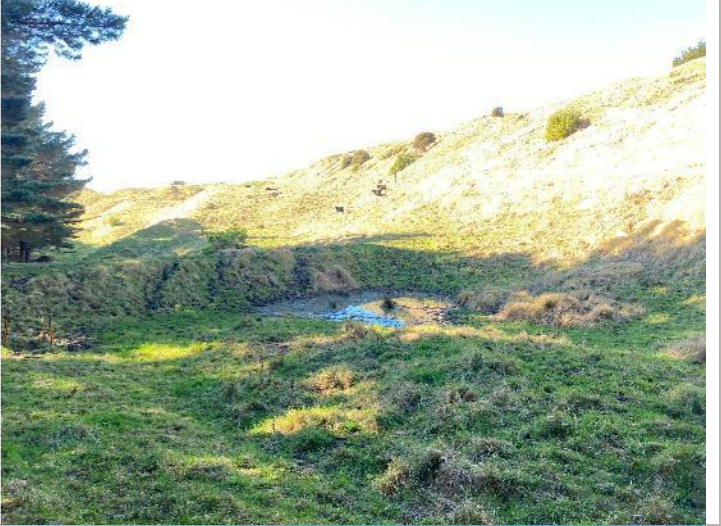
| Dam or Appurtenant Structure | Key Site Inspection Observations | Dam safety issue | Photograph |
|---|---|--|---|
| <p>West Dam</p> | <p>The West Dam was in satisfactory condition. There was a pond of water on the RHS and the ground was muddy.</p> <p>The inlet is clearly marked by 4 waratahs that also help prevent any large debris from blocking the pipe. The pipe inlet was clear of debris as was the outlet.</p> <p>The upstream stock ponds, which are historically in poor condition, were not inspected and landowner of Clifton Station was not home.</p> <p>Flows from the West Dam may flow down a different gully to the motor park below. It was not clear which gully the flood flows travel down and there were water troughs in the downstream area which could be carried by flood flows.</p> | <p>Discuss the stock ponds with the landowner and manage the potential issues and impacts on the flood detention dams (previous DSI).</p> <p>Mark the pipe outlet location for easier maintenance and inspection practices (previous DSI).</p> | |

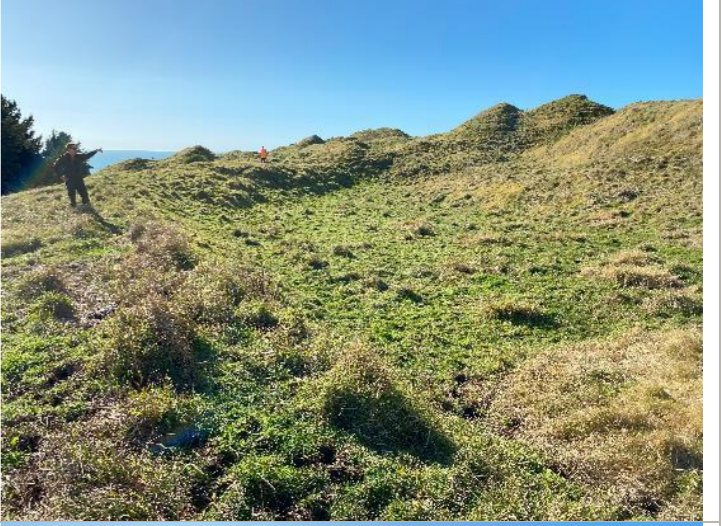
| Dam or Appurtenant Structure | Key Site Inspection Observations | Dam safety issue | Photograph |
|---|---|--|---|
| <p>Lower (Middle) Dam</p> | <p>The Lower Dam was in satisfactory condition.</p> <p>The inlet is clearly marked by 4 waratahs that also help prevent any large debris from blocking the pipe. There was vegetation growing around the inlet but the pipe itself was clear as was the outlet.</p> <p>The lowered crest section in the centre of the embankment (spillway) was clear and stable.</p> | <p>Mark the pipe outlet location for easier maintenance and inspection practices.</p> | |

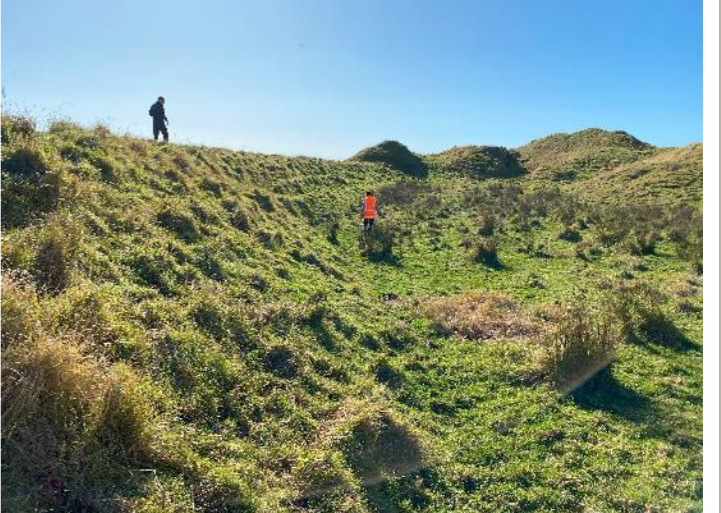
| Dam or Appurtenant Structure | Key Site Inspection Observations | Dam safety issue | Photograph |
|---|---|--|---|
| <p>East Dam</p> | <p>The East Dam was in satisfactory condition.</p> <p>The inlet is a capped pipe with holes to allow water through.</p> <p>The pipe outlet could not be located due to the high grass covering the downstream embankment. The outlet should be maintained with vegetation cleared to ensure unobstructed flows through the pipe.</p> <p>The sea outlet channel was clear and stable, with minor bank erosion visible.</p> | <p>Mark the pipe outlet location so this can be inspected and maintained.</p> | |

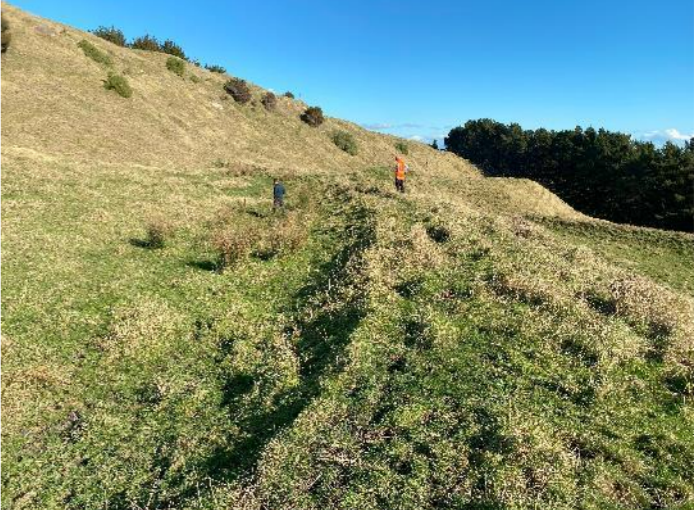
| Dam or Appurtenant Structure | Key Site Inspection Observations | Dam safety issue | Photograph |
|---|--|---|---|
| <p>Upper (Middle) Dam</p> | <p>The Upper Dam was in satisfactory condition.</p> <p>The inlet is clearly marked by 3 waratahs that also help prevent any large debris from blocking the pipe. There was vegetation growing around the inlet but the pipe itself was clear.</p> <p>The pipe outlet could not be located due to the high grass covering the downstream embankment. The outlet should be maintained with vegetation cleared to ensure unobstructed flows through the pipe.</p> | | |

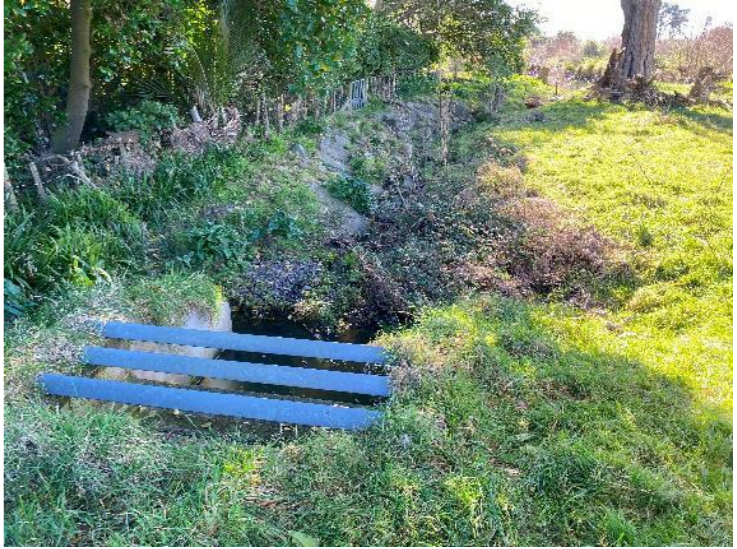
| Dam or Appurtenant Structure | Key Site Inspection Observations | Dam safety issue | Photograph |
|---|---|--|---|
| <p>Pipe & Outlet</p> | <p>During Cyclone Gabrielle, a manhole lid along Clifton Road lifted due to high flows/pressure in the culvert (at a 90 degree bend). The manhole in front of 365 Clifton Road had steel plates to hold the manhole cover down but these had rusted so the manhole cover had limited effect against the ~10 m head of pressure within the pipe at this location. This manhole cover has since been replaced with a stainless steel cover. The other manhole cover in front of 367 Clifton Road still had plates holding the cover on. The pressure in the pipe was enough to lift the concrete manhole cover at the back of 367 Clifton Road property. This concrete manhole was covered in vegetation over the years and the flooding scoured the surrounding earth when the water pressure lifted the manhole, leaving depressions and holes which pose a risk to the public and livestock.</p> <p>The pipe outlet (see image), ~40 m upstream of where discharges into the Maraetotara River, appeared in satisfactory condition. The vegetation was becoming overgrown which hindered inspection and the riprap was partly disturbed.</p> | <p>Clear the vegetation from the concrete manhole at the back of 367 Clifton Road. Raise the manhole so that the manhole lid sits above the ground. Backfill the holes around the manhole.</p> <p>Clear the vegetation from the outlet to inspect rip rap and determine if repairs are needed.</p> | |

| Reference Number | Report Reference | Description | Category | Comments |
|---|---|---|---|--|
| 2023-UTA-2 | S4.3 | Clear the vegetation from the outlet to inspect rip rap and determine if repairs are needed. | PI | |

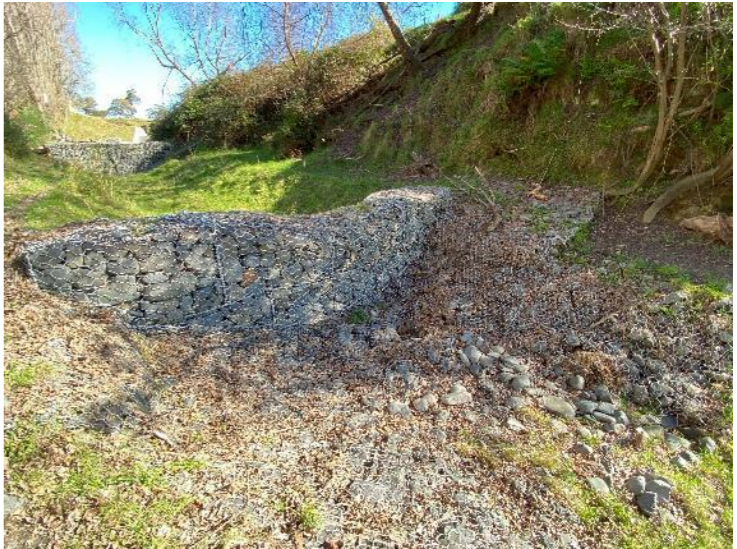
| Dam or Appurtenant Structure | Key Site Inspection Observations | Dam safety issue | Photograph |
|---|---|--|---|
| <p>Spillway Channel</p> | <p>There are two gabion check dams at 20 m intervals downstream of the dam. These were generally stable even though there were clear bulges and holes at the base of the lower one.</p> <p>The gabion wall on the main spillway structure was in similar condition to 2022 but was covered in debris and large branches. The right side is still bulging and the left side now has a large dent.</p> <p>The upper concrete spillway structure was in satisfactory condition.</p> <p>The vertical inlet was in satisfactory condition. There was a small base flow passing through the culvert.</p> | <p>Repair the hole at the base of the lower gabion wall.</p> <p>Monitor the bulges in the gabion walls for movement / further disfigurement. Consider adding a second row of gabions for improved stability.</p> <p>Remove debris.</p> | |

| Reference Number | Report Reference | Description | Category | Comments |
|---|---|---|---|--|
| 2023-UTA-3 | S4.3 | Repair the hole at the base of the lower gabion wall. | PI | |

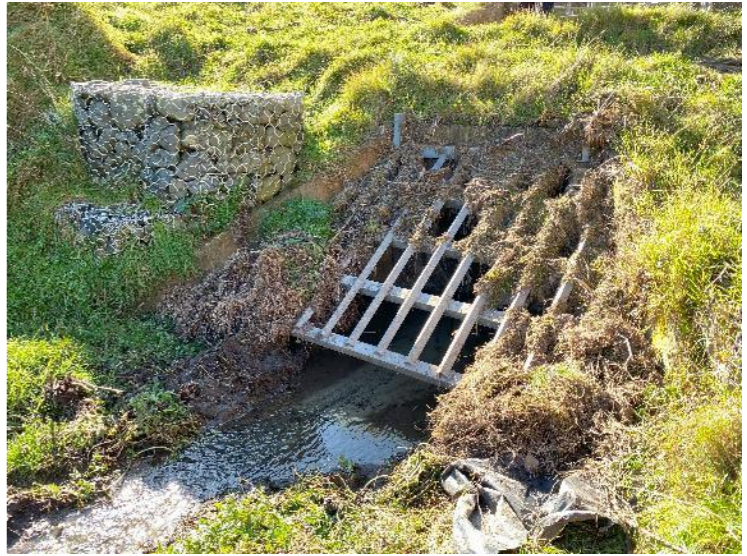
| Dam or Appurtenant Structure | Key Site Inspection Observations | Dam safety issue | Photograph |
|---|---|---|---|
| <p>Culvert & Inlet</p> | <p>The culvert looked clear from the auxiliary inlet but cannot be confirmed without CCTV of the whole pipe. There was some sediment build up near the inlet.</p> <p>The inlet debris screen had some debris and vegetation so that the wing walls were not entirely visible for inspection. The previously cleared vegetation has not returned to the channel in front of the inlet.</p> <p>The gabion wall to the left of the inlet was in in satisfactory condition but was partly covered by vegetation which makes inspection difficult.</p> | <p>Remove screen debris.</p> | |

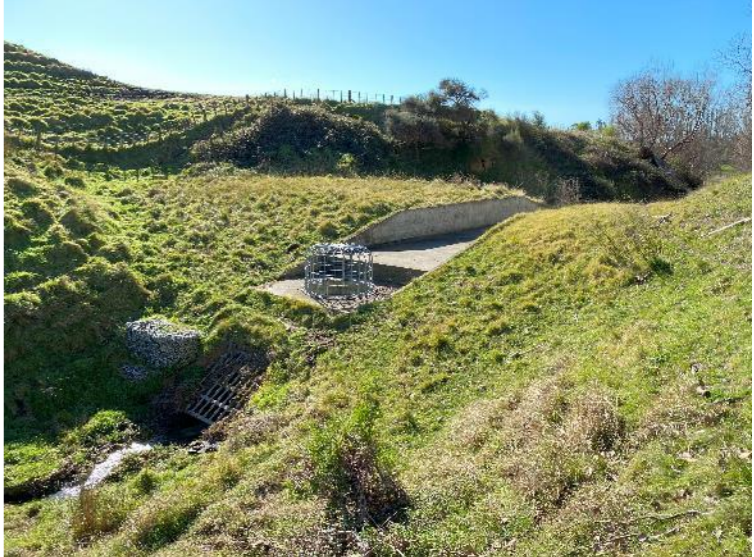
| Dam or Appurtenant Structure | Key Site Inspection Observations | Dam safety issue | Photograph |
|---|---|---|---|
| <p>Dam Embankment</p> | <p>The embankment area was in satisfactory condition with stable slopes and clear crest area.</p> | <p>None.</p> | |

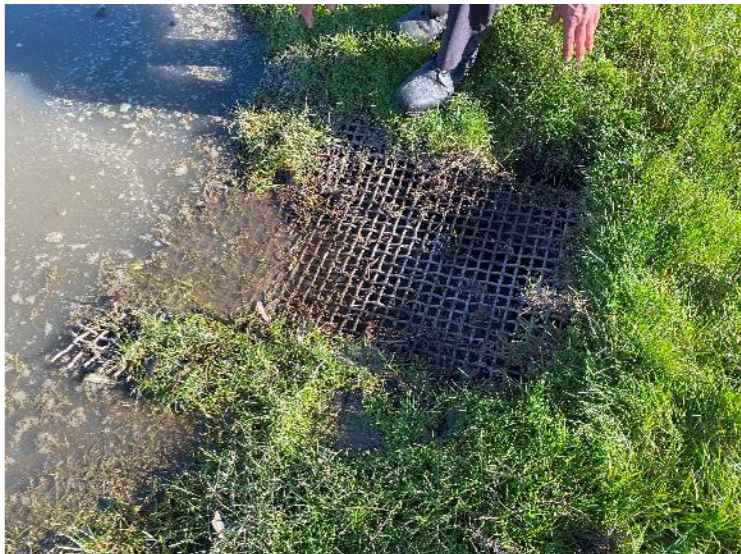
| Dam or Appurtenant Structure | Key Site Inspection Observations | Dam safety issue | Photograph |
|---|--|--|---|
| <p>Left Abutment</p> | <p>The left abutment embankment appeared stable and in satisfactory condition.</p> <p>The pipe through this section was in poor condition where visible and this inlet was not functioning well and was partly blocked by vegetation across the grate.</p> | <p>Previous Dam Safety Issues noted for maintenance of this outlet.</p> | |

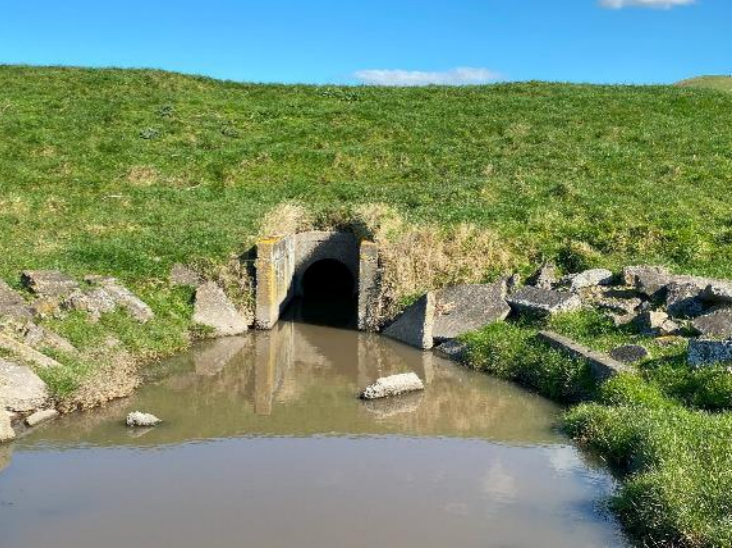
| Dam or Appurtenant Structure | Key Site Inspection Observations | Dam safety issue | Photograph |
|--|--|---|--|
| <p>Spillway and Outlet Culvert</p> | <p>The spillway channel was clear and in satisfactory condition.</p> <p>The inlet structure appeared stable and the debris screen only had minor debris present. The debris included some grass and a couple of cardboard boxes. There was ponded water which prevented an inspection of the invert.</p> <p>The outlet structure was partially obscured by the turbid water flowing through and ponding at the downstream end. The rip rap was scattered, presumably by high flows, so that it no longer performs as intended, and is probably undersized. The rip rap placement should be reviewed and replaced with larger graded stone where it looks light or vulnerable. The structure itself appeared to be in a stable condition.</p> <p>The culvert has previously been recommended to be inspected for movement and current condition. The dams are undergoing CCTV inspection to check on the condition of the culverts, but a quick visual inspection showed no obvious signs of deterioration or settlement of the culvert. Note that CCTV is still recommended due to the low spots on the crest that suggest settlement or internal erosion.</p> | <p>Review and improve the rip rap protection to the area downstream of the culvert and outlet structure (previous DSI).</p> <p>Complete a culvert inspection (CCTV) for current condition and identifying issues (previous DSI).</p> | |

| Reference Number | 2022 Report Reference | Description | Category | Status |
|---|---|---|---|---|
| 2022-UTA-3 | S3.4 | Complete a culvert inspection (CCTV) for current condition and identifying issues. | PI | Planned. |

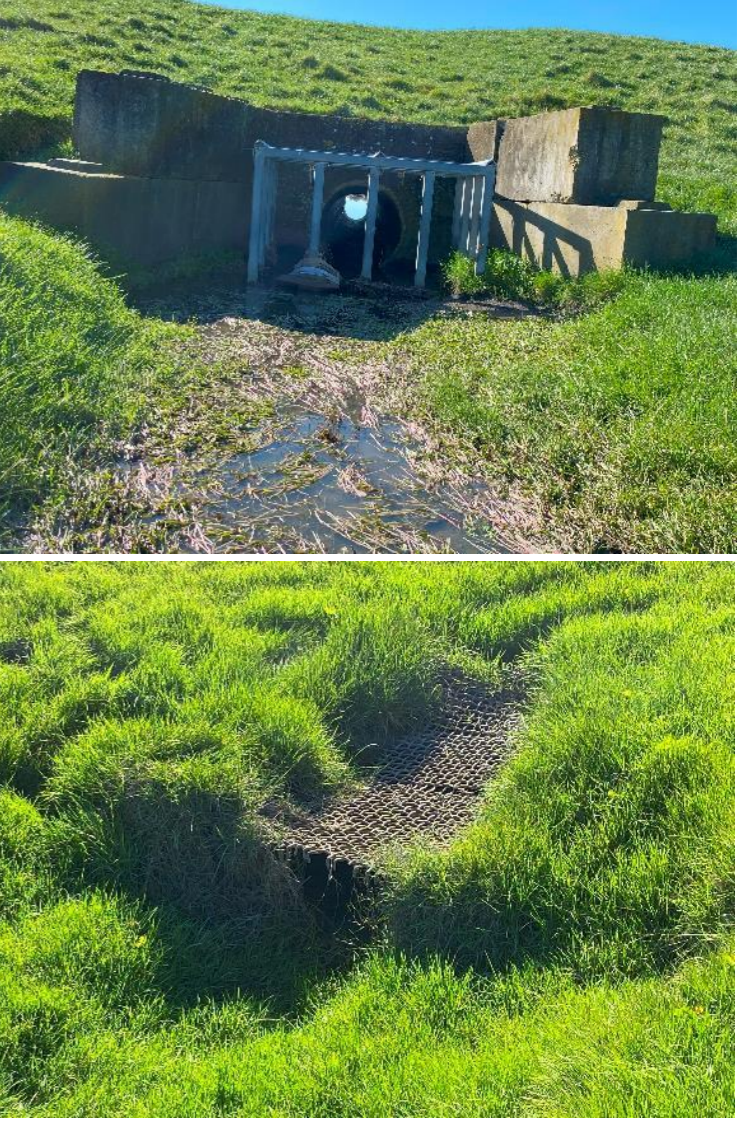
| Dam or Appurtenant Structure | Key Site Inspection Observations | Dam safety issue | Photograph |
|--|--|---|--|
| <p>Embankment, Reservoir and Right Abutment</p> | <p>The main embankment dam was in satisfactory condition with consistent short grass coverage. The previously identified low spot of the crest could indicate settlement or internal erosion around the culvert.</p> <p>The right abutment pipe was overgrown at the outlet and had ponded water. This should be cleared by rodding for improved functionality. The inlet was relatively clear but requires some maintenance and vegetation clearance. The grate covering the inlet was raised to allow small flows through without getting blocked.</p> <p>The reservoir area was clear.</p> | <p>Conduct a detailed dam topographic survey to identify and monitor any low spots (previous DSI).</p> <p>Complete maintenance on the right abutment pipe at the inlet and outlet to ensure this will function adequately (previous DSI).</p> | |

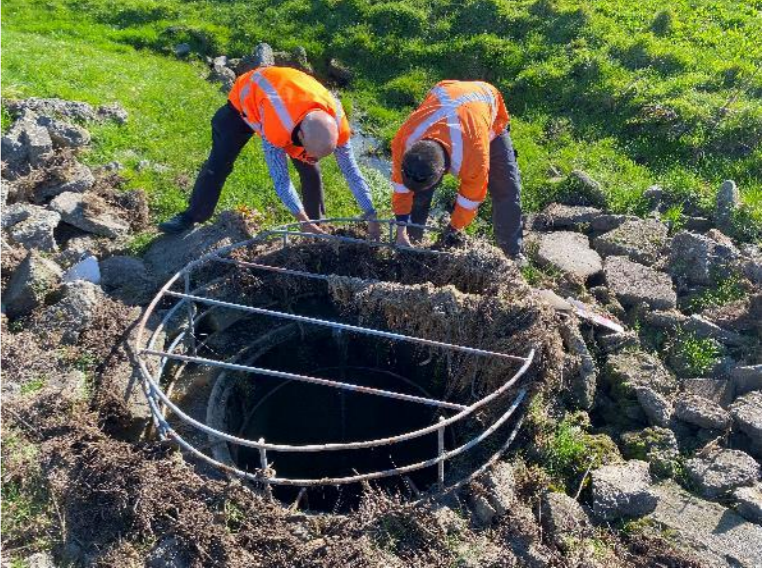
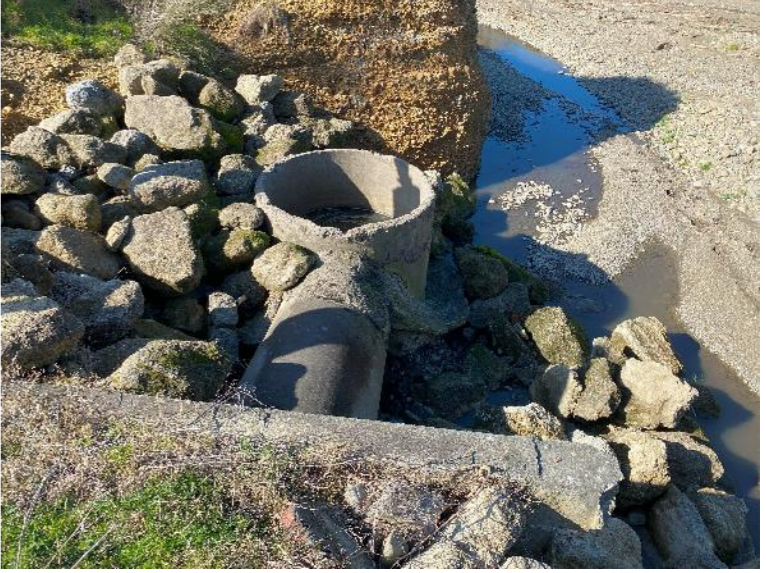
| Dam or Appurtenant Structure | Key Site Inspection Observations | Dam safety issue | Photograph |
|--|--|---|--|
| <p>Downstream Outlet (to Charlton Stream)</p> | <p>The culvert inlet structure was covered in debris. This was removed during the inspection to allow more flow and stop the ponding. Maintenance should be completed around the structure with review of adequacy of inlet structure and replacement of rip rap.</p> <p>The outlet culvert structure was in similar condition to the previous inspections, with the placement of rock protection around the structure (completed previously by HBRC Works Group). Leakage appeared to be exiting outlet near the base and trickling through the rip rap. This is not a significant problem, as flow can be managed through here, but should be monitored for any issues or changes in future.</p> | <p>Complete maintenance at the inlet and outlet of the downstream outlet (Charlton Stream). Previous DSI.</p> <p>Review the adequacy of rip rap around the downstream culvert outlet. Previous DSI.</p> | |

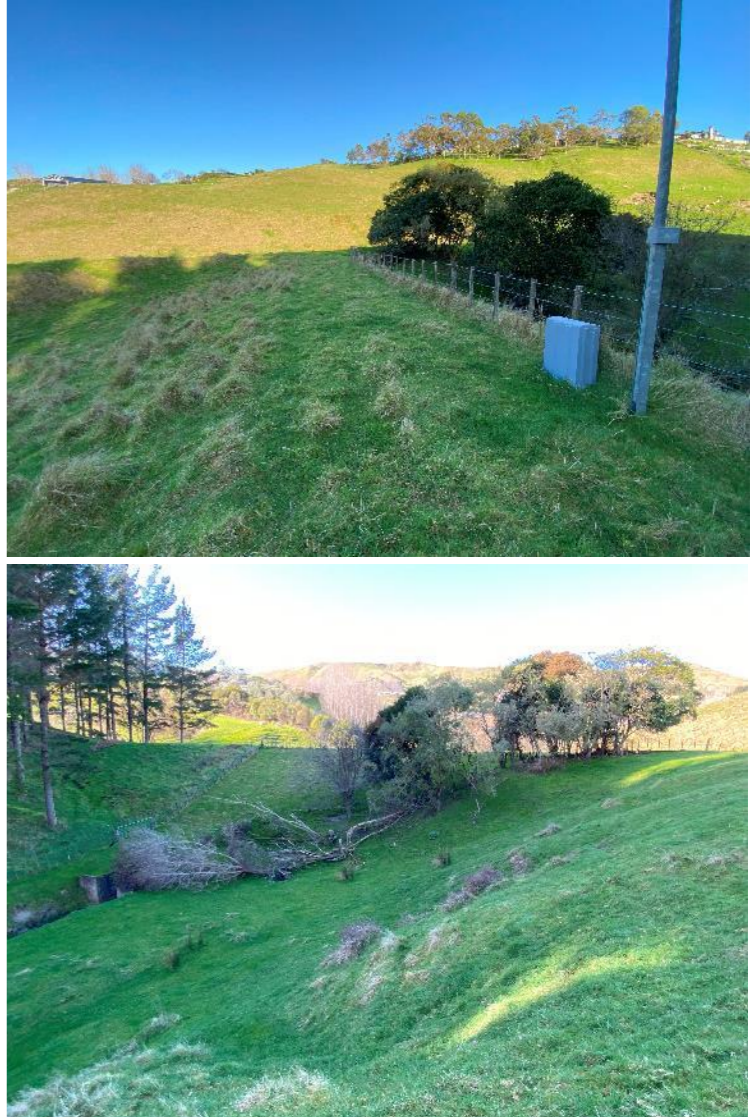
| Dam or Appurtenant Structure | Key Site Inspection Observations | Dam safety issue | Photograph |
|---|--|--|--|
| <p>Embankment</p> | <p>The dam crest and slope in general were in satisfactory condition. There were no obvious issues with slope movement or crest settlement.</p> <p>The trees and vegetation on the downstream left abutment should be removed, as some have already fallen over and should be cleared. This would assist in providing a clear area for inspection and lessen risks of root infiltration into the embankment. As viewed in the previous inspection, this has also caused some surface erosion from runoff.</p> <p>Pine trees identified as becoming established on the upstream right side of the embankment should be removed. Although unclear where the dam turns into the right abutment, there are pine trees on the dam that could cause similar issues as those mentioned above for the trees on left abutment.</p> <p>Sheep were present in the valley, helping to maintain appropriate grass length. Use of sheep to control vegetation is an acceptable practice. There was also a dead sheep on the downstream embankment which should be removed.</p> | <p>Clear trees and vegetation from the downstream left abutment (between the dam and spillway) (previous DSI).</p> <p>Clear the pine trees on the upstream slope and crest near the right abutment (previous DSI).</p> | |

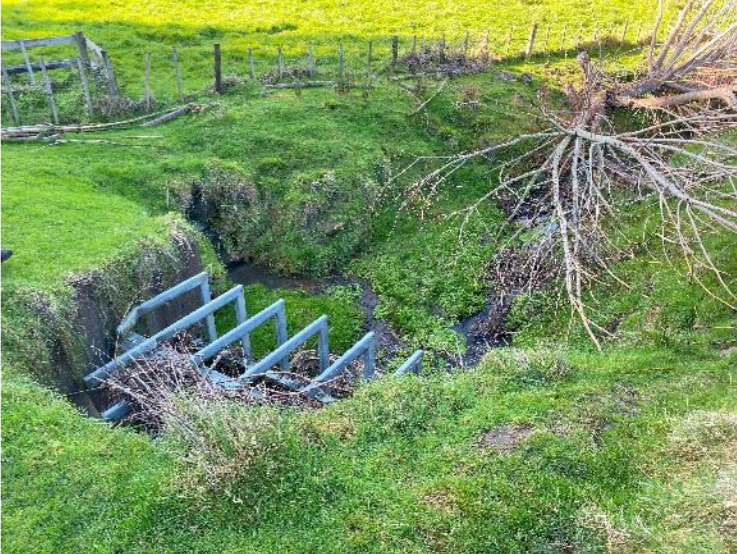
| Dam or Appurtenant Structure | Key Site Inspection Observations | Dam safety issue | Photograph |
|---|--|---|---|
| <p>Upstream Channel and Inlet Structure</p> | <p>The upstream channel from the culvert inlet had large trees that have fallen. The trees were not blocking the low flow during the inspection but would be a problem for larger flows and should be removed.</p> <p>The inlet also had debris blocking the screen which impedes flow and should be cleared. Karituwhenua is the only Havelock North dam without an auxiliary inlet that can be used if the inlet gets blocked. Options to install an auxiliary inlet should be investigated.</p> <p>Keeping debris clear will also help prevent damage to the instrument (RHS of inlet) that monitors the reservoir level.</p> <p>A side channel feeds into the inlet from the RHS. There is a culvert at the property boundary fence that drops the water to the inlet channel. The culvert was in poor condition, and most of the flow was bypassing it. The culvert inlet was surrounded by a wooden fence but the hole where most of the water flows is in open field and the outlet, just upstream of the dam's inlet, was overgrown.</p> | <p>Remove trees from upstream channel (including those that have fallen over) (previous DSI).</p> <p>Clear debris from inlet screen.</p> <p>Repair side channel culvert to control inflows.</p> <p>Investigate the installation of an auxiliary inlet (previous DSI).</p> | |

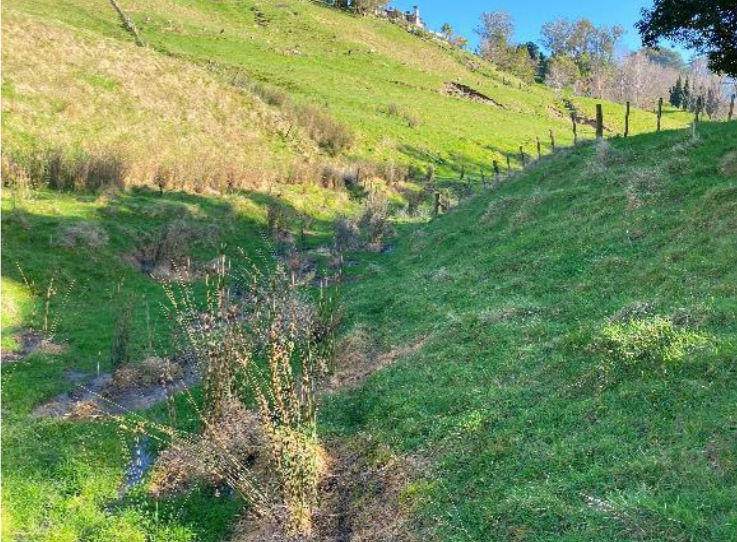
| Dam or Appurtenant Structure | Key Site Inspection Observations | Dam safety issue | Photograph |
|---|--|---|---|
| <p>Spillway Channel</p> | <p>The spillway channel was wet during the inspection from recent rainfall. Otherwise, the spillway channel was in satisfactory condition.</p> <p>Fencing within part of the spillway channel about halfway down has the potential to be a restriction during flood operation of the spillway. This should be removed or at the very least pushed back out of the trapezoidal spillway channel.</p> <p>Downstream of the spillway channel there is an open corrugated half pipe with timber headboards to direct flows. This is ineffective as the flow travels underneath this pipe and has scoured large areas under it. This structure is far enough away from the dam to not cause concern but will continue to erode and may wash away in a large flood.</p> | <p>Remove or adjust all fencing from within the spillway channel (previous DSI).</p> <p>Re-design the spillway outlet structure and restore the eroded slope (previous DSI).</p> | |

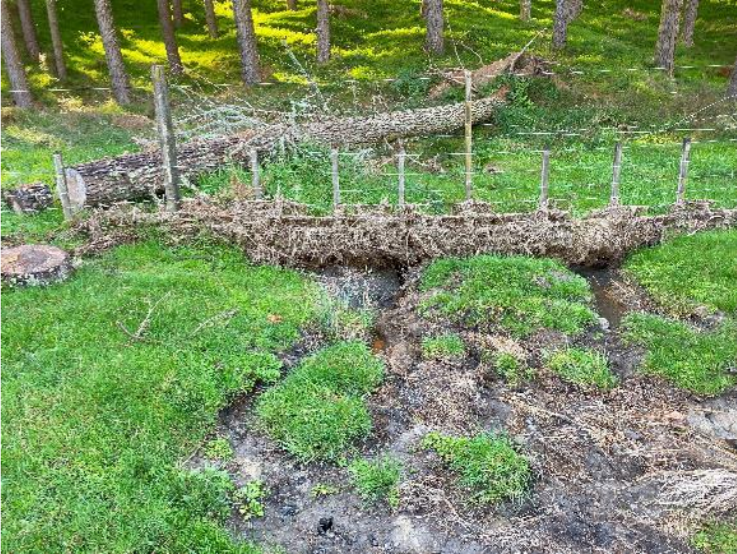
| Dam or Appurtenant Structure | Key Site Inspection Observations | Dam safety issue | Photograph |
|---|--|---|---|
| <p>Outlet Structure and Downstream Channel</p> | <p>The culvert outlet structure was partially obscured by a fallen tree on the LHS. This tree (and the rest on the LHS of downstream face mentioned under embankment) should be removed to allow a clear view. A fence should be installed around the outlet structure to prevent people/stock falling in.</p> <p>The water in the outlet was turbid so a clear view of the dissipators and outlet structure floor was not possible. The concrete walls looked to be in satisfactory condition with some minor damage to the end of the LHS wall. Immediately downstream of the outlet structure had a lot of scour, especially of the left bank. Surface drainage from the trees on the LHS of downstream face was entering the stream in the same area and likely contributed to the scour on the left bank.</p> <p>The downstream channel was mostly clear. There were signs of slips along the downstream valley. There is a fence across the stream which had a lot of small debris and was damaged by a fallen tree. The debris and tree should be removed so that flow is not impeded. If possible, the fence should also be removed. The tree narrowly missed falling on the borehole/ gauge. HDC should check which resident owns this instrument and what data they collect.</p> | <p>Remove trees that have fallen over outlet & downstream channel (previous DSI).</p> <p>Reinstate the bank from scour damage and protect further scour at outlet structure (LHS in particular).</p> | |

| Reference Number | Report Reference | Description | Category | Comments |
|---|---|---|---|--|
| 2023-KW-2 | S4.5 | Reinstate the bank from scour damage and protect further scour at outlet structure (LHS in particular). | PI | |

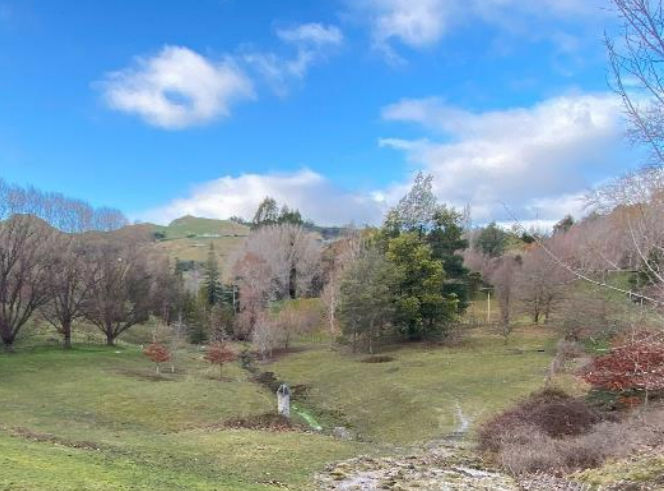
| Dam or Appurtenant Structure | Key Site Inspection Observations | Dam safety issue | Photograph |
|---|--|--|---|
| <p>Reservoir Area, Upstream Channel, and Inlet Culvert</p> | <p>There was evidence of channel erosion in the upstream channel as well as several dead sheep. A patch of bushes and most of the trees in the upstream channel area have withstood the cyclone event. There were some trees that came down and lost their branches, but these were mainly at the abutments. All vegetation and trees near the channel should be removed as they can impact flow and the trees that have fallen should also be removed to prevent them blocking the inlet.</p> <p>The inlet culvert was blocked with debris, including a dead sheep. There was still a small flow passing through the culvert but signs of ponding upstream. The telemetry system that records reservoir level sits on the right of the inlet.</p> | <p>Remove trees from upstream channel (especially those that have fallen over) – previous DSI.</p> <p>Remove vegetation, debris, and dead sheep from upstream channel & culvert inlet.</p> | |

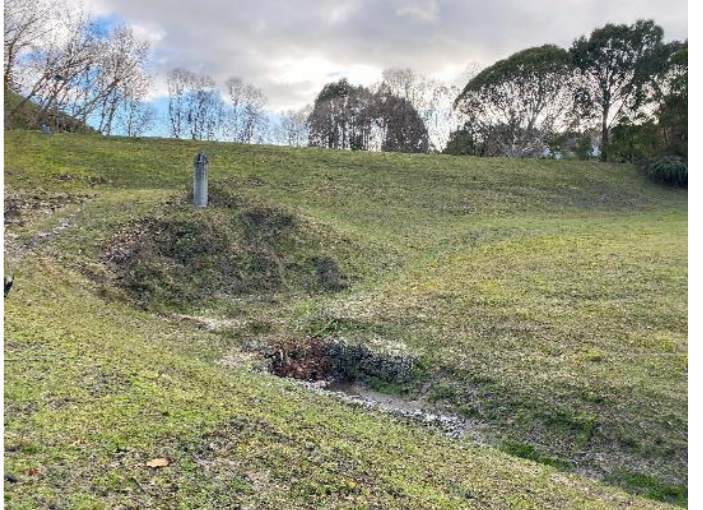
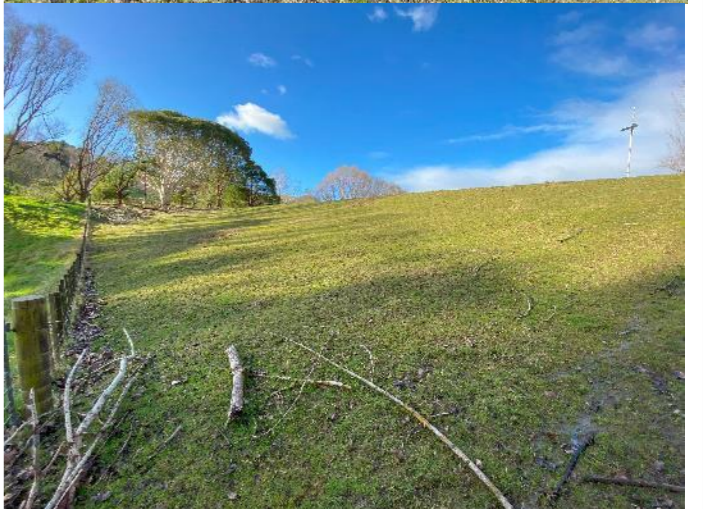
| Dam or Appurtenant Structure | Key Site Inspection Observations | Dam safety issue | Photograph |
|---|---|---|--|
| <p>Embankment</p> | <p>The dam crest and slopes appeared stable with no signs of instability. The abutments showed signs of slips with material seen on the LHS of the upstream face. Since the ground was wet, the tracks where the owner had traversed to the paddocks were clearly visible and muddy.</p> <p>A cable (most likely pressure sensor cable for depth measurement) had been exposed between the inlet and auxiliary inlet. Measures should be taken to ensure this does not get damaged (e.g., bury it again).</p> <p>The pond upstream of the spillway on the right abutment was high and so a small amount of water was flowing across the toe of the dam towards the inlet. This means that until the pond level goes down, the toe of the dam will remain saturated.</p> <p>The downstream face was in satisfactory condition with large branches and cut up trees scattered at the bottom. These should be removed to prevent damage to the outlet structure.</p> | <p>Monitor the slips on the upstream left abutment for further movement.</p> <p>Protect the exposed telemetry cable below the auxiliary inlet.</p> <p>Remove debris.</p> | |

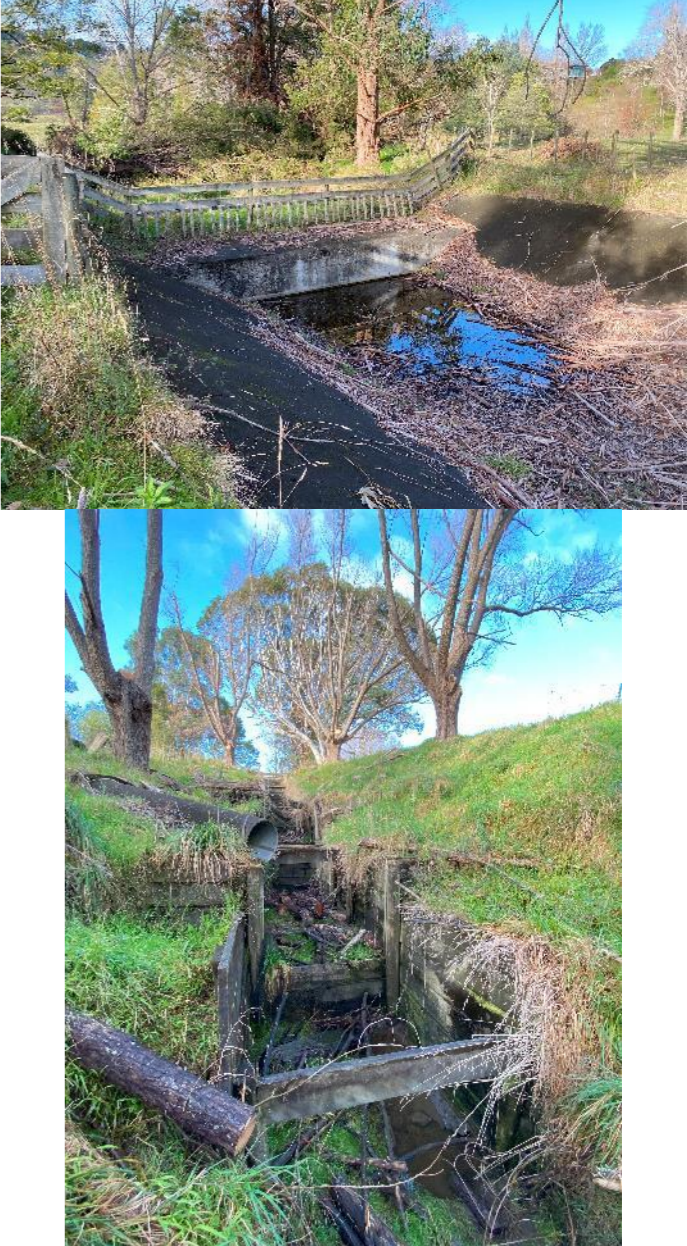
| Dam or Appurtenant Structure | Key Site Inspection Observations | Dam safety issue | Photograph |
|---|---|--|---|
| <p>Spillway</p> | <p>A large tree had fallen and was blocking the spillway entrance channel. The large trees around the spillway entrance need to be removed to restore spillway capacity. There were also trees lining the spillway channel that should be removed before their roots do more damage to the spillway structure.</p> <p>The concrete spillway appeared in satisfactory condition but tree roots were starting to lift the panels out of place on the left. The fence with swing gate across the start of the spillway structure is a dam safety issue in large floods, as it will constrict flows. Significant blockage is also likely. Currently the fence/gate does not open easily due to the stiff hinges and grass/debris.</p> <p>The long grass and vegetation around and within the wooden spillway structure obscures the timber which made inspection difficult. The surrounding long grass should be trimmed, and the channel invert cleared out as part of maintenance to allow for visual inspections. From the timber cross supports that could be inspected, a number were cracked or missing and should be replaced.</p> <p>There is a culvert with a small headwall that feeds a side channel into the spillway structure. During the inspection there was only a small amount of water coming through, but there was evidence on the left wall of the spillway structure that more water has passed through. There was some debris and vegetation around the culvert inlet that should be cleared.</p> <p>At the bottom of the wooden spillway structure there was a lot of wood from fallen trees that had been chopped up. This should be removed so that it does not obstruct the flow and become hazards downstream.</p> | <p>Clear trees and vegetation from upstream of, within, and along the sides of the spillway.</p> <p>Clear debris from and monitor the entrance to the side culvert (right side of spillway).</p> | |

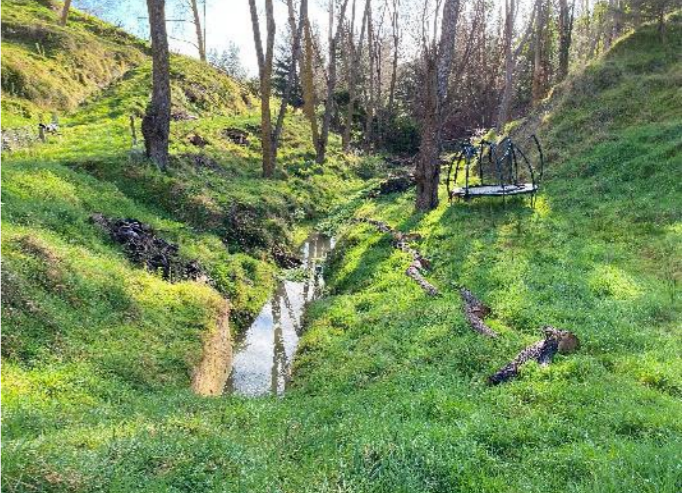
| Dam or Appurtenant Structure | Key Site Inspection Observations | Dam safety issue | Photograph |
|---|---|--|---|
| <p>Outlet Culvert and Downstream Channel</p> | <p>The downstream channel area was flowing and clear, however above the channel flow there were numerous trees, branches, and logs. These represent significant debris and blockage potential and hazards downstream so should be removed. There was also an old trampoline that should be removed.</p> <p>The outlet structure was in satisfactory condition. The invert of the structure was not visible for inspection due to the depth of turbid water.</p> | <p>Remove the trees, large branches, and logs from within the downstream channel area in the vicinity of the dam (previous DSI).</p> <p>Remove the trampoline.</p> | |

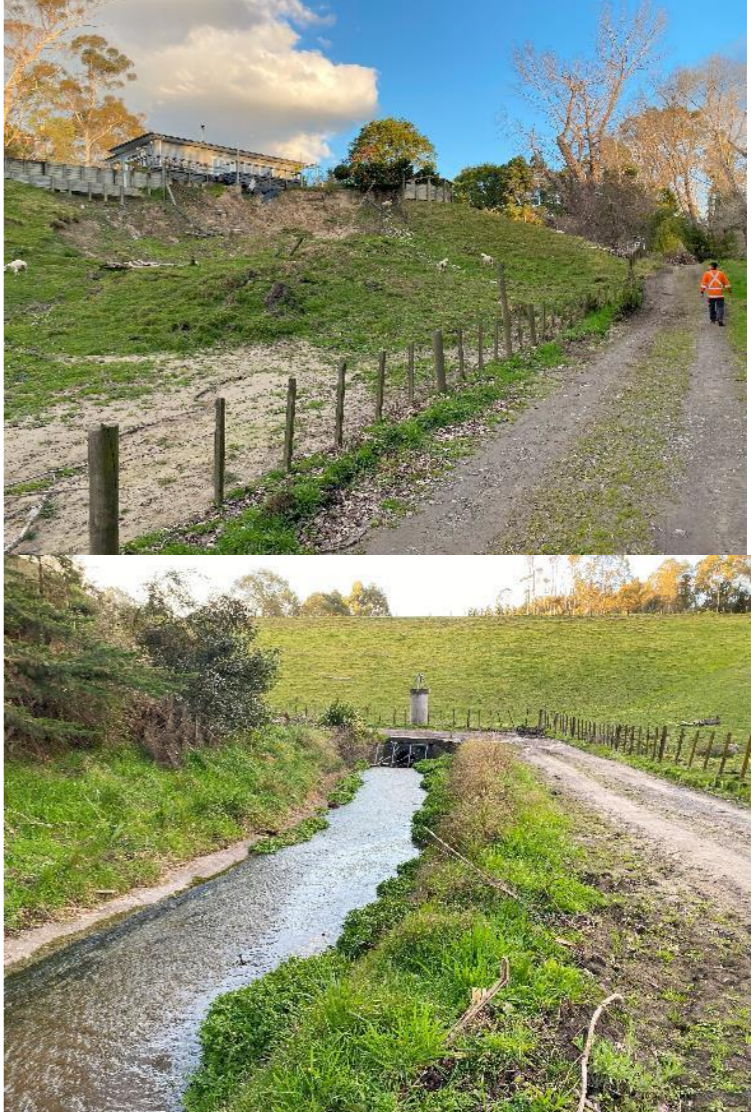
| Dam or Appurtenant Structure | Key Site Inspection Observations | Dam safety issue | Photograph |
|---|---|--|--|
| <p>Reservoir Area, Upstream Channel, and Inlet Structure</p> | <p>The upstream channel was in a satisfactory condition. There was some erosion damage to the channel from the cyclone. The footbridge has been previously identified in poor condition and should not be used.</p> <p>The reservoir area incorporates a driveway for one of the properties which will be impacted during an extreme flood event (it would have been under a few metres of reservoir for a few hours during the cyclone). There was a large landslide that had washed away the deck of the house in the immediate reservoir area upstream of the dam. The ground should be monitored for further signs of landslides. There were sheep grazing in the upper reservoir area.</p> <p>The vertical auxiliary inlet structure was in satisfactory condition. There was some vegetation around the inlet and concrete channel that should be removed to keep the capacity of the inlet.</p> <p>No issues were identified with water previously appearing to be seeping in various places (mainly at joints) on the right concrete slope of the upstream channel. But with wetter conditions on the day this would have been harder to detect. This should be monitored in future inspections for any issues.</p> | <p>Clear the upstream channel and inlet of vegetation and remove the branch across the inlet (previous DSI).</p> <p>Remove trees from upstream channel (previous DSI).</p> | |

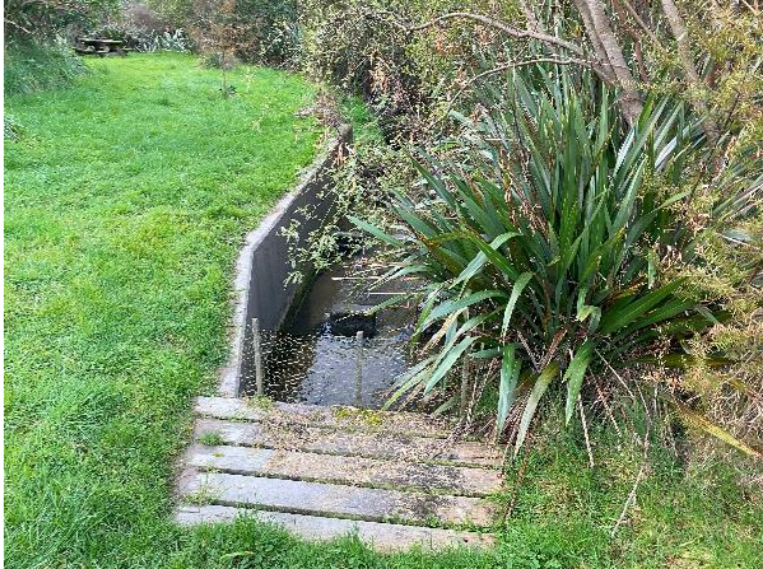
| Dam or Appurtenant Structure | Key Site Inspection Observations | Dam safety issue | Photograph |
|---|--|--|--|
| <p>Outlet Culvert and Downstream Channel</p> | <p>The outlet culvert structure was in satisfactory condition and was clear at the outlet and within the stilling basin. The view of the outlet structure was partially obscured by vegetation growing on the right side of the outlet structure. There is already a small fence/barrier above the outlet structure which could be improved to prevent falls into the outlet.</p> <p>The flow was low enough to allow view of the dissipation blocks which seemed in satisfactory condition. There was some sediment sitting in the stilling basin.</p> <p>The downstream channel has been landscaped into a picnic area with new trees planted. As long as the new trees are not planted in an area that will impact large flows, this is acceptable. The public should be aware of the dam and any potential consequences from heavy rainfall and floods.</p> <p>The vegetation around the confluence of spillway with outlet should be cleared to improve the outflow capacity. There were signs of some erosion in the downstream channel, especially at the spillway outlet. The channel should be monitored for further erosion and may require rip rap if more damage occurs.</p> | <p>Clear the vegetation from the RHS of the outlet structure to allow better view for inspections (previous DSI).</p> | |

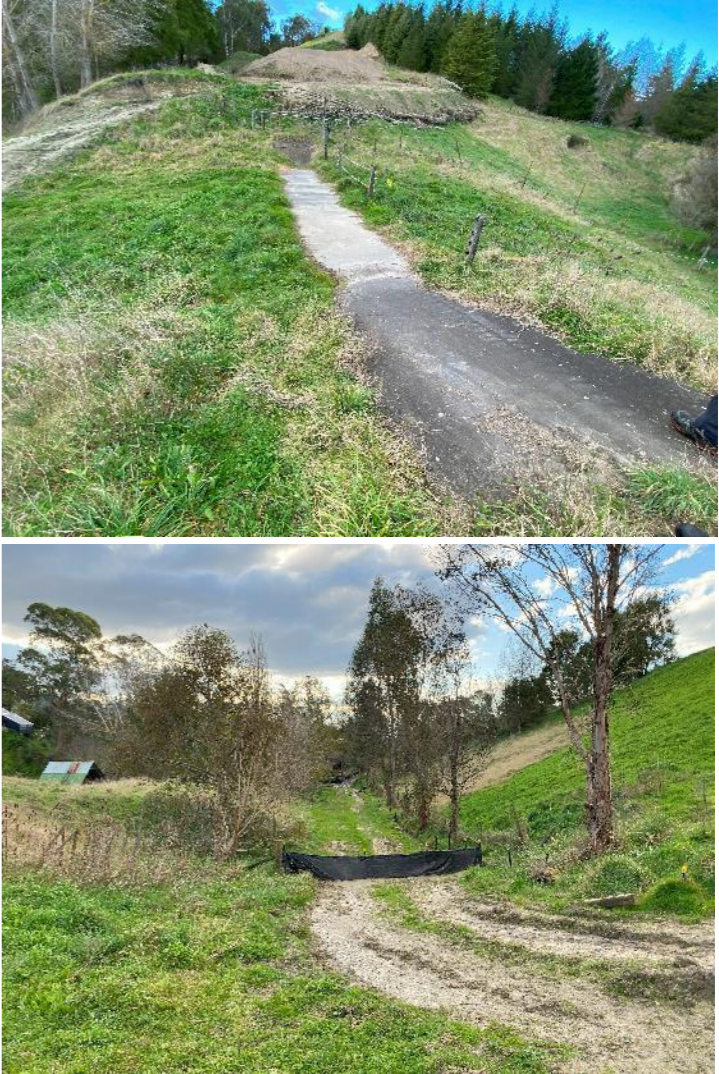
| Dam or Appurtenant Structure | Key Site Inspection Observations | Dam safety issue | Photograph |
|---|---|--|--|
| <p>Spillway Channel</p> | <p>The spillway channel was being used as an access road by the developer of the adjacent subdivision and the plans seem to show the spillway channel acting as a driveway for the completed development. This should be discussed with the developer as it would affect access during flood events and spillway operation.</p> <p>The developer had installed temporary silt fences along the right side of the spillway channel which were damaged due to flow from the spillway operation in the cyclone. There was also a silt curtain across the channel which will block flow down the spillway and should be removed.</p> <p>The spillway channel was lined with trees and fences which will reduce flow capacity. Some of the obstructions are still within the roughly trapezoidal channel where the majority of the flow passes through. These should be removed or at least pushed back out of the main channel.</p> <p>Some scour was evident at the top of the channel where the stream flows under the spillway (in a culvert) which suggests this stream overtopped and flowed down the spillway channel. The developer has already made efforts to restore the spillway channel as the access road, but if this is used as a driveway in the future, the residents should be aware of this and the possible operation of this channel in flood events which may prevent them access during and after the event.</p> <p>The concrete sill at the spillway crest was in satisfactory condition. The surrounding grass should be maintained shorter and the electric fence across the channel removed.</p> | <p>Remove the electric fence from across the spillway structure and silt curtains across the spillway channel.</p> <p>Remove the vegetation, trees, and adjust fences from within the spillway channel (previous DSI).</p> <p>Remove silt fences and silt from along the side of the spillway channel once development is completed (previous DSI).</p> | |

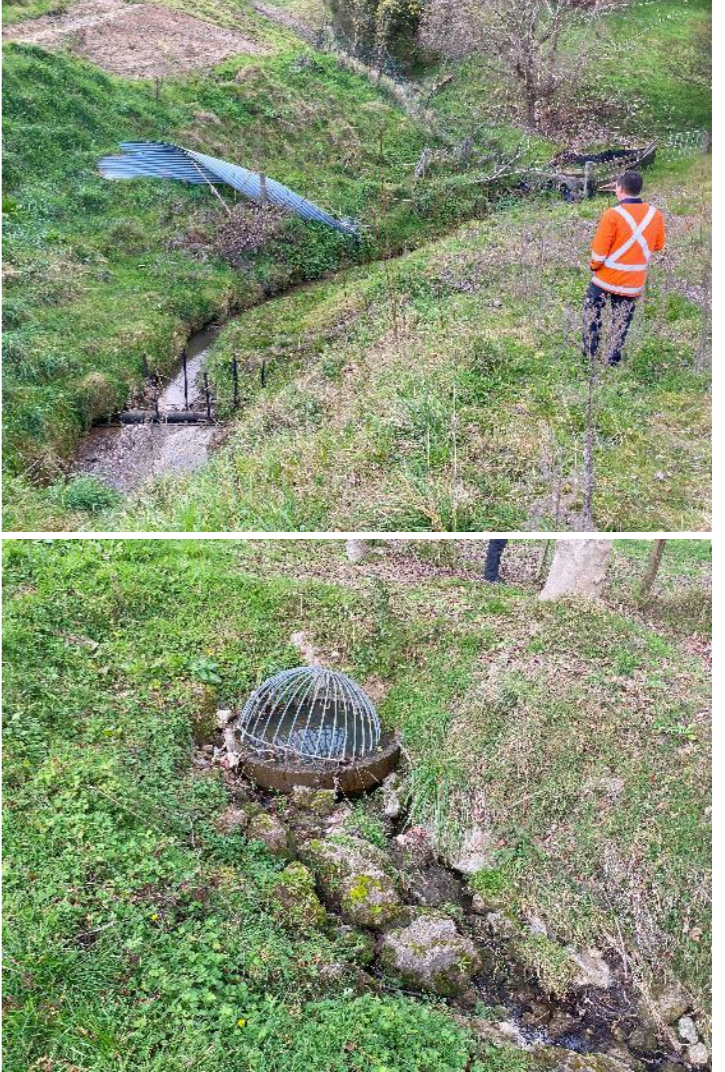
| Dam or Appurtenant Structure | Key Site Inspection Observations | Dam safety issue | Photograph |
|---|---|---|--|
| <p>Upstream Channels</p> | <p>The side channel culvert that runs under the spillway (downstream to upstream) to the dam's upstream channel has undergone upstream works since the last inspection. The culvert inlet now has a concrete pad (~1m long) with waratahs at the upstream end to catch large debris and horizontal bars across the inlet for any debris the waratahs do not capture. The developer may have completed these improvements, without consulting the council, after the Cyclone Gabrielle event where water from this stream overtopped and flowed down the spillway channel. There is still a chance for overtopping if the loose fencing in the upstream channel were to catch on the waratahs and block the culvert. The scruffy dome of the outlet has not been fixed since the last inspection, but the surrounding rock channel does not seem worse. The condition of the flap gate is unknown.</p> <p>The main upstream channel, just upstream of the inlet, was scoured in places and had a few large branches and trees lying on the banks. Some of the fallen trees in the reservoir area have been chopped into smaller pieces, but not yet removed. Vegetation is still a concern and should still be monitored. There is a build-up of silt on the channel banks and sand in the stream bed.</p> | <p>Maintenance of the side channel outlet and restore the scruffy dome to correct position. Investigate the flap gate (previous DSI).</p> <p>Discuss improvements with developer and investigate rip rap for spillway above side channel inlet.</p> <p>Clear sediment build up in the channel just upstream of the inlet.</p> <p>Remove trees from upstream channel especially those that have fallen over.</p> | <p>The top photograph shows a person in an orange safety vest standing on a grassy slope next to a culvert outlet. A blue corrugated metal structure is visible in the background. The bottom photograph is a close-up of a circular, wire-mesh dome structure partially buried in a rocky channel.</p> |
