**FLOOD DETENTION DAMS - 2023
INTERMEDIATE DAM SAFETY REVIEW**

27 September 2023

Prepared for:
Hastings District Council

Prepared by:
Stantec

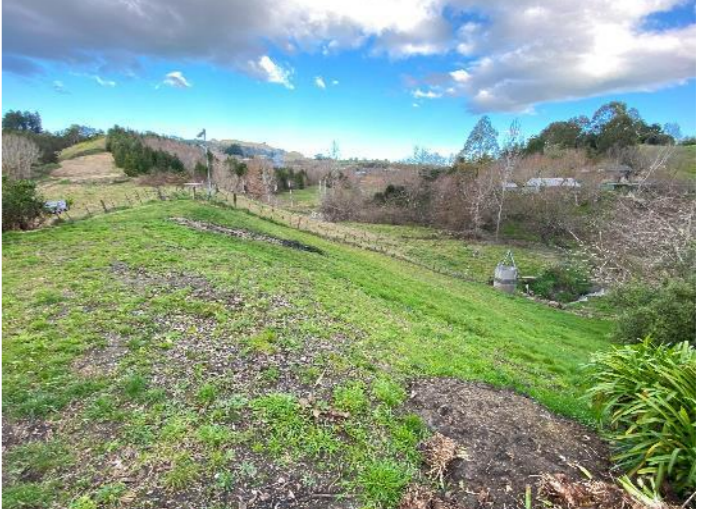
| Dam or Appurtenant Structure | Key Site Inspection Observations | Dam safety issue | Photograph |
|---|---|---|--|
| <p>Embankment</p> | <p>The downstream embankment area was generally in satisfactory condition. The grass was overgrown which made it difficult to spot any issues like animal burrows. There was no stock present and various fences ranging from fair to poor condition run across the dam embankments. Some areas of the crest were in poor condition from previous stock use and these areas should be repaired (i.e., backfilled and grassed over).</p> <p>There was a slight line (~1 m) on the downstream face that suggests a slump but no indication of further movement and appeared stable at the time of inspection. There were stringlines set up down the left abutment along the garden edge. It is worth keeping communication with the residents to understand future development of the land.</p> <p>The upstream embankment had a patch of scorched earth. This is not a significant issue but is a good reminder of the public's access and misuse of the dam.</p> <p>Some evidence was still visible as to the level of storage during the cyclone, with vegetation/debris on the upstream slope and fence lines.</p> | <p>Remove fences and clear vegetation across the dam area. Repair damaged areas such as erosion across the crest (previous DSI).</p> <p>Monitor for changes to the slump on the downstream slope.</p> | <p>The photograph shows a wide view of the dam embankment. In the foreground, there is a grassy slope with a visible line of slump. Fences run across the embankment. In the background, there are trees and a blue sky with some clouds.</p> |

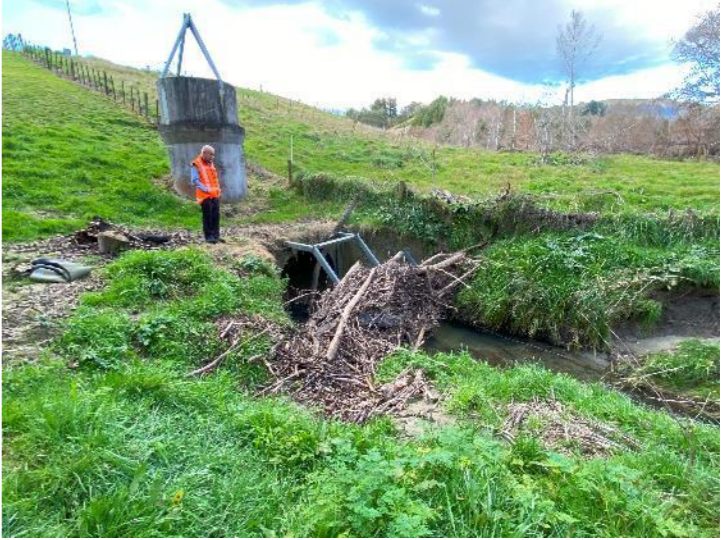
| Dam or Appurtenant Structure | Key Site Inspection Observations | Dam safety issue | Photograph |
|---|---|---|--|
| <p>Inlet Structure</p> | <p>The inlet had a lot of debris built up on the screen. This debris is blocking the inlet so needs to be removed. The inlet should also be monitored for any significant sediment build up that could also block flow.</p> <p>The vertical auxiliary inlet structure appeared in satisfactory condition.</p> | <p>Clear debris from the inlet screen.</p> | |

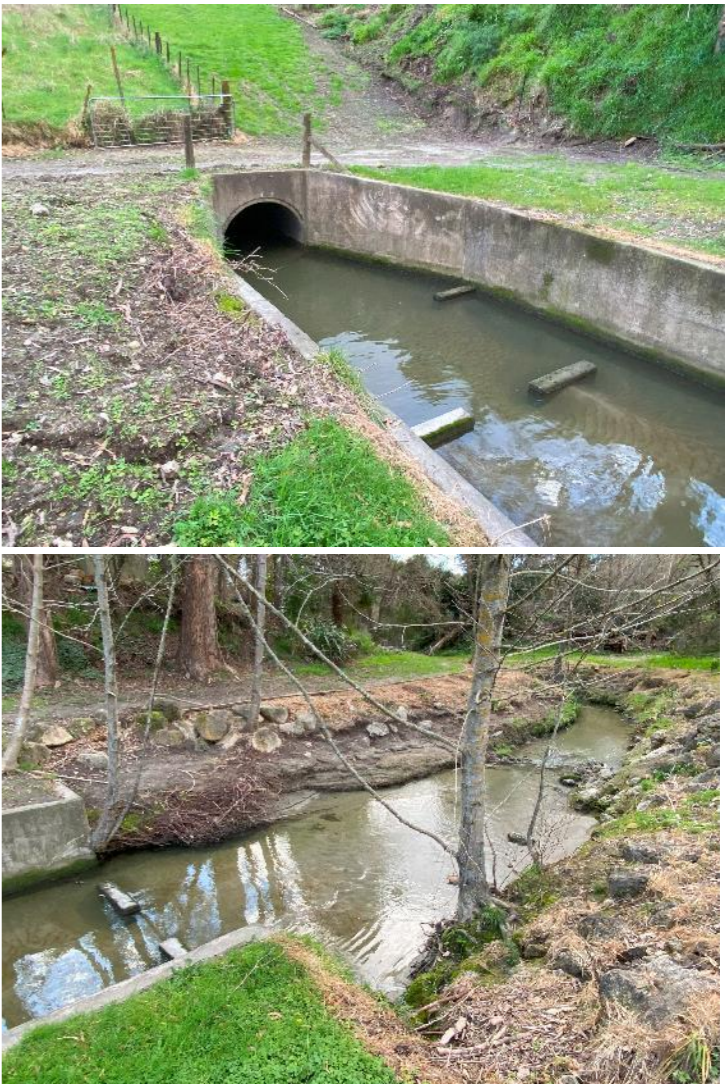
| Dam or Appurtenant Structure | Key Site Inspection Observations | Dam safety issue | Photograph |
|---|---|---|--|
| <p>Outlet Structure and Downstream Channel</p> | <p>The outlet structure appeared in reasonable condition with some sediment deposits in the stilling basin. The trees at the end of the stilling basin had managed to survive even though scour had exposed their roots. These trees are at great risk of falling and should be removed to prevent damage.</p> <p>The downstream channel showed signs of scour but has had significant upgrades to make a public pathway and bank repairs following the cyclone. There were a couple of fences and picnic tables on the left bank as well as an eel feeding shelter. The planting and regeneration along the left bank are acceptable but will require ongoing maintenance.</p> <p>On the right bank, the developer had installed a silt curtain across the lower spillway channel where it would flow back into the stream. This silt curtain will hinder flow and so should be removed, and an alternative solution found that will not block flow.</p> | <p>Remove trees from the ends of the outlet structure (stilling basin) (previous DSI).</p> <p>Remove silt curtain blocking the spillway channel where it flows back into the stream. Discuss alternatives with the developer.</p> | |

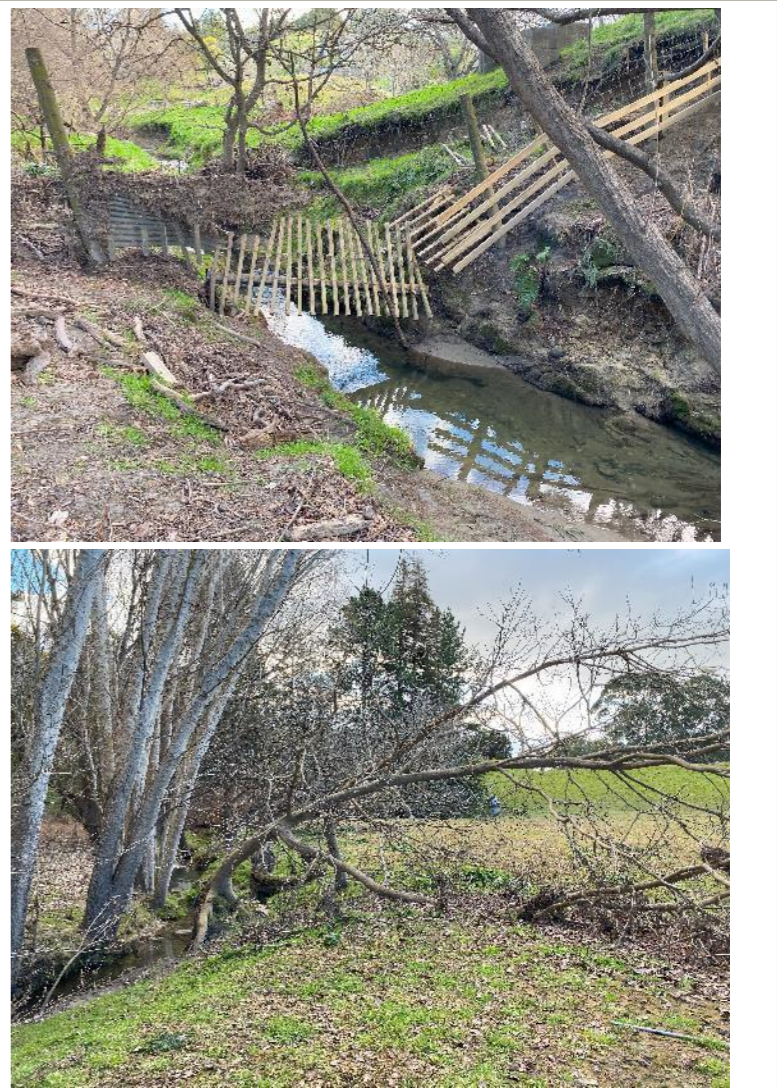
| Dam or Appurtenant Structure | Key Site Inspection Observations | Dam safety issue | Photograph |
|---|---|---|--|
| <p>Reservoir Area and Upstream Channel</p> | <p>The reservoir area was clear and open and contains mostly open pasture, surrounded by trees. There was a noticeable layer of silt in the reservoir area. Some large fallen trees had been chopped into smaller pieces but not yet removed and others have just been left. These are potential debris that could block the inlet.</p> <p>The boundary fence had a lot of debris caught in the wire and the left side fence looked new so was likely replaced. Upstream of the fence, a power line pole appeared to have fallen.</p> <p>The culvert/bridge upstream of the inlet structure was still stable. The timber supports were in similar condition to previous inspection in that some of them are broken or damaged and could deteriorate quickly. There was evidence of scour behind the timber supports on the left downstream corner. The vegetation, especially upstream, had mostly been cleared by scour and slumping of the channel banks. The flap gate was still hanging loose on the left side. The reason for this access bridge is unknown.</p> | <p>Remove trees and branches from around the upstream channel, especially those that have already fallen and may block the inlet (previous DSI).</p> | |

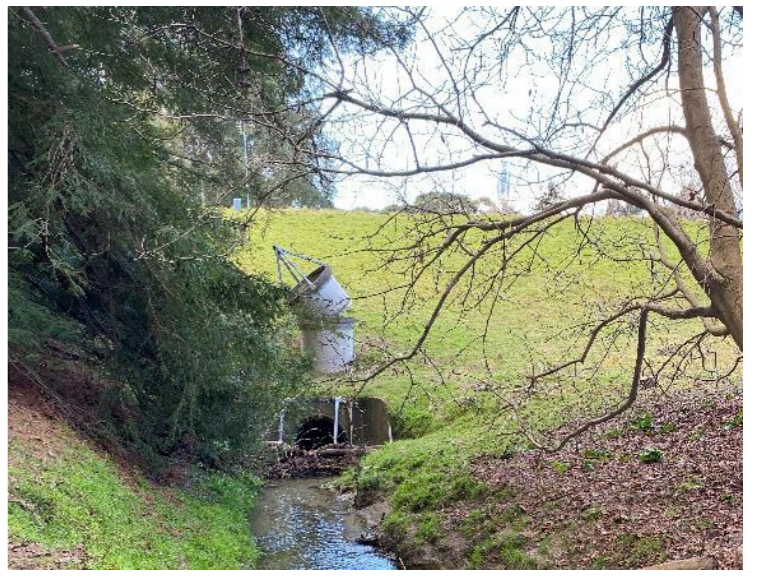
| Dam or Appurtenant Structure | Key Site Inspection Observations | Dam safety issue | Photograph |
|---|---|---|--|
| <p>Inlet Structure</p> | <p>The culvert appeared in satisfactory condition as could be viewed from the upstream end with a torch. A CCTV review of the culvert should be done to check if there is any damage or misalignment. The auxiliary inlet needs repair and strapped down as the top section had lifted and been knocked out of alignment. The inlet was partially blocked by debris on the screen which has also allowed some sediment to build up in front of the inlet. The debris should be cleared.</p> <p>The large trees upstream of the inlet structure should be removed before they start causing issues at the inlet structure.</p> | <p>Complete wider tree clearance around the inlet, especially the left abutment (previous DSI).</p> <p>Repair the auxiliary inlet and secure so that pipe section cannot be displaced again. Investigate all auxiliary inlets on the other dams for similar design flaws.</p> <p>Clear debris from inlet screen.</p> | |

| Reference Number | Report Reference | Description | Category | Comments |
|---|---|---|---|---|
| 2023-HH-1 | S4.8 | Repair the auxiliary inlet. | PI | |

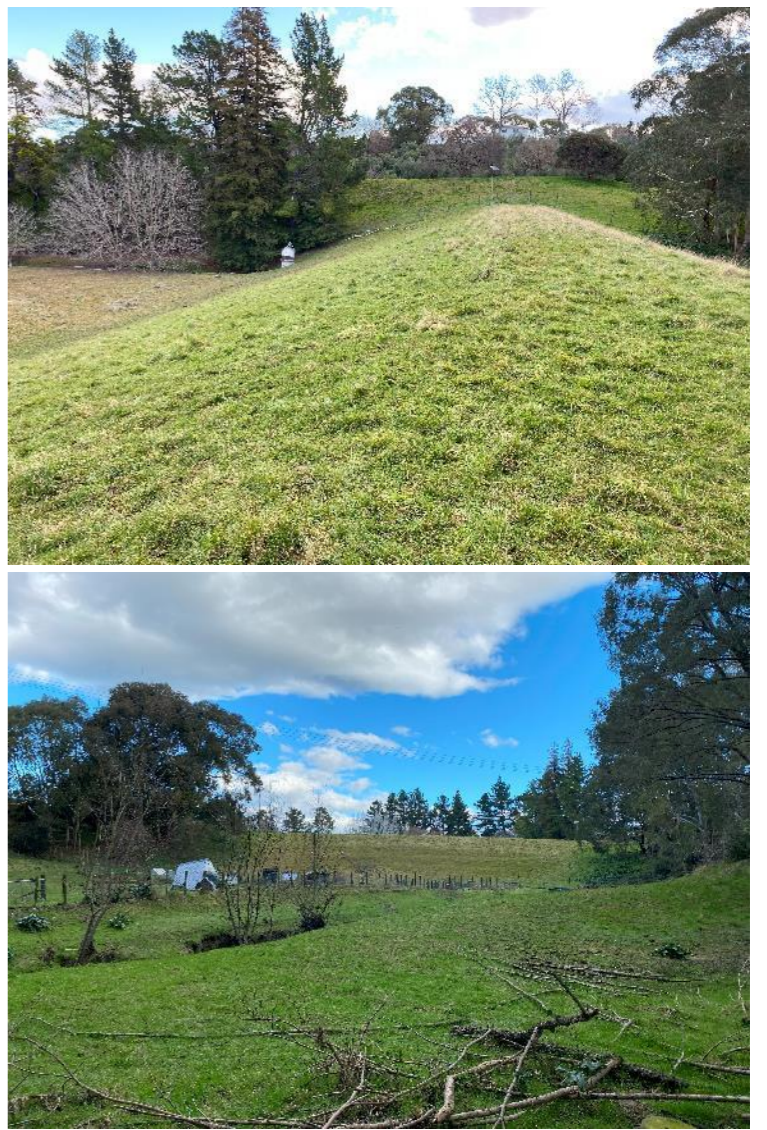
| Dam or Appurtenant Structure | Key Site Inspection Observations | Dam safety issue | Photograph |
|---|---|---|--|
| <p>Embankment</p> | <p>The upstream face was in satisfactory condition with stable slopes. There were no obvious signs of movement or settlement across the dam crest.</p> <p>The downstream face was similar to the upstream face and crest. The trees on the downstream left and right abutments were close to encroaching on the embankment which could lead to penetrating roots. These trees should be removed.</p> | <p>Remove the trees from the downstream left and right abutment areas (previous DSI).</p> | |

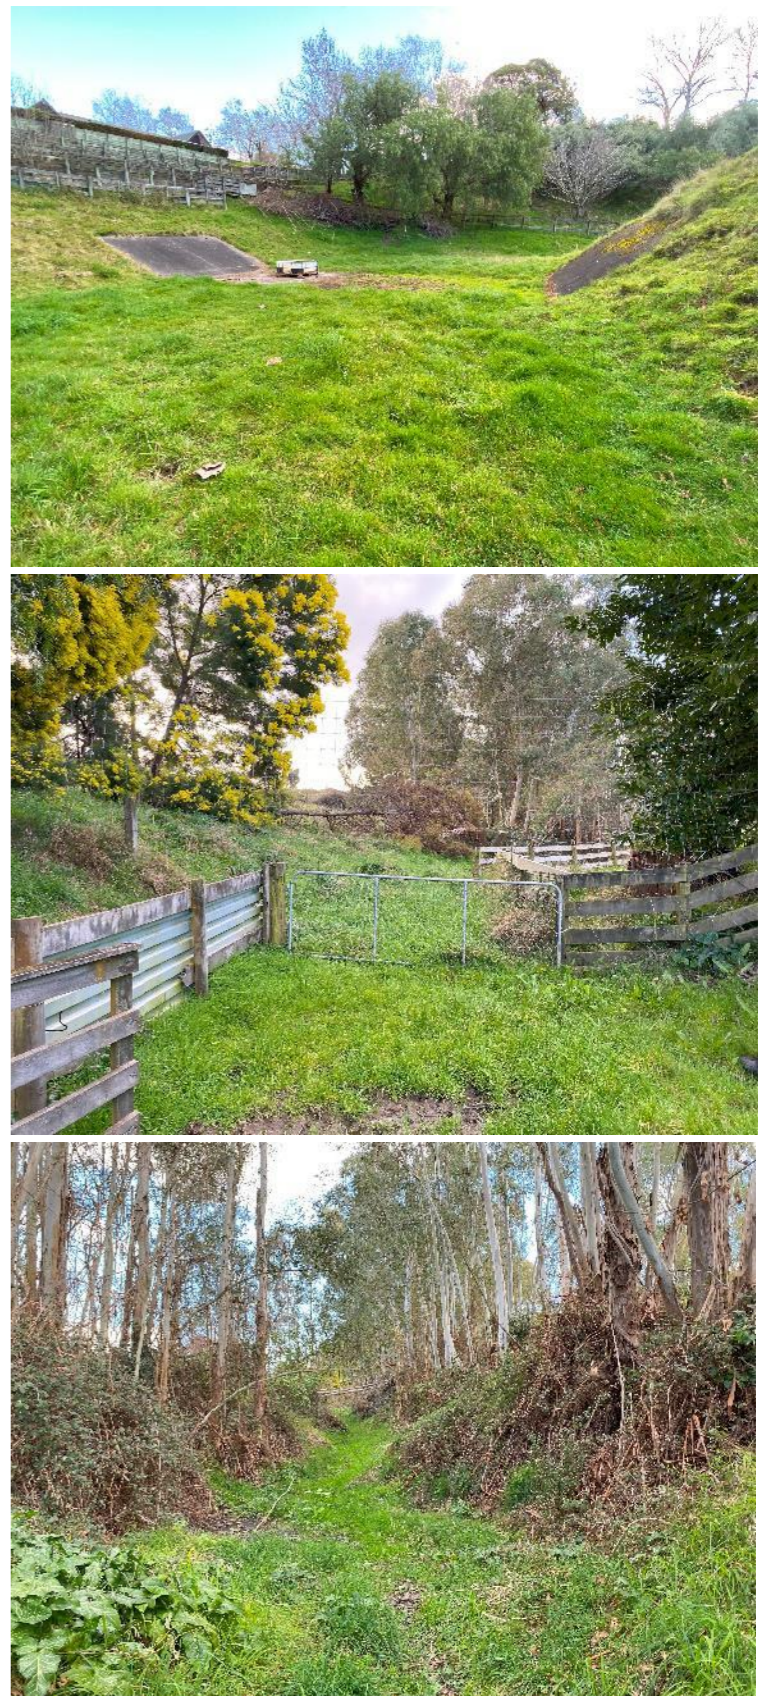
| Dam or Appurtenant Structure | Key Site Inspection Observations | Dam safety issue | Photograph |
|---|---|--|--|
| <p>Spillway</p> | <p>The concrete sill was in satisfactory condition. There were animal troughs (large buckets) left around the spillway channel that should be removed.</p> <p>The wooden fence and trees along the left side of the channel should be removed, as they have encroached on the trapezoidal channel and will impact on flow capacity during operation. The fence can just be moved a few meters up the hill and out of the channel if the purpose is still important. The trees outside of the channel should be removed or at least well maintained so that they cannot fall into the spillway.</p> <p>At the downstream end of the trapezoidal spillway channel, a gate was located across the spillway (as per previous inspections). This gate and the surrounding fencing should be removed to keep the full capacity of the spillway available. The little shed/ hen house had been moved up to the left bank since the last inspection.</p> <p>The house on the right side of the spillway should be checked against flood levels when the spillway is in use (previous CDSR DSI). At the very least, the house may be cut off so residents should be prepared.</p> <p>The downstream spillway channel drops down steeply from the house and the channel is narrower. There was a small trickle of water during the inspection, likely due to wet ground. There was a lot of vegetation in this area which could be removed or at least maintained to prevent more fallen trees and tree stumps blocking the channel.</p> <p>There is more fencing where the spillway meets back with the stream that was covered in debris. Since the spillway was operating during the Cyclone Gabrielle event, the debris must have come from the stream itself which suggests a large flow or that the stream was blocked.</p> | <p>Complete maintenance in the spillway channel (clear trees and vegetation and move wooden fence on left side) (previous DSI).</p> <p>Remove/alter the fence and gate at the downstream end of the trapezoidal channel (previous DSI).</p> <p>Remove vegetation & fallen trees in the downstream spillway channel.</p> | |

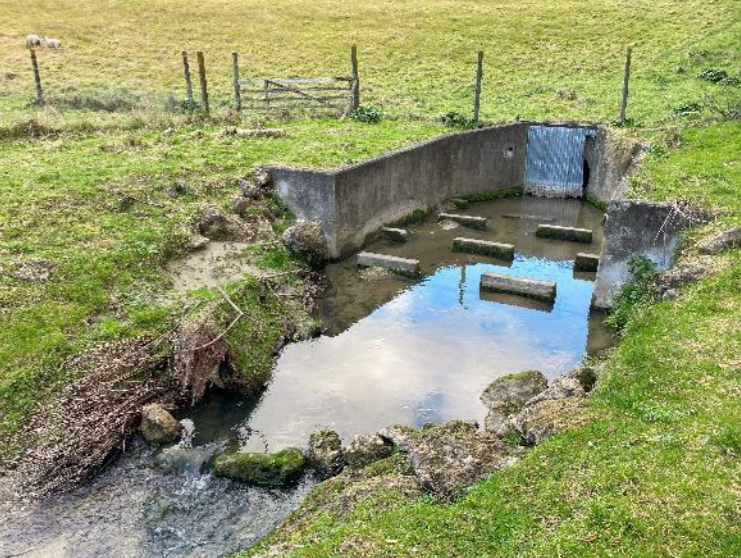
| Dam or Appurtenant Structure | Key Site Inspection Observations | Dam safety issue | Photograph |
|---|---|---|---|
| <p>Outlet Structure and Downstream Channel</p> | <p>The downstream channel was scoured in a few places but generally in satisfactory condition. There was some fencing and a small bridge that had a build-up of debris and should be removed to allow flow downstream.</p> <p>The stilling basin was generally in satisfactory condition but one of the dissipators had been sheared off and there was some build-up of sediment on the right side of the stilling basin. The vegetation seen in the previous inspection has been washed away. The reverse-flap gate (corrugated iron sheet) was in poor condition but still serves its purpose (presumably for stock exclusion).</p> <p>There were some small vertical holes behind the left wall of the outlet structure that cannot be explained. They were too uniform for animals, and it was difficult to determine the depth. Downstream of the outlet structure there was some scour of the stream banks.</p> | <p>Repair the dissipation block that had been damaged.</p> | |

| Reference Number | Report Reference | Description | Category | Comments |
|---|---|---|---|---|
| 2023-HH-4 | S4.8 | Repair dissipation block in stilling basin. | PI | |

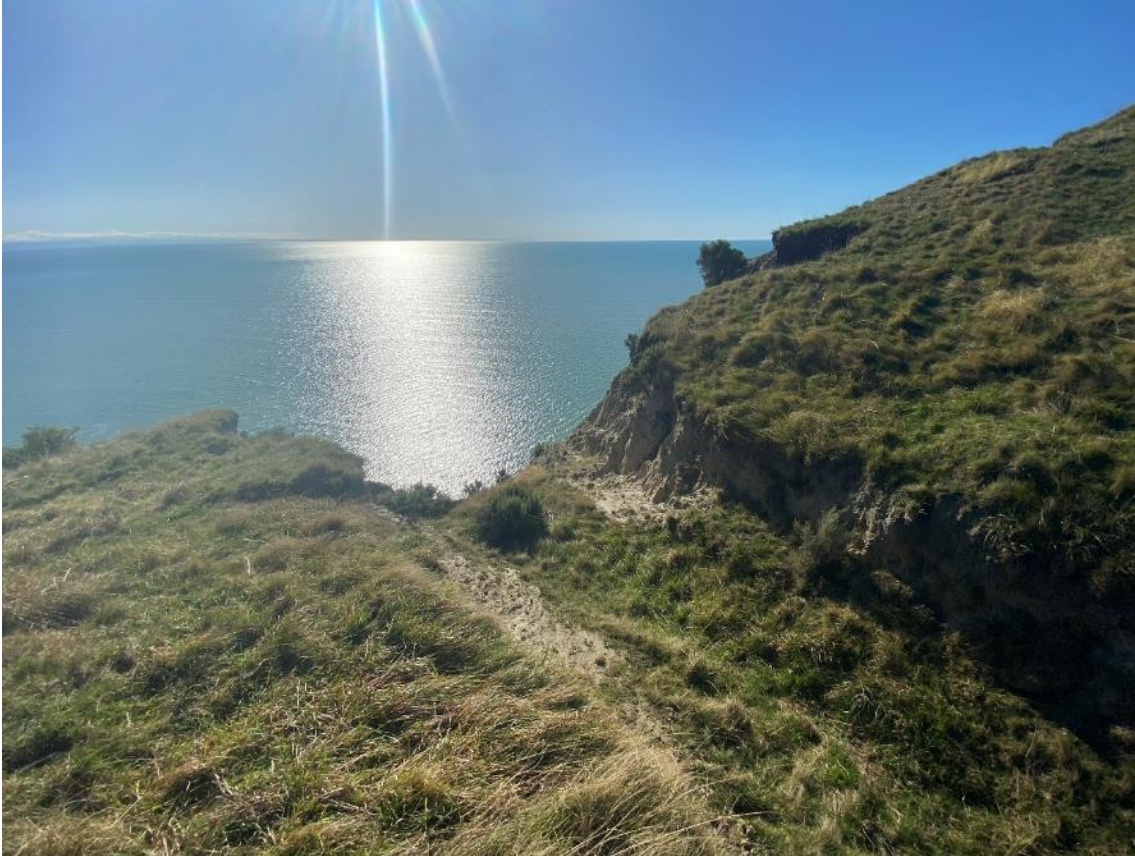
Figure 9-3. Erosion of sea outlet channel for overflow from Eastern Dam.

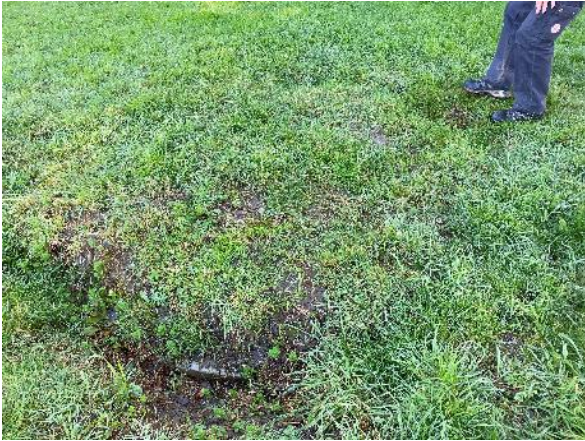
Figure 9-4. Lower: Manhole lid that lifted from culvert water pressure.

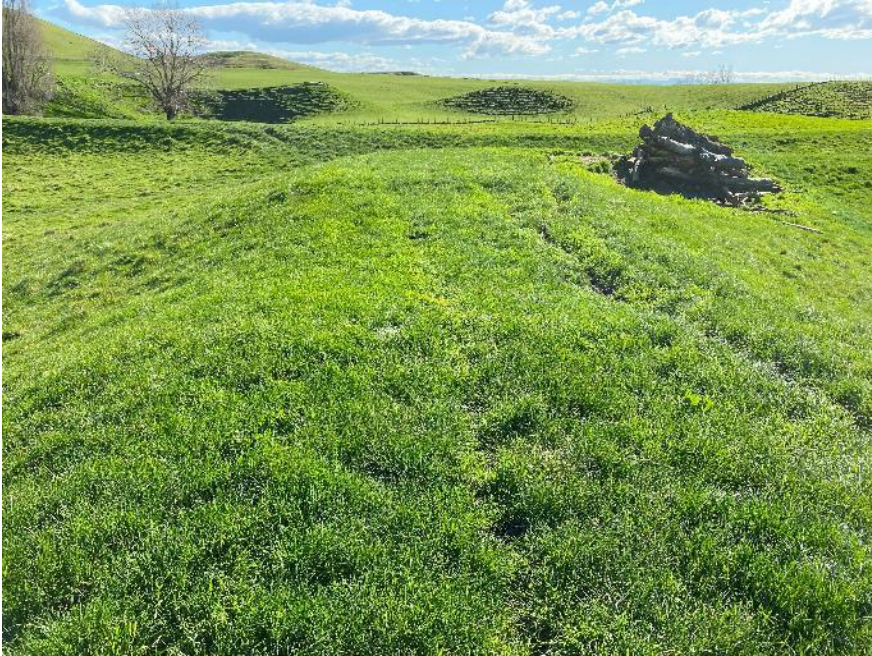
Figure 9-7. Upper: Settlement of crest

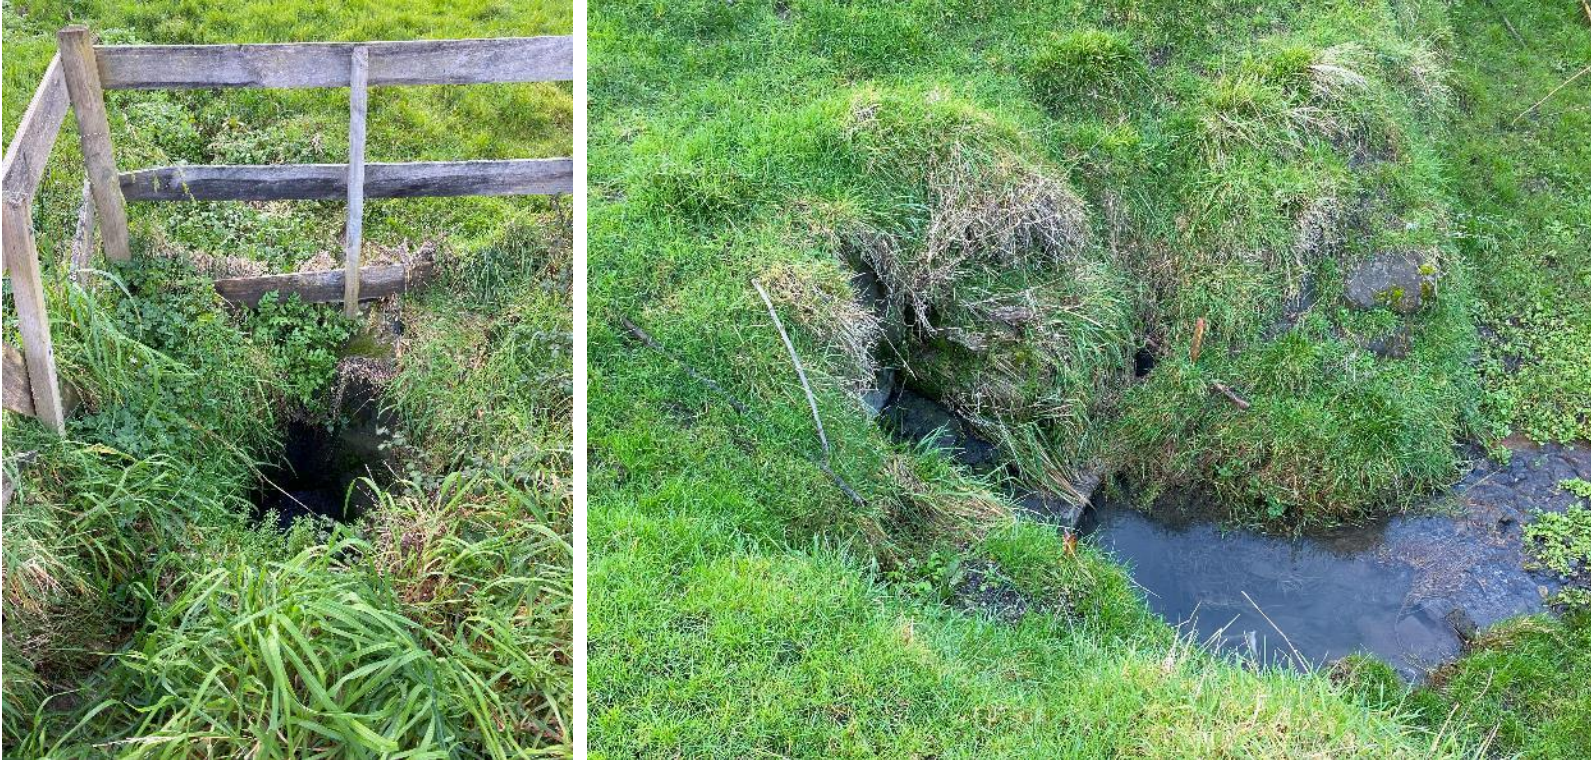
Figure 9-8. Side Channel (RHS of inlet) culvert inlet and outlet.

| Reference Number | Report Reference | Description | Category | Comments |
|---|---|---|---|--|
| 2023-KW-1 | S4.5 | Investigate repair of the side channel culvert. | PI | |

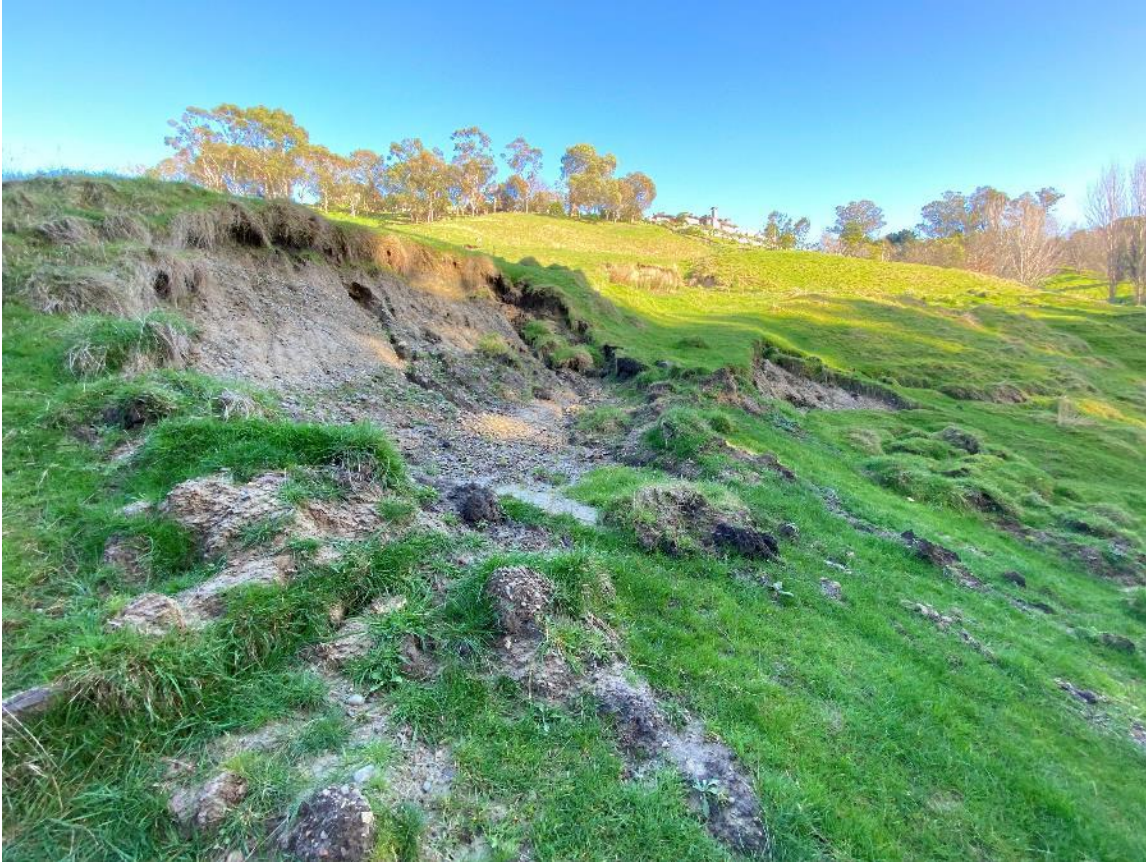
Figure 9-10. Landslides along the valley slopes (downstream of Spillway Downstream Structure).

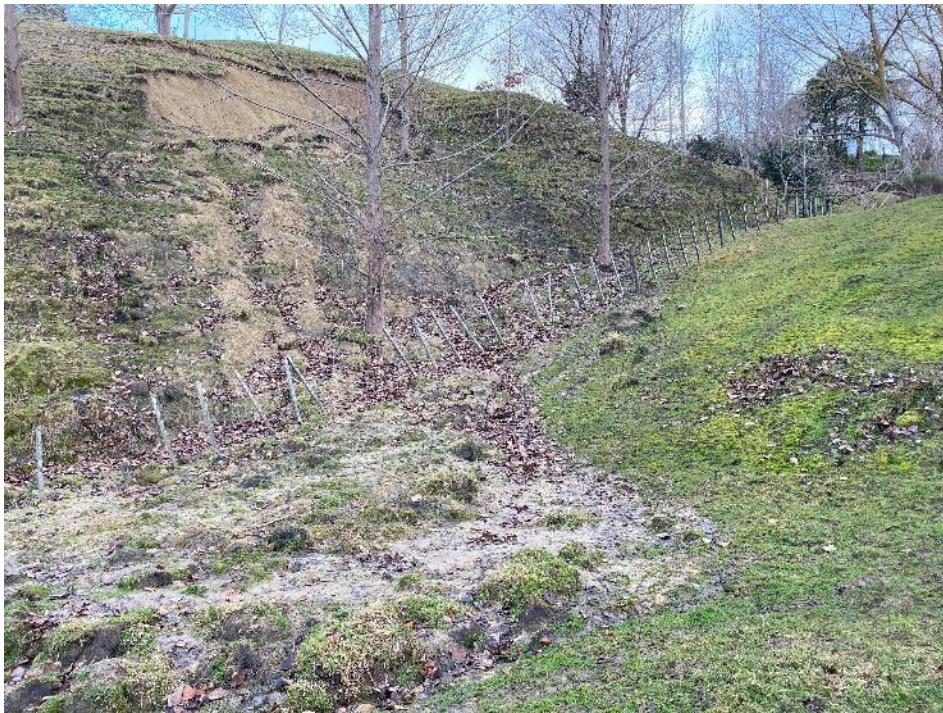
Figure 9-12. Landslide on Upstream Left Abutment.

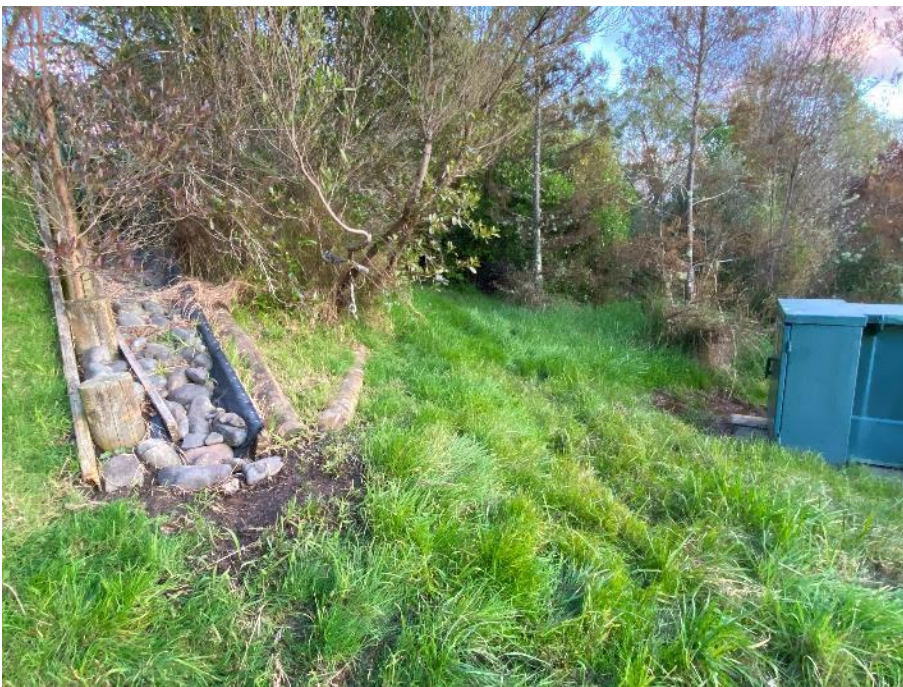
Figure 9-15. Wet patch on Downstream Right Abutment.

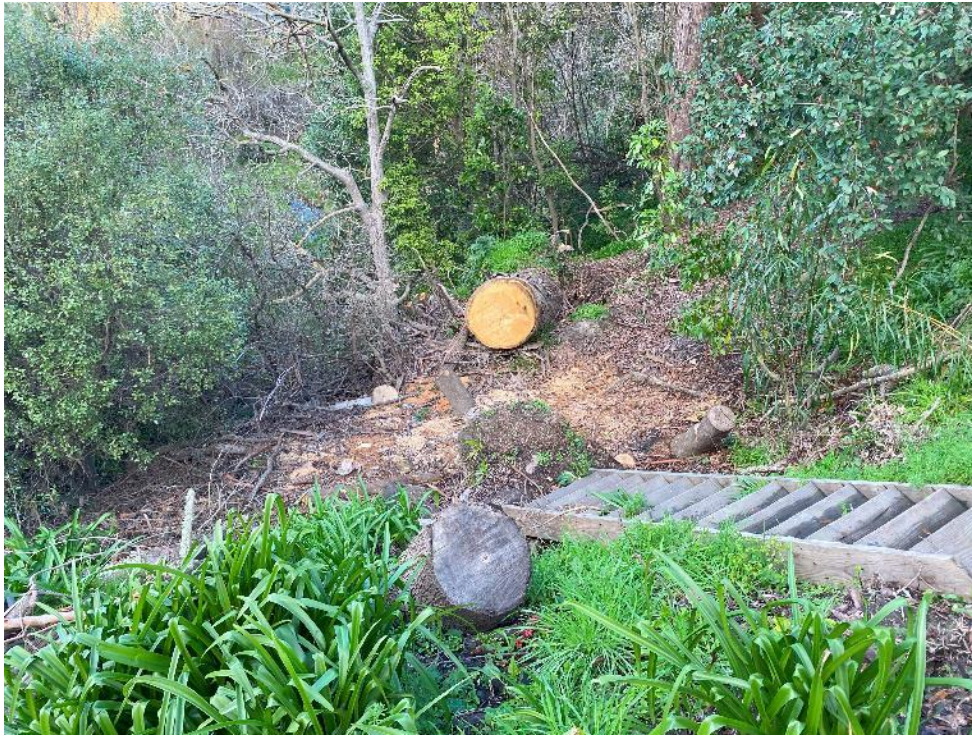
Figure 9-18. Tree that fell on house on Upstream Left Abutment.

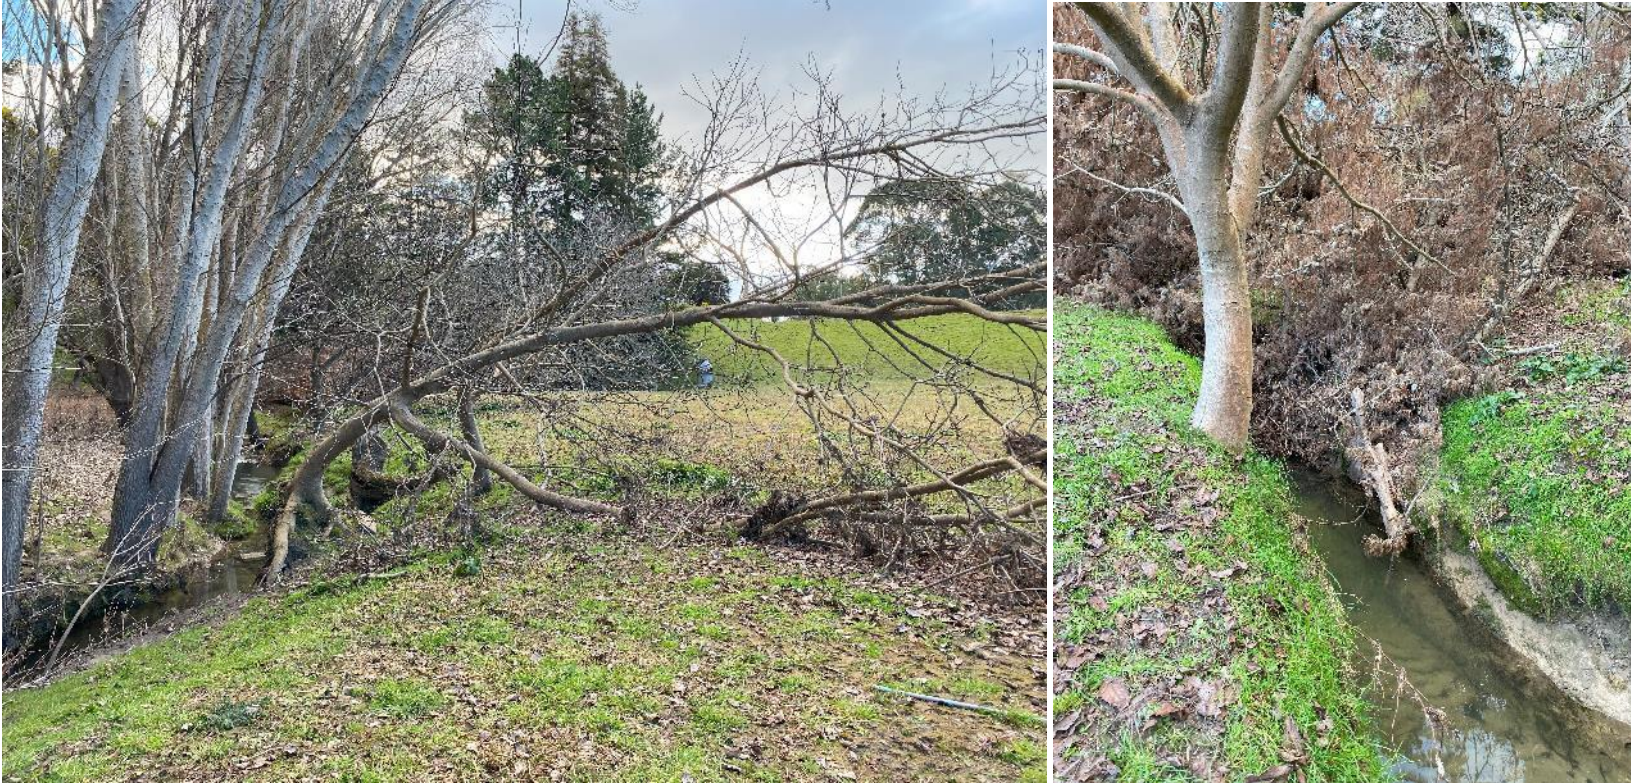
Figure 9-19. Trees fallen over Upstream Channel
