### **Preliminary Geotechnical Investigation**

**PRELIMINARY GEOTECHNICAL INVESTIGATION FOR PROPOSED NEW TKKM  
TE WANANGA WHARE TAPERE O TAKITIMU**

**90-120 BENNETT ROAD, HASTINGS**

Project Reference: 13348\_Rev1  
24 August 2017

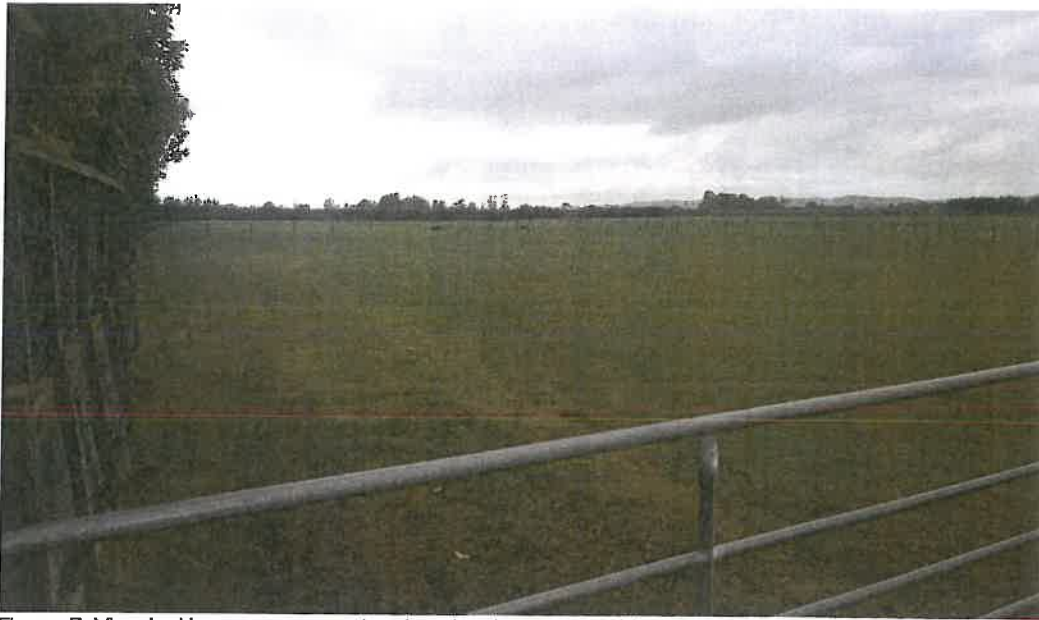
Figure 3: View looking east across the site, showing open paddock.

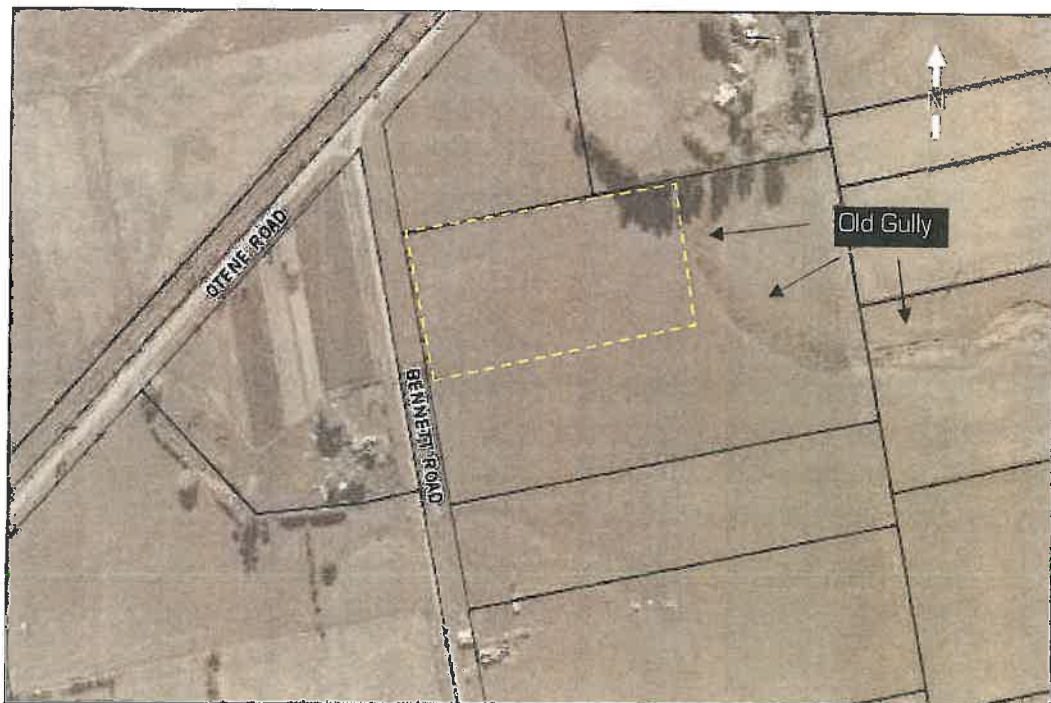
A review of the Hastings District Council (HDC) historical imagery indicated that to the immediate east of the assessed area is a former gully that has been mostly infilled (Figure 4).

Figure 4: Historic aerial photograph (1949) showing location of former gully to the east of the assessed land area that is now mostly infilled (Source: Hastings District Council Intramaps).

8. It is however recommended that consideration be given to the potential for lateral spreading to occur for any building located within approximately 200m of the infilled stream channel to the east of the site, unless the existing fill is either further investigated or remediated.

Alternatively, additional investigations and/or earthworks could be undertaken to evaluate the nature and condition of the channel back-fill to further evaluate / address the lateral spread potential at the site.

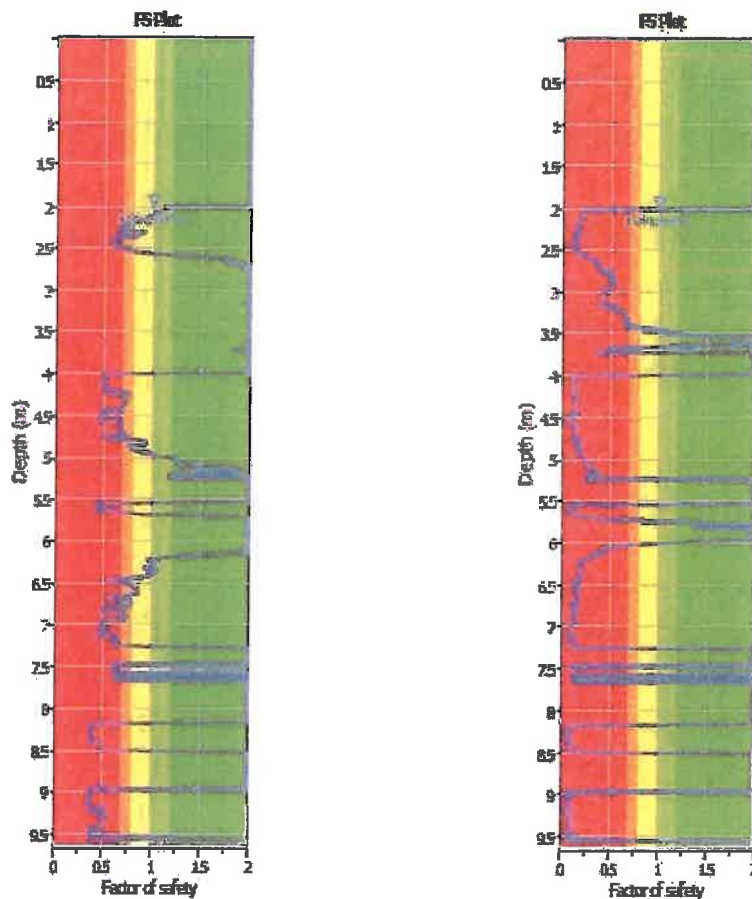
The analyses indicate that under earthquake loading there is the potential for some liquefaction of the loose to medium dense silty sand and silt layers underlying the site (Figure 6, left). As the earthquake shaking increases, the number and severity of the subsoils susceptible to liquefaction increases, resulting in essentially the entire subsoil profile beneath the water table indicated to liquefy (Figure 6, right).

The CPT and liquefaction profiles terminate on the dense layer (gravels) inferred beneath the site at between 7.6m to 10.6m depth. These dense gravels are not likely to undergo any significant liquefaction during either SLS or ULS earthquakes, and are likely to be suitable for supporting deep piles for high value structures (IL3 or more as set out in Tables 1 and 2). However, any pile design that relies on the inferred gravels for bearing / liquefaction resistance should be further investigated (via machine boreholes) to prove the thickness and consistency of the inferred gravel layer.

Figure 6: Representative profile of layers susceptible to liquefaction. Plots both from CPT3, with SLS 0.13g PGA on left and ULS 0.67g PGA on right. Note that the illegible words at 2.0m depth are 'During earthq' and indicates the groundwater level used in the calculations.

For normal classroom type structures, this would lend itself to timber floor / prefab style of construction with some additional enhancements, or enhanced concrete slab foundations with ground improvement.

Larger buildings and Importance Level 3 (IL3) structures will need detailed investigation and assessment, but are likely to require some form of deep treatment or foundation type, such as deep piles (>7-10m) or cement stone columns and deep soil mixing.
