## ARCHAEOLOGICAL SCREENING: ESK PARK

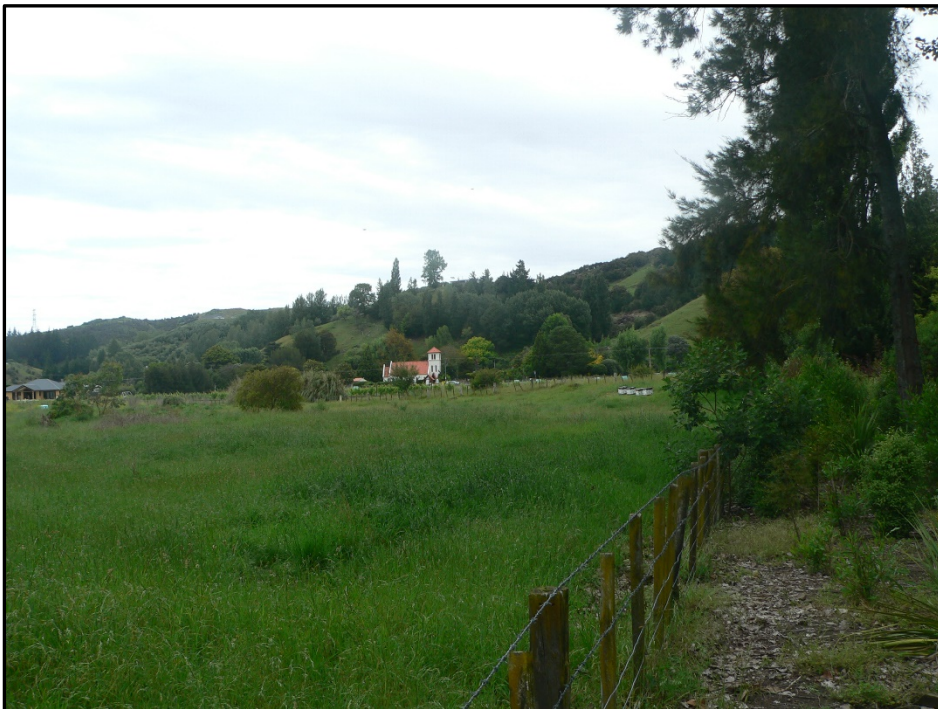
View from public area of Esk Park across leaed paddocks towards SH5 and the Esk Church.

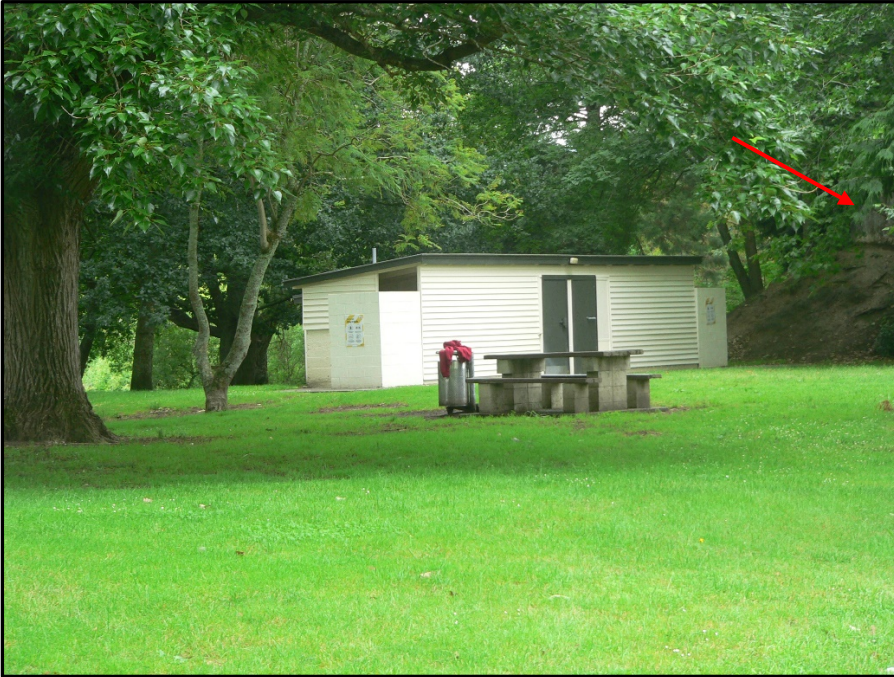
mound atop which a water tank has been placed. The maturity of the trees growing on this mound suggests it has been there for some time.

Toilet block with artificial mound (right of image) atop which sits a water tank (arrowed) – note maturity of trees growing on the mound.

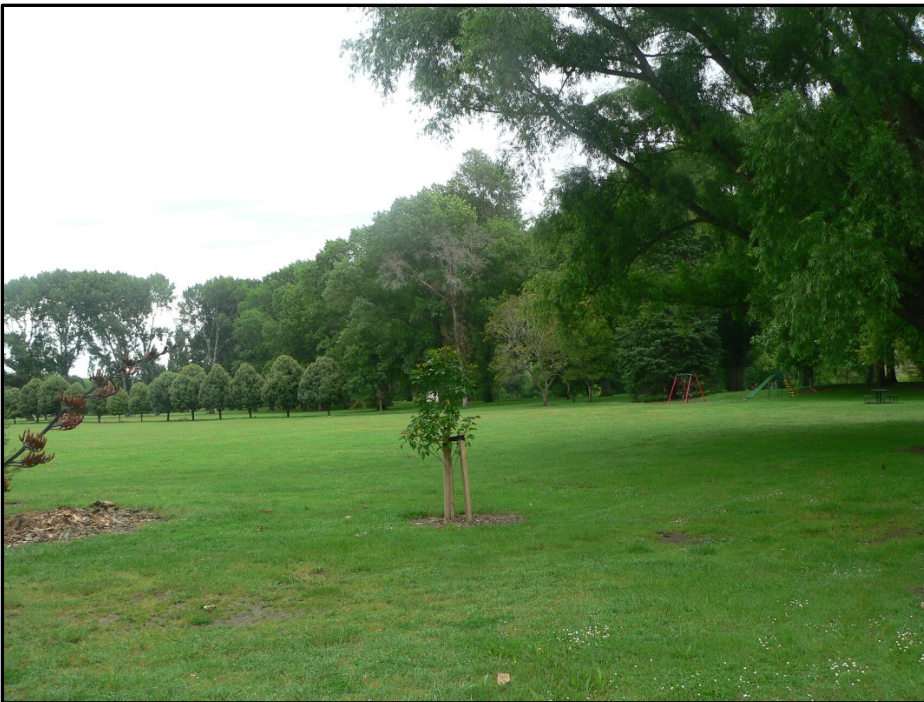
It was apparent that the main park area is a moderately undulating valley bottom that has been heavily landscaped through planting both in the historic past and more recently as evidenced by large numbers of trees ranging from mature to sapling. There are localised areas of excavation where items of playground equipment have been installed, along with two toilet block structures with associated services. Adjacent to one block is an artificial

General view of the park from eastern boundary: note trees lining the access road and the mix of very mature trees and recently planted saplings.

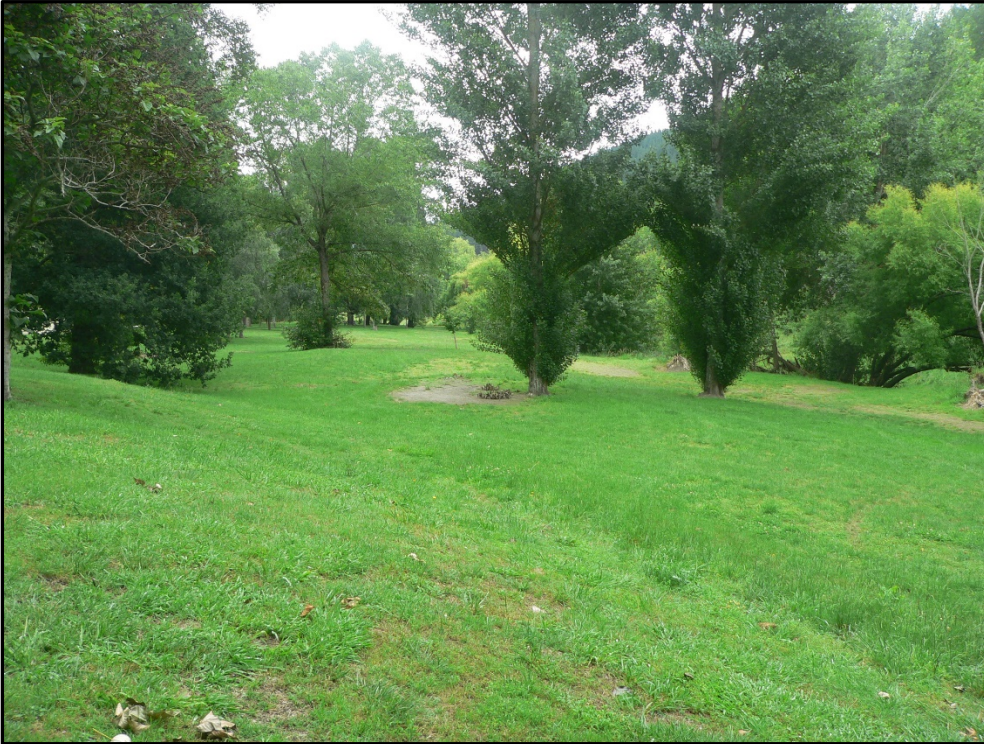
The Esk River flows adjacent to the park, the channel of which features several small terraces, presumably representing low and high water flow rates. The banks of the Esk appeared to show evidence of periodic scouring as would be expected given the flood history of the river. The banks were not examined closely given the flow depth and rate, and working alone at the time of visit. It is not considered likely that a closer inspection at this time would have revealed anything of note. However, this could be verified if required at a time when the flow rate and conditions are safer to do so.

Series of terraces dropping from the main park level down towards the river.

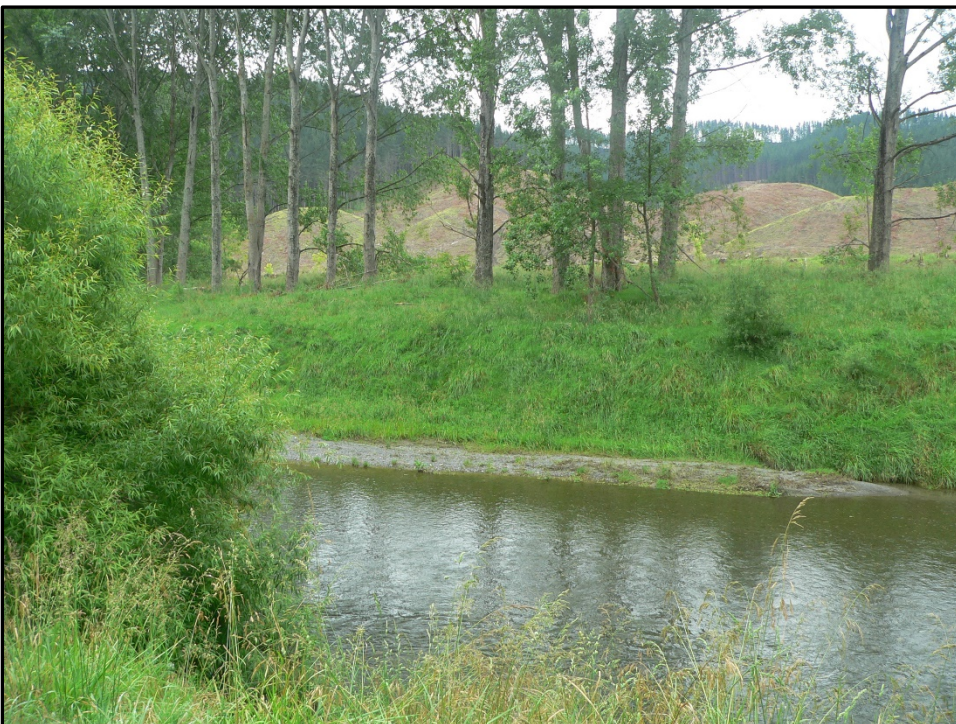
Esk River channel looking across to the PanPac forests.
