FLOOD DETENTION DAMS - 2019 INTERMEDIATE DAM SAFETY REVIEW

PREPARED FOR HASTINGS DISTRICT COUNCIL

March 2020

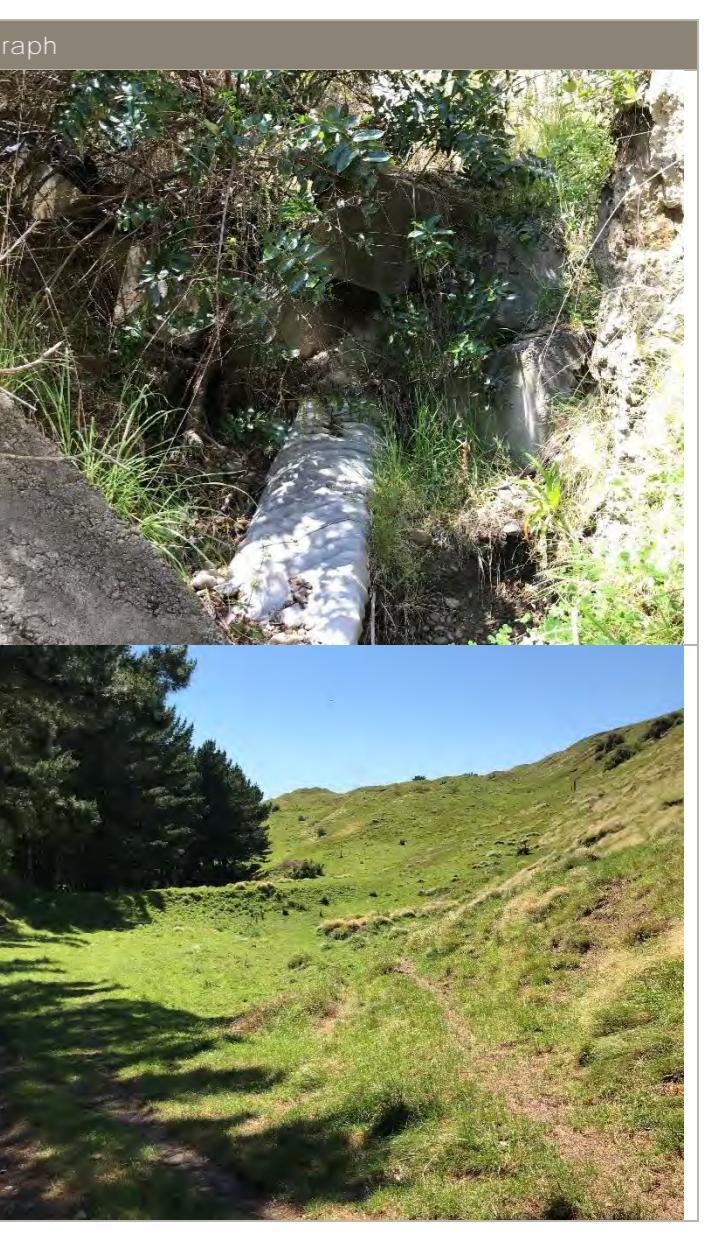
Dam or Appurtenant Structure	Key Site Inspection Observations	Recommendation	Photog
Motor Camp Stormwater Gully	The stormwater gully was in similar condition to previous years with damaged pipe sections and concrete blocks. The damage was caused by flooding in April 2011. The full length of the previous pipe was traversed. Section of corrugated metal pipe, concrete blocks, concrete manhole, etc remain in the gully. These could be mobilised further down the gully in future flood events. Flood flows from the catchment and flood detention dams behind the camp will flow down this gully without the control of the manholes/culvert system that was previously there for this purpose. The downstream channel, in the camp, has aggraded significantly, and now appears to have limited flow capacity. In flood events, it is likely flows will easily overtop this channel and spill out into the camp, and playground area on the right. The concrete box channel through the camp to the beach had sediment build up at both the upstream and downstream (beach) end. Beach stones have built up around the culvert exit.	The remediation of the gully or other stormwater control options should be investigated. Clear the downstream gully stormwater channel upstream of the concrete box section, and within the concrete box section.	Real Provide Action of the second sec

West Dam	The west dam was in satisfactory condition. The pipe inlet and outlet were both clear and being well maintained around the inlet/outlet area. Some maintenance of the vegetation across the crest is recommended.

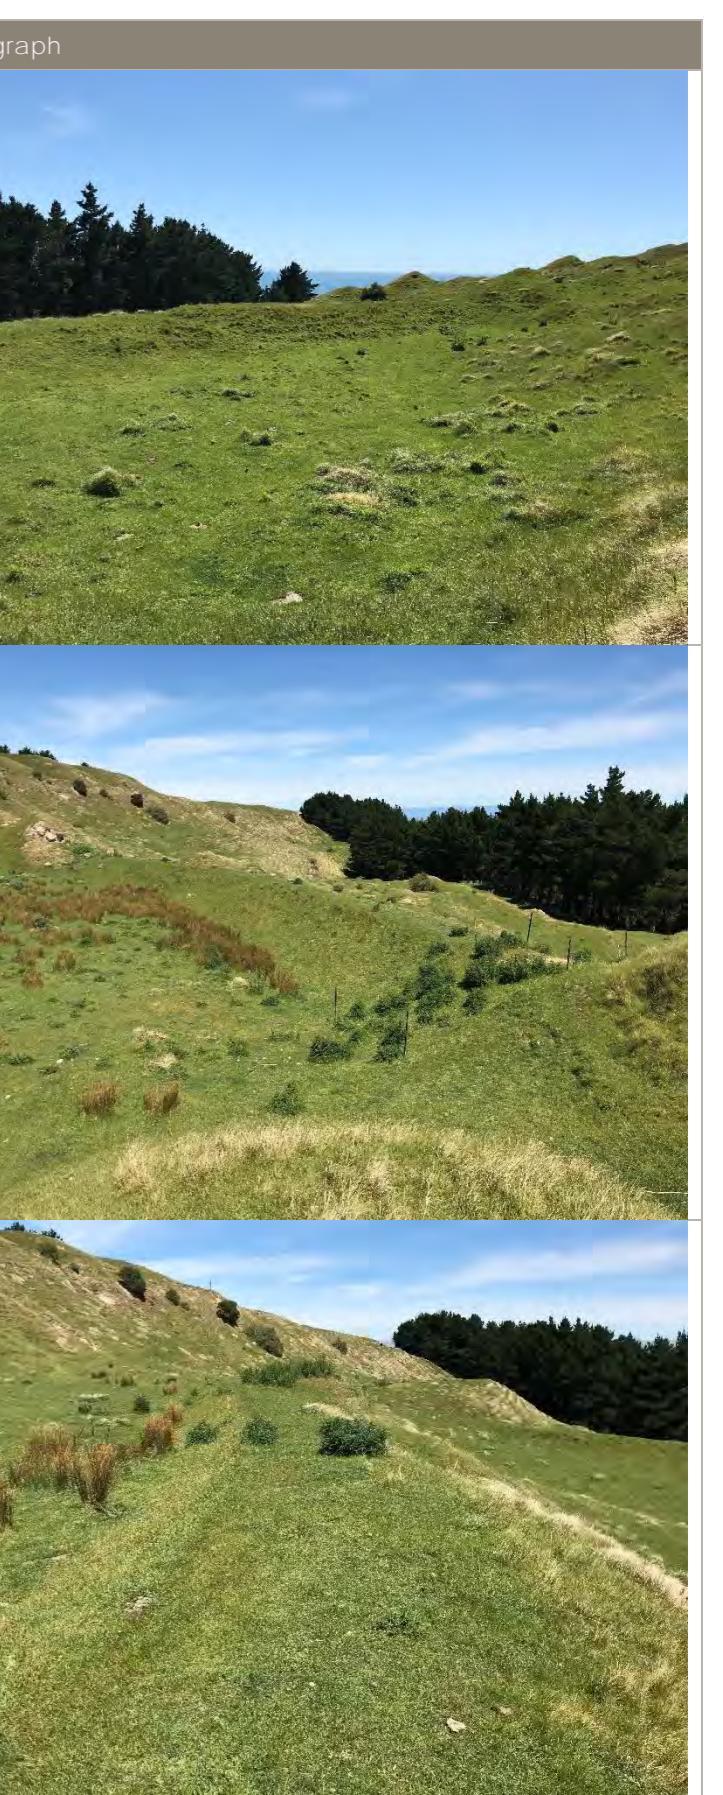
Dam or Appurtenant Structure	Key Site Inspection Observations	Recommendation	Photog
Lower Middle Dam	The lower middle dam was in satisfactory condition. The pipe inlet and outlet were clear but becoming partially filled in at the inlet, and the outlet was partially blocked. The lowered crest section in the centre of the embankment (spillway) was clear and stable.	Clear the pipe for any sediment build up (this was obvious and occurring at the inlet and outlet).	
East Dam	The east dam was in satisfactory condition. Grass was of a suitable short length (e.g. 50-150 mm), but other vegetation was becoming prevalent in the reservoir area and across the crest and downstream slope. The barbed wire fencing installed on the left and right abutments to prevent stock damage previously seen has worked well to prevent further stock tracking, but is now containing vegetation that should be maintained. The sea outlet channel was clear and stable, with minor bank erosion visible. The pipe inlet was mostly clear. The outlet was not found, or not confirmed. An investigation such as long wire, or water flow, should be used to confirm the outlet location.	Investigate the outlet location and mark out the outlet of the pipe through the East Dam. Pegging out of all outlets would be useful.

Upper Middle Dam	The upper middle dam was in satisfactory condition. Grass length was suitable as per the other dams, but other vegetation was becoming prevalent. The inlet and outlet of the pipe was viewed and appeared mostly clear.

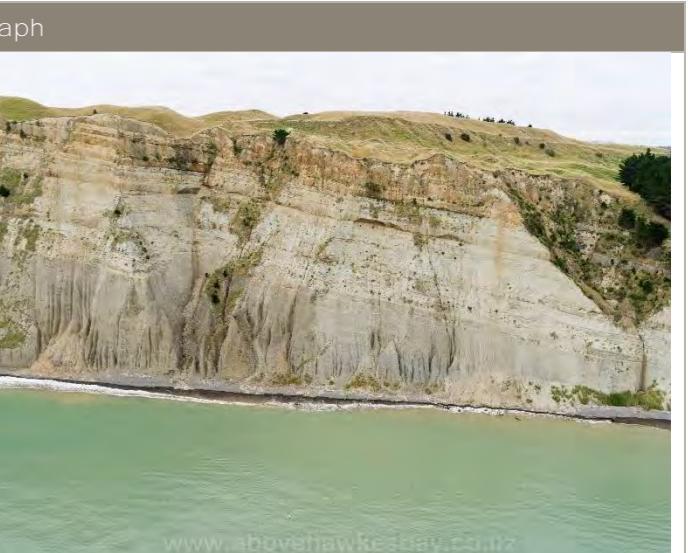
Dam or Appurtenant Structure	Key Site Inspection Observations	Recommendation	Photogr
Catchment	The reservoir areas mostly consist of open grass farmland. The catchment comprises steep slopes and evidence of recent slips. During separate work on landslides following a cliff collapse at Cape Kidnappers in January 2019, Stantec Engineering Geologist Matt Shore identified that the Clifton area where the dams are located is an historic landslide. This was notified to HDC. This should be considered with longer term work associated with the dams.

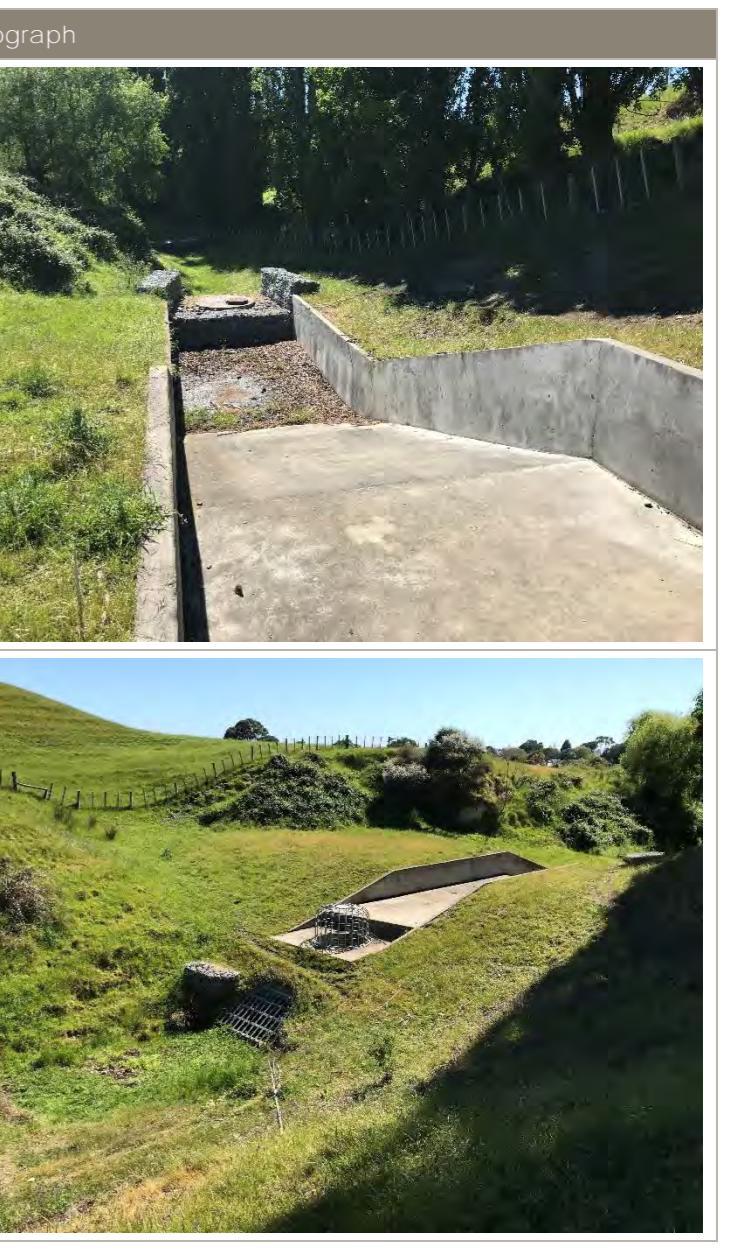
Dam or Appurtenant Structure	Key Site Inspection Observations	Recommendation	Pho
Spillway Channel	As identified in the 2017 flood study of the Te Awanga dams, the gabion spill weirs appear to have been constructed differently to the assumed design intention, and have been infilled in the central sections (which Stantec think should be the spill slot). The upper concrete spillway structure was in good condition. The gabion wall on the right side of the main spillway structure was leaning out (to the right facing downstream), as identified in previous inspections. This should be monitoring for any future stability issues.	Remove the central gabion sections so the gabion drop structures become "spill through" rather than "spill over", and as originally intended in the design.	
Reservoir Area and Upstream Channel	The reservoir area is within a narrow gorge section. This was mostly clear and stable. The heavy build-up of vegetation seen in 2018 had been cleared within the upstream channel and in front of the culvert inlet.

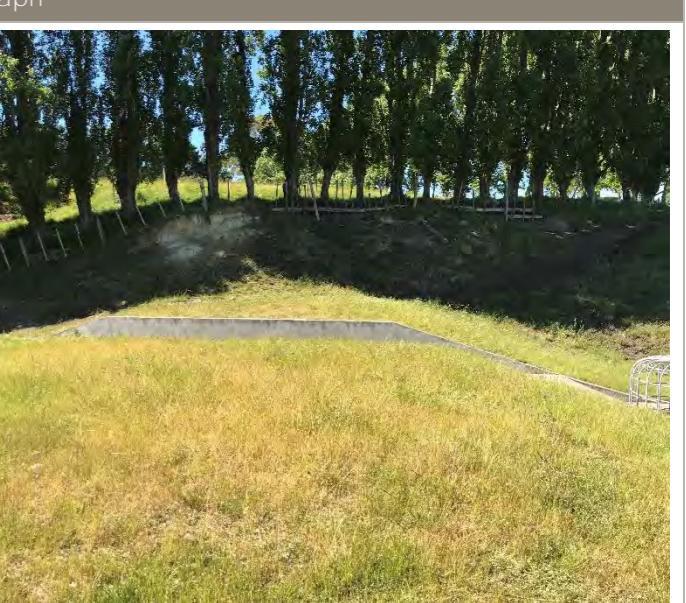
Dam or Appurtenant Structure	Key Site Inspection Observations	Recommendation	Photogra
Dam Embankment	The embankment area was in good condition with stable slopes and clear crest area.

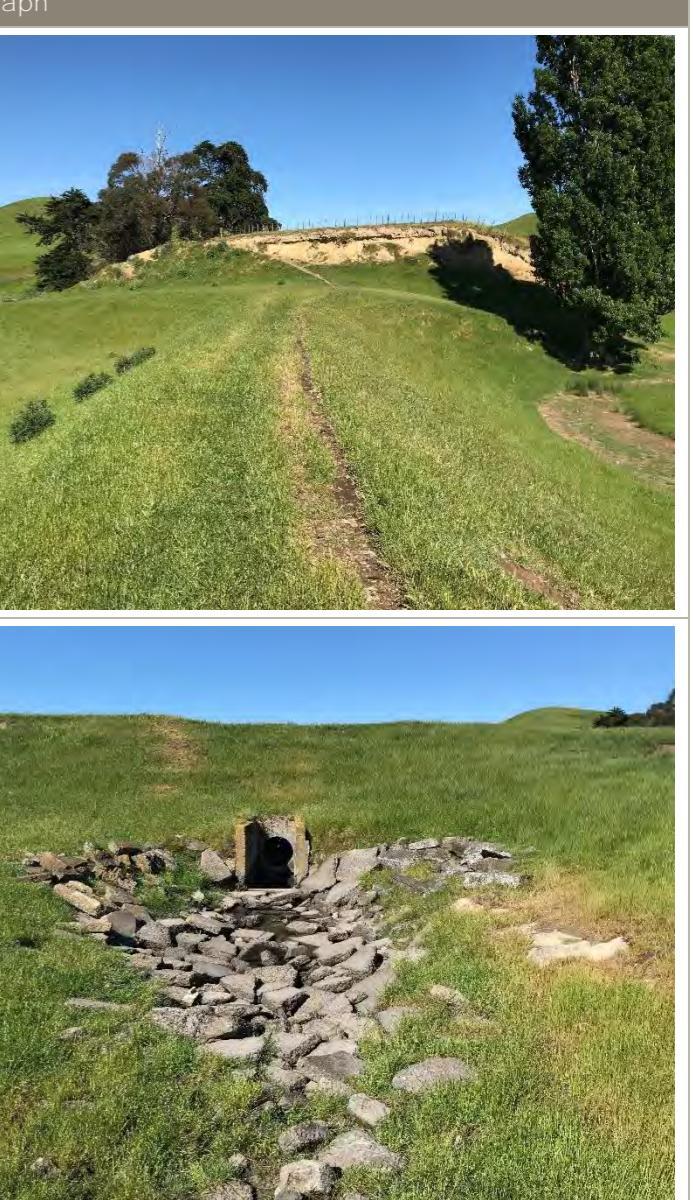
Dam or Appurtenant Structure	Key Site Inspection Observations	Recommendation	Photogr
Left Abutment	The left abutment embankment was stable and in fair condition. The pipe through this section is in poor condition and this inlet would not function well and the outlet is partially blocked/buried.	Complete maintenance on the left abutment pipe at the inlet and outlet to ensure this will function adequately.	
Spillway and Outlet Culvert	The spillway channel was clear. The outlet structure was similar to previous inspections and in satisfactory condition. The rip rap placement in the downstream channel (to provide erosion protection to the area immediately downstream of the culvert and outlet structure) should be reviewed and improved/replaced where it looks light or vulnerable. The culvert has previously been recommended to be inspected for movement and current condition, and should be completed as part of the HDC dams culvert inspections (which will be set out in the OMS Manual but should be completed at least 5 yearly to coincide with the CDSRs). Some lowered crest level of the embankment (noticed in previous inspections) indicates some movement or internal erosion has occurred with or associated with the culvert location.	Review and improve the rip rap to the area downstream of the culvert and outlet structure. Complete a culvert inspection (CCTV) for current condition and identifying issues.

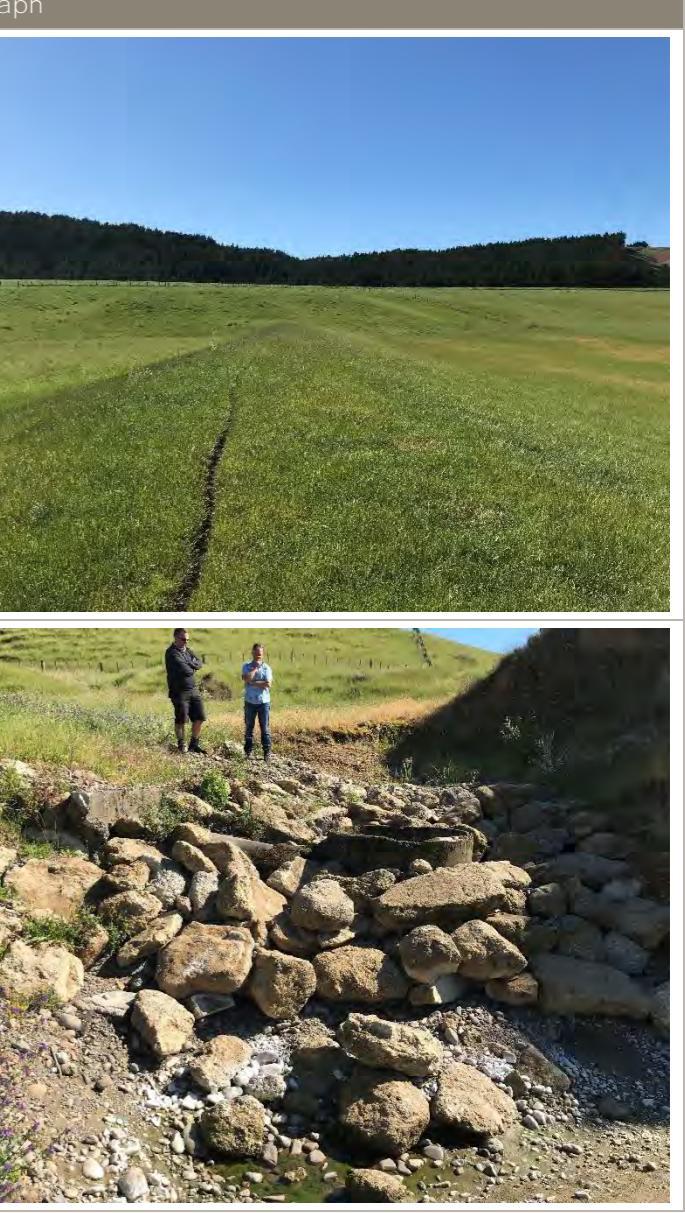
Dam or Appurtenant Structure	Key Site Inspection Observations	Recommendation	Photog
Embankment	The main embankment dam was in good condition with consistent short grass coverage. The right abutment pipe was blocked/buried at the inlet and outlet (in particular) and should be cleared for adequate function.	Complete maintenance on the right abutment pipe at the inlet and outlet to ensure this will function adequately.	
Downstream Outlet (to Charlton Stream)	The manhole inlet structure was in similar condition to previous inspections. Maintenance should be completed around the structure such as clearing of vegetation and review and replacement of rip rap. The outlet culvert structure was in similar condition to previous inspections, but placement of rock protection around the structure had been completed by HBRC Works Group maintenance.	Complete maintenance at the downstream outlet (Charlton Stream) inlet manhole (vegetation and rip rap).

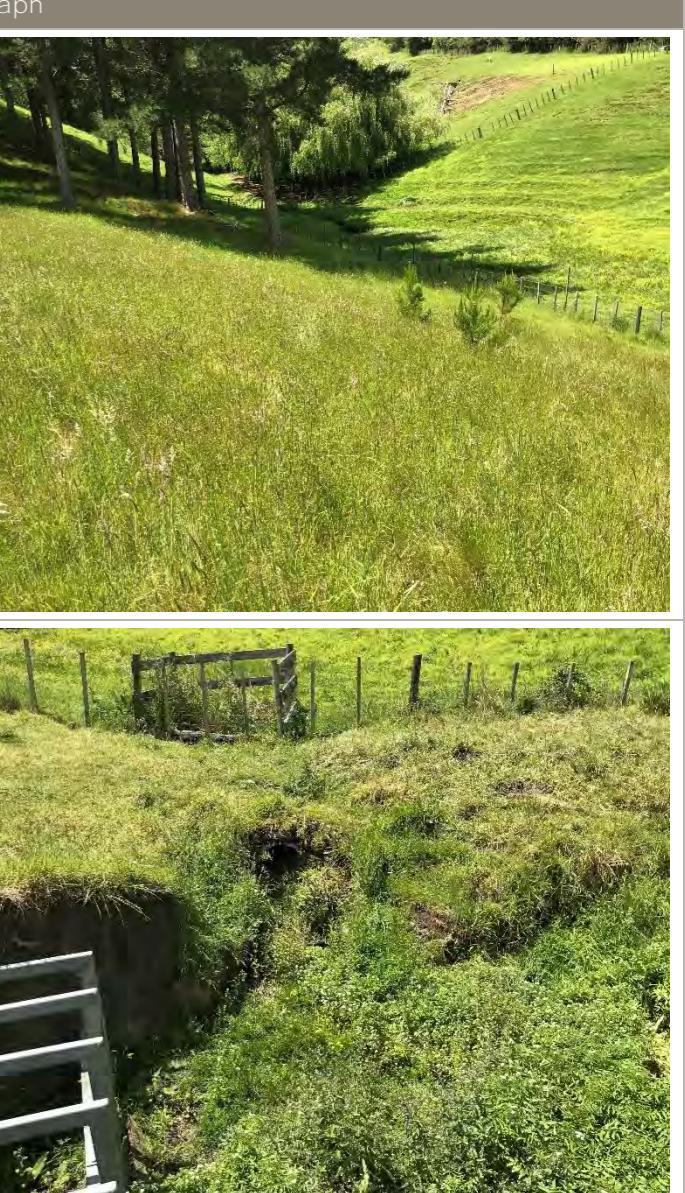
Dam or Appurtenant Structure	Key Site Inspection Observations	Recommendation	Photo
Embankment	The dam crest and slope in general were in good condition. Long grass made inspection of the slopes more difficulty, but there were no obvious issues with slope movements or crest settlement.		State of the second sec
	Removal of trees and vegetation on the downstream left abutment should be considered. This is not thought to be directly part of the dam, but would assist in providing a clear area for inspection, and lesson risks of potential root infiltration to the embankment. New pine trees were identified as becoming established on the upstream right side of the embankment. Clearance of these trees before they become more established should be completed, as well as consideration of some of the poarby more established pine trees in (around the embankment poar the	Clear trees and vegetation from the downstream left abutment (between the dam and spillway). Clear the new pine trees on the upstream slope near the right abutment, and consider clearing established pines in/around the embankment near the right abutment.

right abutment. Cattle was present in the dam area, which hadn't been seen in previous years. This should be monitored for damage in/around the embankment area.	length.	
Upstream Channel and Inlet Structure	The upstream channel from the culvert inlet was becoming heavily vegetated and should be cleared out, including some larger trees just upstream. The side channel inlet flow was missing the concrete manhole (seen in previous years), and should be rectified, mainly as it is so close to the culvert inlet. This could be redesigned/constructed. The inlet structure and debris screen were in good condition.	Upstream channel vegetation maintenance including some larger trees. Redesign the side channel inlet flow (right side of inlet structure) as currently flow is bypassing the manhole and causing erosion.

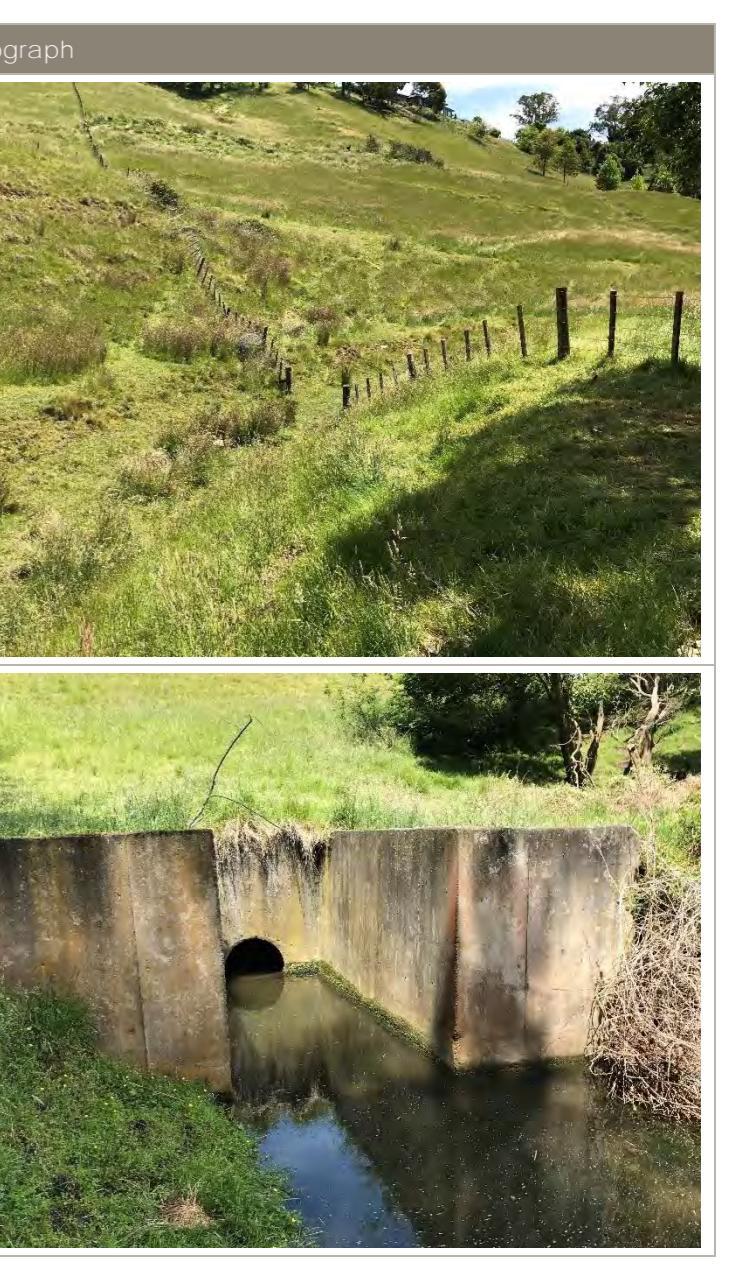
Dam or Appurtenant Structure	Key Site Inspection Observations	Recommendation	Photo
Spillway Chanel	The upstream channel had long grass which should be maintained shorter. Fencing within part of the spillway channel about halfway down has the potential to be a restriction during flood operation of the spillway. This should be removed. The spillway outlet corrugated iron channel requires maintenance from vegetation and erosion scour. Ideally the structure would be removed as it's not serving its purpose, and the slope be armoured or grass reinforced.	Maintenance of grass in spillway channel. Remove all fencing from within the spillway channel. Remove the spillway outlet structure and redesign the erosion protection works (e.g. rock or Reno mattress).	
Outlet Structure and Downstream Channel	The culvert outlet was clear and in satisfactory condition. Vegetation was building up around the downstream walls and should be cleared. The downstream channel was mostly clear but was becoming quite heavily vegetated.	Clear vegetation from around the culvert outlet structure and in the downstream channel.

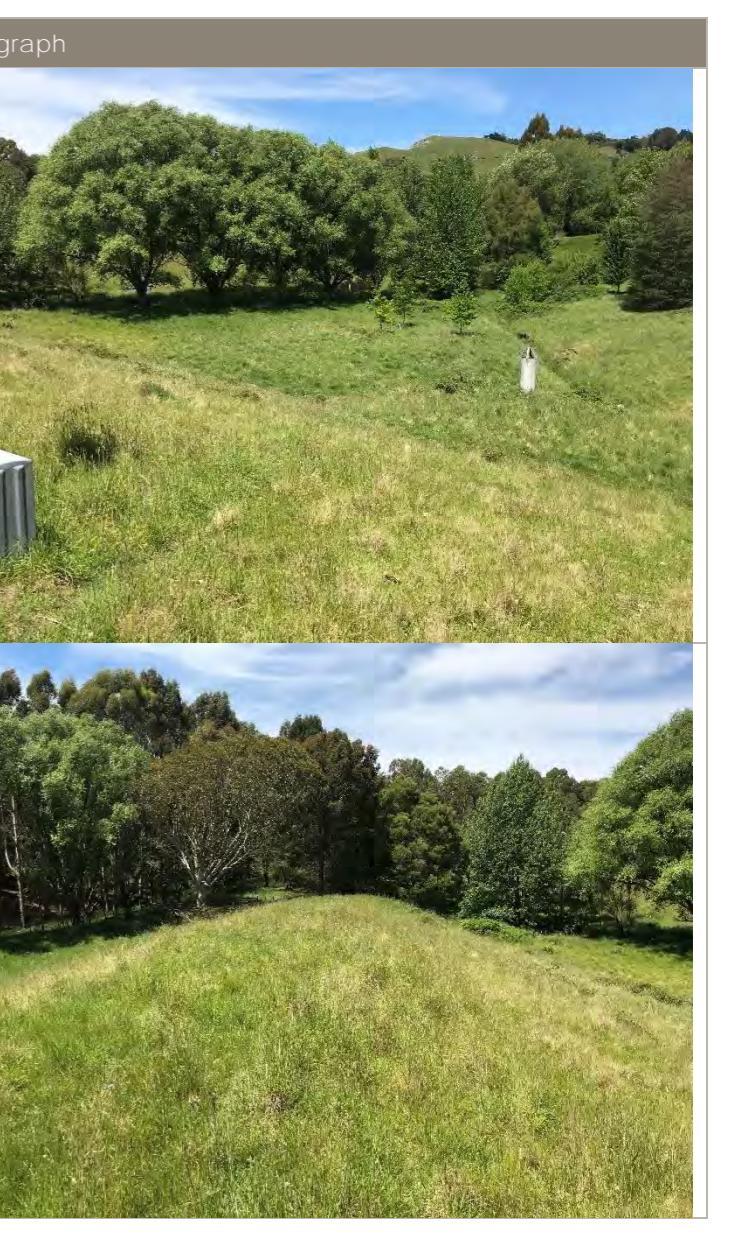
Dam or Appurtenant Structure	Key Site Inspection Observations	Recommendation	Photo
Reservoir Area, Upstream Channel, and Inlet Culvert	The reservoir has a number of large trees, which have the potential to provide significant debris in a large flood event (branches, leaves, trees) which could block the inlet structure. The vertical inlet assists with this should the inlet be blocked. The upstream channel was heavily vegetated and should be cleared. The management of trees in the reservoir area should be improved.	Clear vegetation in the upstream channel.	
Embankment	The dam crest and slopes were stable with no signs of instability. The grass length was long which prevented any detailed inspection of the crest and slopes, however there were no obvious signs of movement or settlement.	Maintain a shorter grass length of 50 mm (min) to 150 mm (max) over the dam crest and slopes.

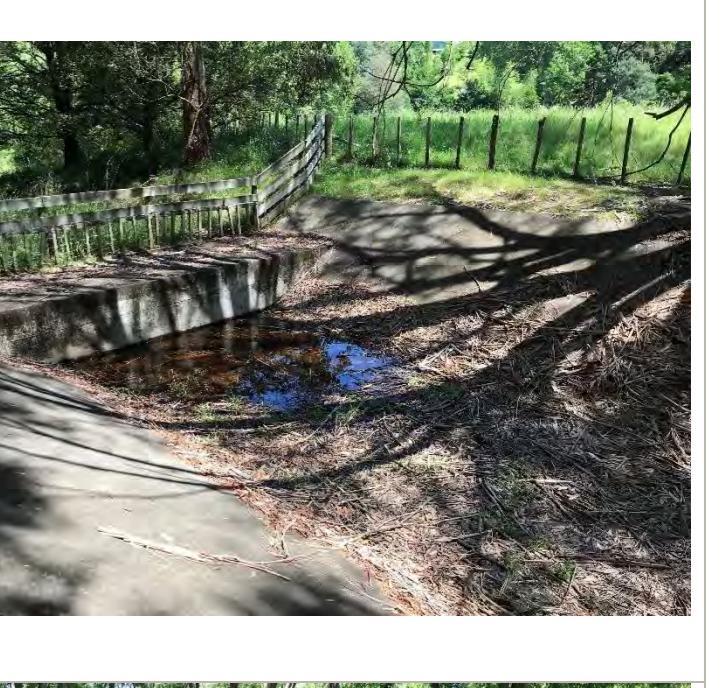
Dam or Appurtenant Structure	Key Site Inspection Observations	Recommendation	Photo
Spillway	The spillway entrance channel was overgrown with grass and contains some large trees. Ideally the approach channel would be clear of all trees and vegetation and be maintained as a clear approach to the start of the spillway structure. A fence and swing gate are present across the start of the spillway structure (as per previous years). This represents a dam safety issue as it will constrict and potentially cause significant blockage during a flood event, preventing design flow down the spillway. HDC have previously considered whether this issue can be included in the proposed O&M documentation, in which the landowner, or contractor, can open the fence/gate in the event of forecast extreme flooding. This should be considered in the context of the likely short duration, high intensity, flood events for this catchment, and possible limited time or ability to achieve this. This should be the minimum approach, and still needs a modification to allow easy opening of the spillway. The side culvert (right of spillway) entrance was blocked with debris and should be cleared to prevent uncontrolled storm overflow into the spillway structure. The invert of the wooden spillway structure has become infilled with leaves and woody debris and other vegetation, and breakdown into soil with grass and vegetation. The invert of the channel should be cleared out and maintained.	Clear the spillway approach channel from trees and vegetation. Remove the fence and gate from across the start of the spillway structure, and/or include in the proposed O&M documentation about opening (but following appropriate modification). Clear the debris from the entrance to the side culvert (right side of spillway) Clear out and maintain the invert of the wooden spillway structure. Complete the recommendations from the Spillway Structural Condition Assessment (Stantec 2018).

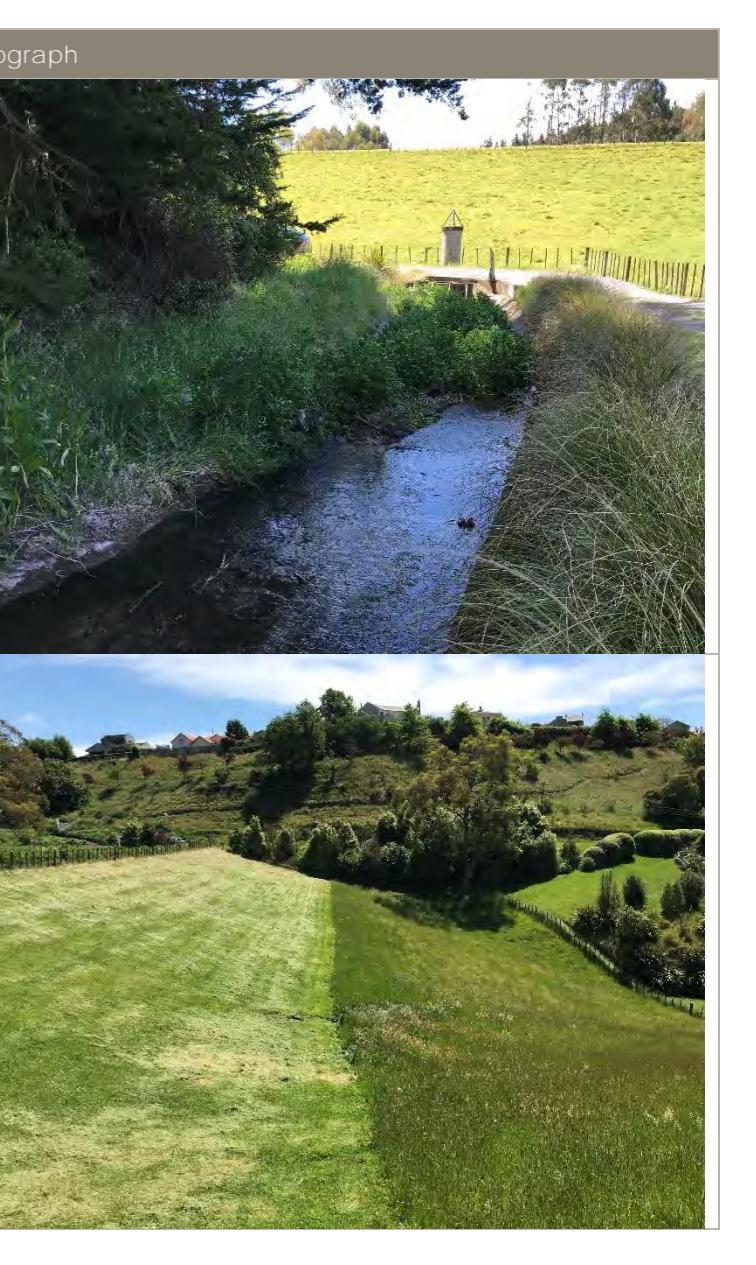
Dam or Appurtenant Structure	Key Site Inspection Observations	Recommendation	Phot
Reservoir Area, Upstream Channel, and Inlet Structure	The upstream channel bank erosion and a large hole around the large tree were similar to the previous inspection. Maintenance of this area should be considered to prevent this worsening or causing problems during a flood event. The channel upstream of the concrete section was overgrown with vegetation. The concrete section of the channel upstream of the inlet culvert was in fair condition. Clearance of silt build up and vegetation in the invert is recommended. The side inlet culvert (right side) had flow along the outside of the pipe/culvert and was entering via gaps/joins in the side slope of the concrete rather than the pipe. This should be fixed/replaced. Water appeared to be seeping in various places (mainly at joins) on the right concrete slope of the upstream channel. This should be investigated further with the fix/replacement of the side inlet culvert.	Clear the upstream channel of vegetation (upstream of concrete section) and clear silt and vegetation from within and around the concrete section. Fix/replace the side inlet culvert (right side) into the inlet channel, as some flow is flowing along the outside of the pipe. Also investigate other seepage areas along the right side concrete slope for areas of vulnerability.

Embankment	The crest was in good condition, with the road and kerb showing no signs of erosion or displacement. The dam slopes were covered in short grass and in good condition, with no obvious movement or settlement. The upper half of the downstream slope had been mown short, which allowed for good inspection of the slope. The standpipes at the downstream toe were similar to previous inspections. These are not monitored. These have previously been recommended to be monitored, at least having them reinstated and monitored irregularly.	Reinstate the downstream toe standpipes and plan future monitoring as part of the Dam Safety Management System.

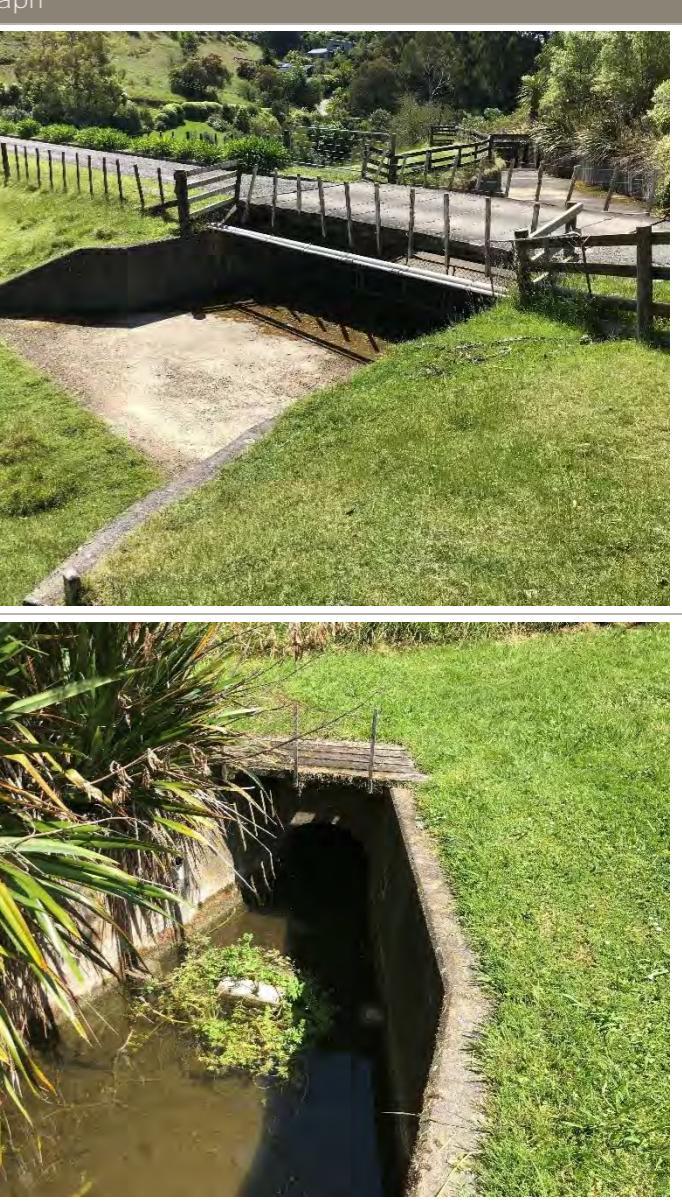
Dam or Appurtenant Structure	Key Site Inspection Observations	Recommendation	Photo
Spillway	The concrete section of the spillway was in similar condition to previous inspections. The gate across the top of the spillway (under the bridge) remains in place as per previous years. This can swing in the direction of flow, but it's unsure how effective this will be. It's recommended this be removed, or at least modified to work more effectively. As per School Stream Dam, HDC are looking at including this in the proposed O&M procedures to contractor and/or owner operation of the gate during predicted flood events. This gate should be more easily modified to be opening effectively during a flood emergency. Significant established trees and plants are located along both sides of the spillway channel, the downstream wooden section in particular. These have caused issues for the wooden structure and have previously been recommended to be removed. The recommendations to replace and strengthen elements of the wooden structure (Stantec structural assessment) should be in conjunction with removal of trees which have contributed to the issue. Removal may be needed as part of maintenance to the wooden structure anyway. The invert of the spillway should also be cleaned out and maintained.	Complete the recommendations from the Spillway Structural Condition Assessment (Stantec 2018). Remove the gate from across the start of the spillway structure, and/or include in the proposed O&M documentation about opening (but following appropriate modification). Note the owner will need to be notified.

Outlet Culvert and Downstream Channel	The outlet culvert structure was in good condition and was clear at the outlet and within most of the stilling basin. The downstream channel, and part of the downstream section of the stilling basin had heavy vegetation. The channel should be significantly cleared.	Clear the stilling basin and downstream channel of all vegetation.

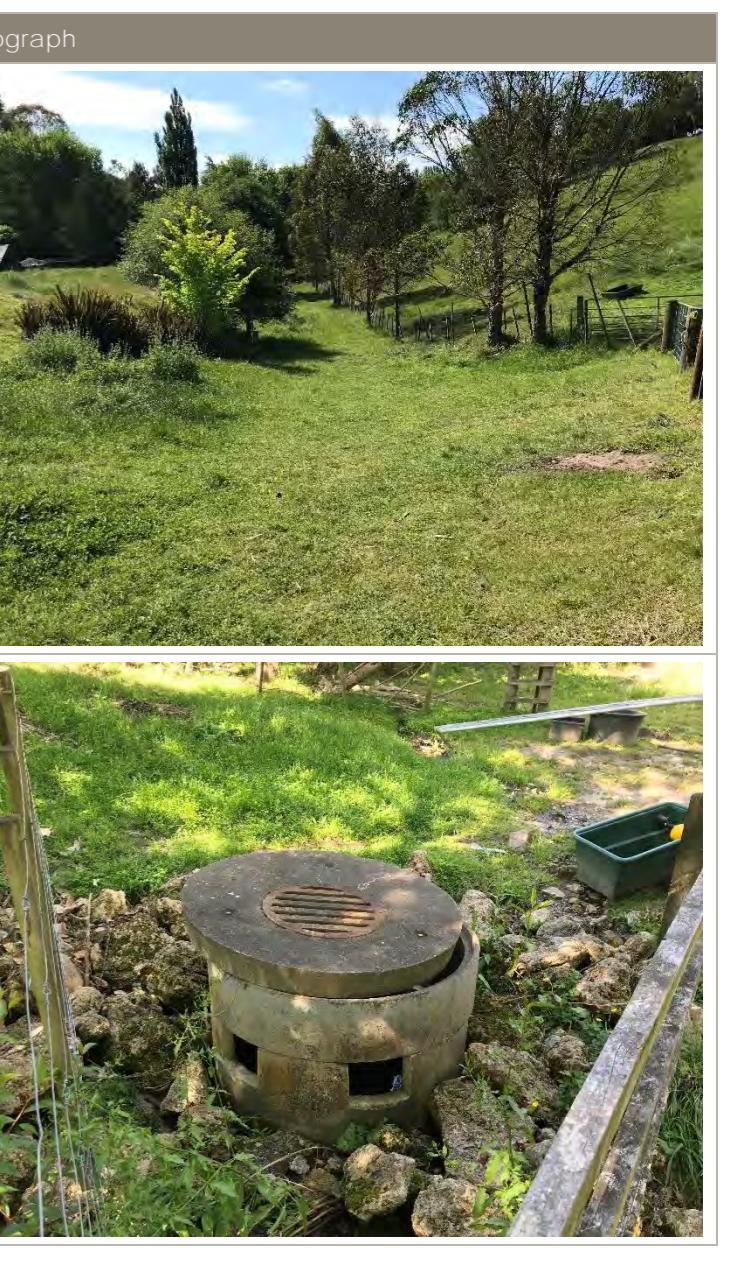
Dam or Appurtenant Structure	Key Site Inspection Observations	Recommendation	Photo
Spillway Channel	The channel on the right abutment was in similar condition to previous inspections. Vegetation and debris piles were present in the channel. Trees and fencing are located down the sides of the channel. All vegetation and debris should be cleared from the channel along with trees and fences. This is to ensure that the design flood flow can be safely contained and discharged. The concrete sill at the spillway crest was in satisfactory condition.	Remove vegetation, debris piles, trees, and fences from within the spillway channel.	
Upstream Channels	 The side inlet channel was in similar condition to previous inspections. The manhole lid is not positioned correctly and should be rectified. Some minor leaf debris was present in the area immediately upstream of the inlet culvert and should be cleared. The outlet to the side channel at the upstream right abutment was not viewed due to presence of animals but in 2018 it was in poor condition. The scruffy dome was not attached to the manhole correctly. The flap gate was not working and should be removed or maintained. The main channel upstream of the inlet structure was very overgrown with vegetation and trees and should be cleared. 	Replace manhole lid correctly at the side inlet channel (right side of upper spillway). Clear the debris from the inlet area of the side inlet channel culvert. Maintenance of the side channel outlet at the upstream right abutment including scruffy dome attachment and removing/fixing the flap gate. Clear the main upstream channel of trees and vegetation.

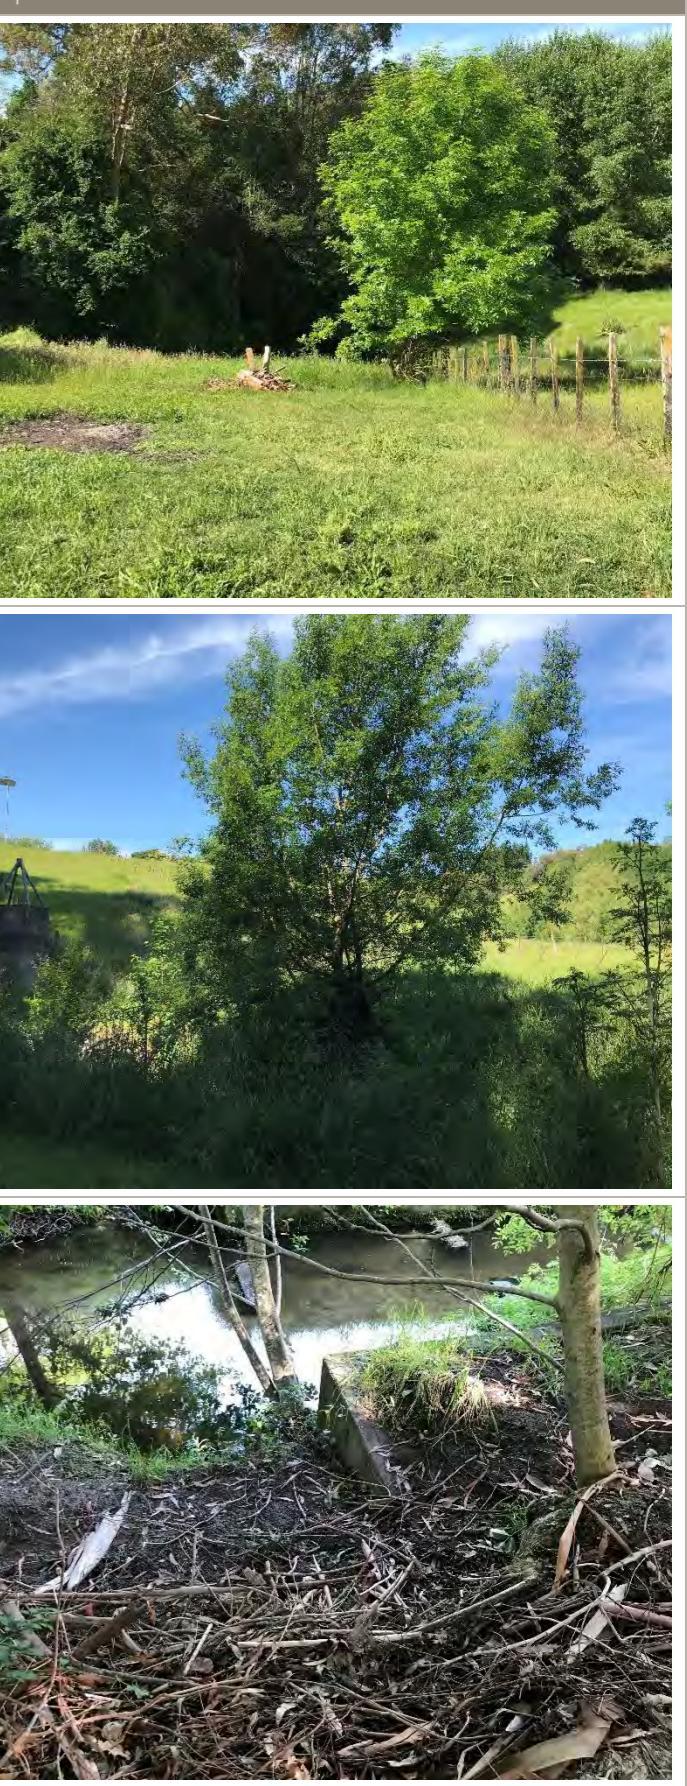
Dam or Appurtenant Structure	Key Site Inspection Observations	Recommendation	Photog
	The downstream embankment area was generally in good condition. Some grass was getting long.		
	The crest areas were in poor condition with vegetation clearance needed and stock erosion in places.	Backfill existing animal burrows and prevent burrowing animals from the dam area.	
Embankment	The downstream slopes of the right abutment (between the spillway and the dam) are steep and undulating, with this area previously having issues with animal burrows. A few burrows and animals were identified again in this inspection. Even though these are not located on the embankment section, discouragement of burrowing animals from the site is recommended.	Clear fences, vegetation, and other items from across the dam area. Repair damaged areas such as erosion across the crest. Clear trees on the dam embankment near the	
	The embankment area included a mixture of animal fencing, long grass, and vegetation.	downstream left abutment. Maintain grass at an acceptable length of 50 mm (min) to 150 mm (max).

A tree is present on the downstream left of the embankment slope and should be removed.		
Inlet Structure	The area around the inlet was becoming heavily vegetated and should be cleared. This also prevents adequate inspection of the inlet and culvert. The vertical inlet structure appeared in good condition.		
Outlet Structure and Downstream Channel	Trees were established on the sides and ends of the outlet structure (stilling basin) and should be removed. The outlet culvert and stilling basin structure appeared in satisfactory condition. The downstream channel had a number of trees and these should be cleared, as they are encroaching on the channel. The downstream boundary wooden swing fence was in unknown condition due to the heavy vegetation.	Remove trees on the sides and ends of the outlet structure (stilling basin). Remove trees in downstream channel. Clear or remove downstream boundary wooden swing fence.

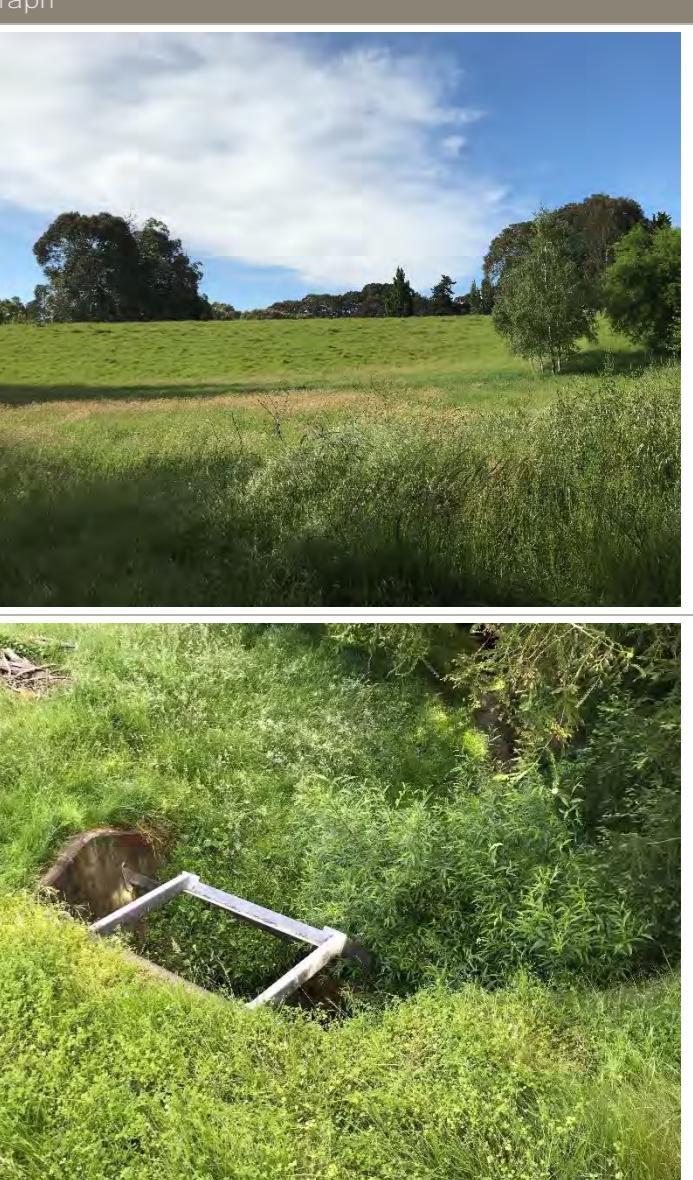
Dam or Appurtenant Structure	Key Site Inspection Observations	Recommendation	Photo
Reservoir Area and Upstream Channel	The reservoir area was fairly clear and contains mostly open pasture, surrounded by trees. The upstream channel between the boundary fence and the inlet structure was becoming heavily vegetated with lots of trees along the sides of the channel. The channel should be cleared out. The culvert/bridge upstream of the inlet structure was clear and stable. Some of the timber support surrounds were becoming damaged and broken. The reason for this access bridge is unknown.	Remove established trees in the upstream channel to maintain a clear channel and to reduce the potential for future blockage potential at the inlet culvert area.	
Inlet Structure	The upstream inlet structure area was hard to view due to vegetation in and around the structure and within the channel. The culvert appeared in good condition as could be viewed from the upstream end. The tree on the hydraulic left side of the structure should be removed.	Remove the vegetation from within and around the inlet channel area and structure. Consider wider tree clearance around the upstream left abutment where some large trees are present (proactive maintenance at least).

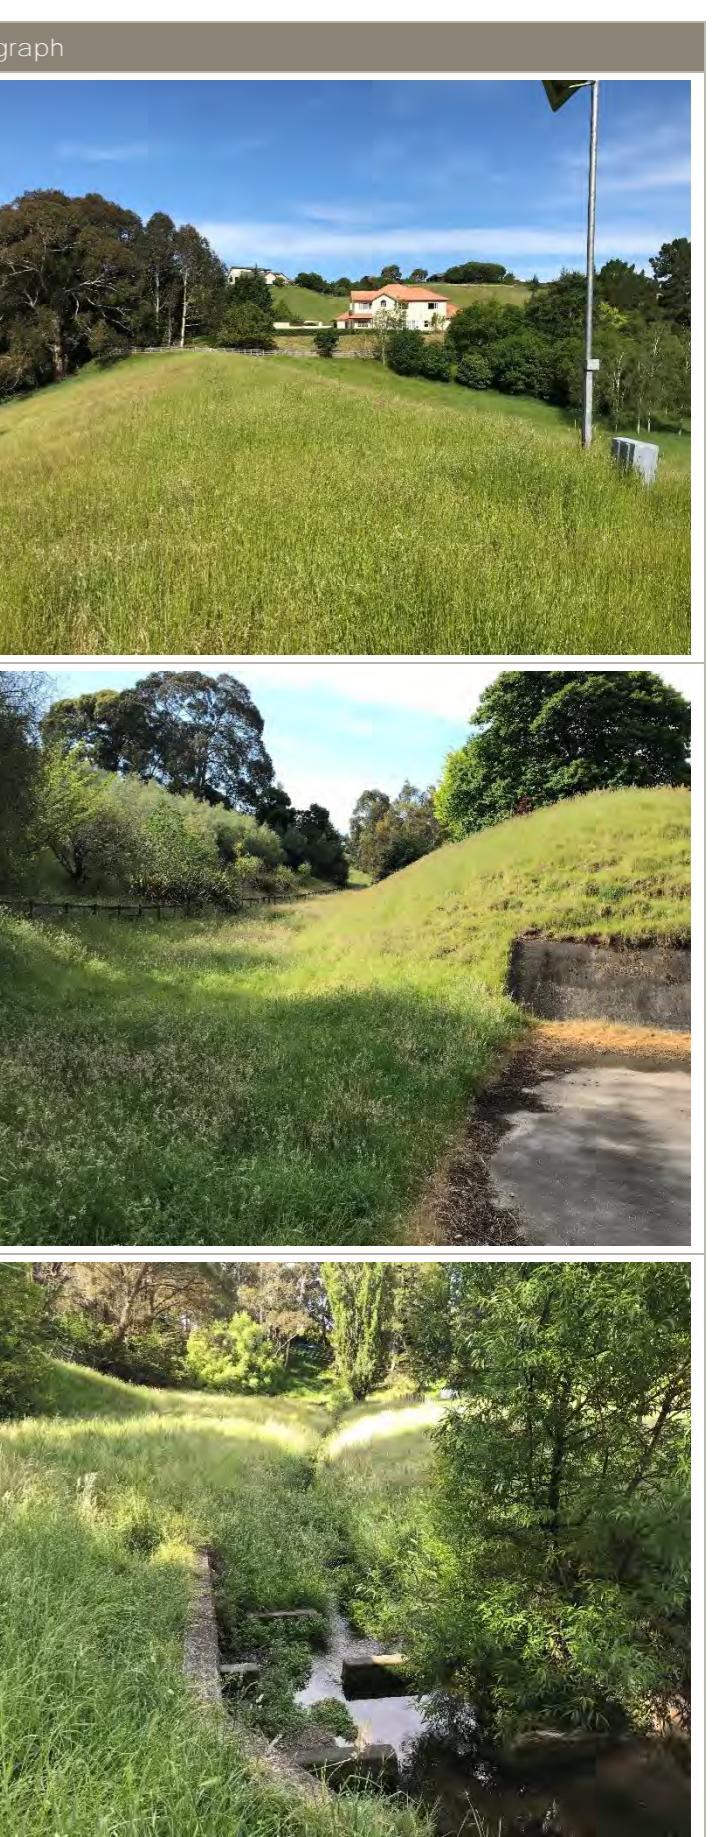
Dam or Appurtenant Structure	Key Site Inspection Observations	Recommendation	Photo
Embankment	The upstream face was in good condition with stable slopes. Medium to long grass coverage was across the dam crest and slopes. There were no obvious signs of movement or settlement. The downstream face was similar to the upstream face and crest. The trees on the downstream left and right abutment should be cleared so they don't cause any potential impacts on the embankment or outlet area, and to allow clear inspection.	Remove the trees from the downstream left and right abutment areas. Maintain grass at an acceptable length of 50 mm (min) to 150 mm (max).	
Spillway	 The concrete sill was in good condition. The spillway channel had very long grass and should be cut back. The wooden fence and trees along the left side of the channel should be removed. The large trees across the lower slopes upstream of the spillway channel (adjacent to the inlet structure) should have maintenance or be removed so as not to cause issues during a large flood. Remove/alter the fence and gate across the spillway channel at the property boundary (mid section of spillway), as this represents a blockage potential. The downstream spillway channel was viewed from the fence/gate and was becoming overgrown with vegetation and trees and other items. The house on the right side is also close by. The flood levels from spillway flows should be checked against the levels at this house. 	Complete maintenance in the spillway channel (clear trees and vegetation and remove wooden fence). Complete maintenance on or remove the large trees at the lower slope upstream of the spillway channel. Remove/alter the fence and gate at the mid section of the spillway channel. Check spillway flood flow levels against the levels of the house on the right side of the spillway channel (halfway down).

Outlet Structure and Downstream Channel	The downstream channel was generally clear and stable but contained long grass. The outlet structure was generally in satisfactory condition. A tree in the stilling basin should be removed. The stilling basin invert should be cleaned out and inspected for any issues. The iron flap gate (stock prevention) should be cleared as it was blocked up with debris. This gate should be removed and stock prevented from accessing this area by other means (fencing around outlet structure and downstream channel).	Remove the tree in and clear the invert of the stilling basin outlet structure. Remove iron flap gate from the culvert outlet.
