FLOOD DETENTION DAMS - 2019 INTERMEDIATE DAM SAFETY REVIEW

PREPARED FOR HASTINGS DISTRICT COUNCIL

March 2020

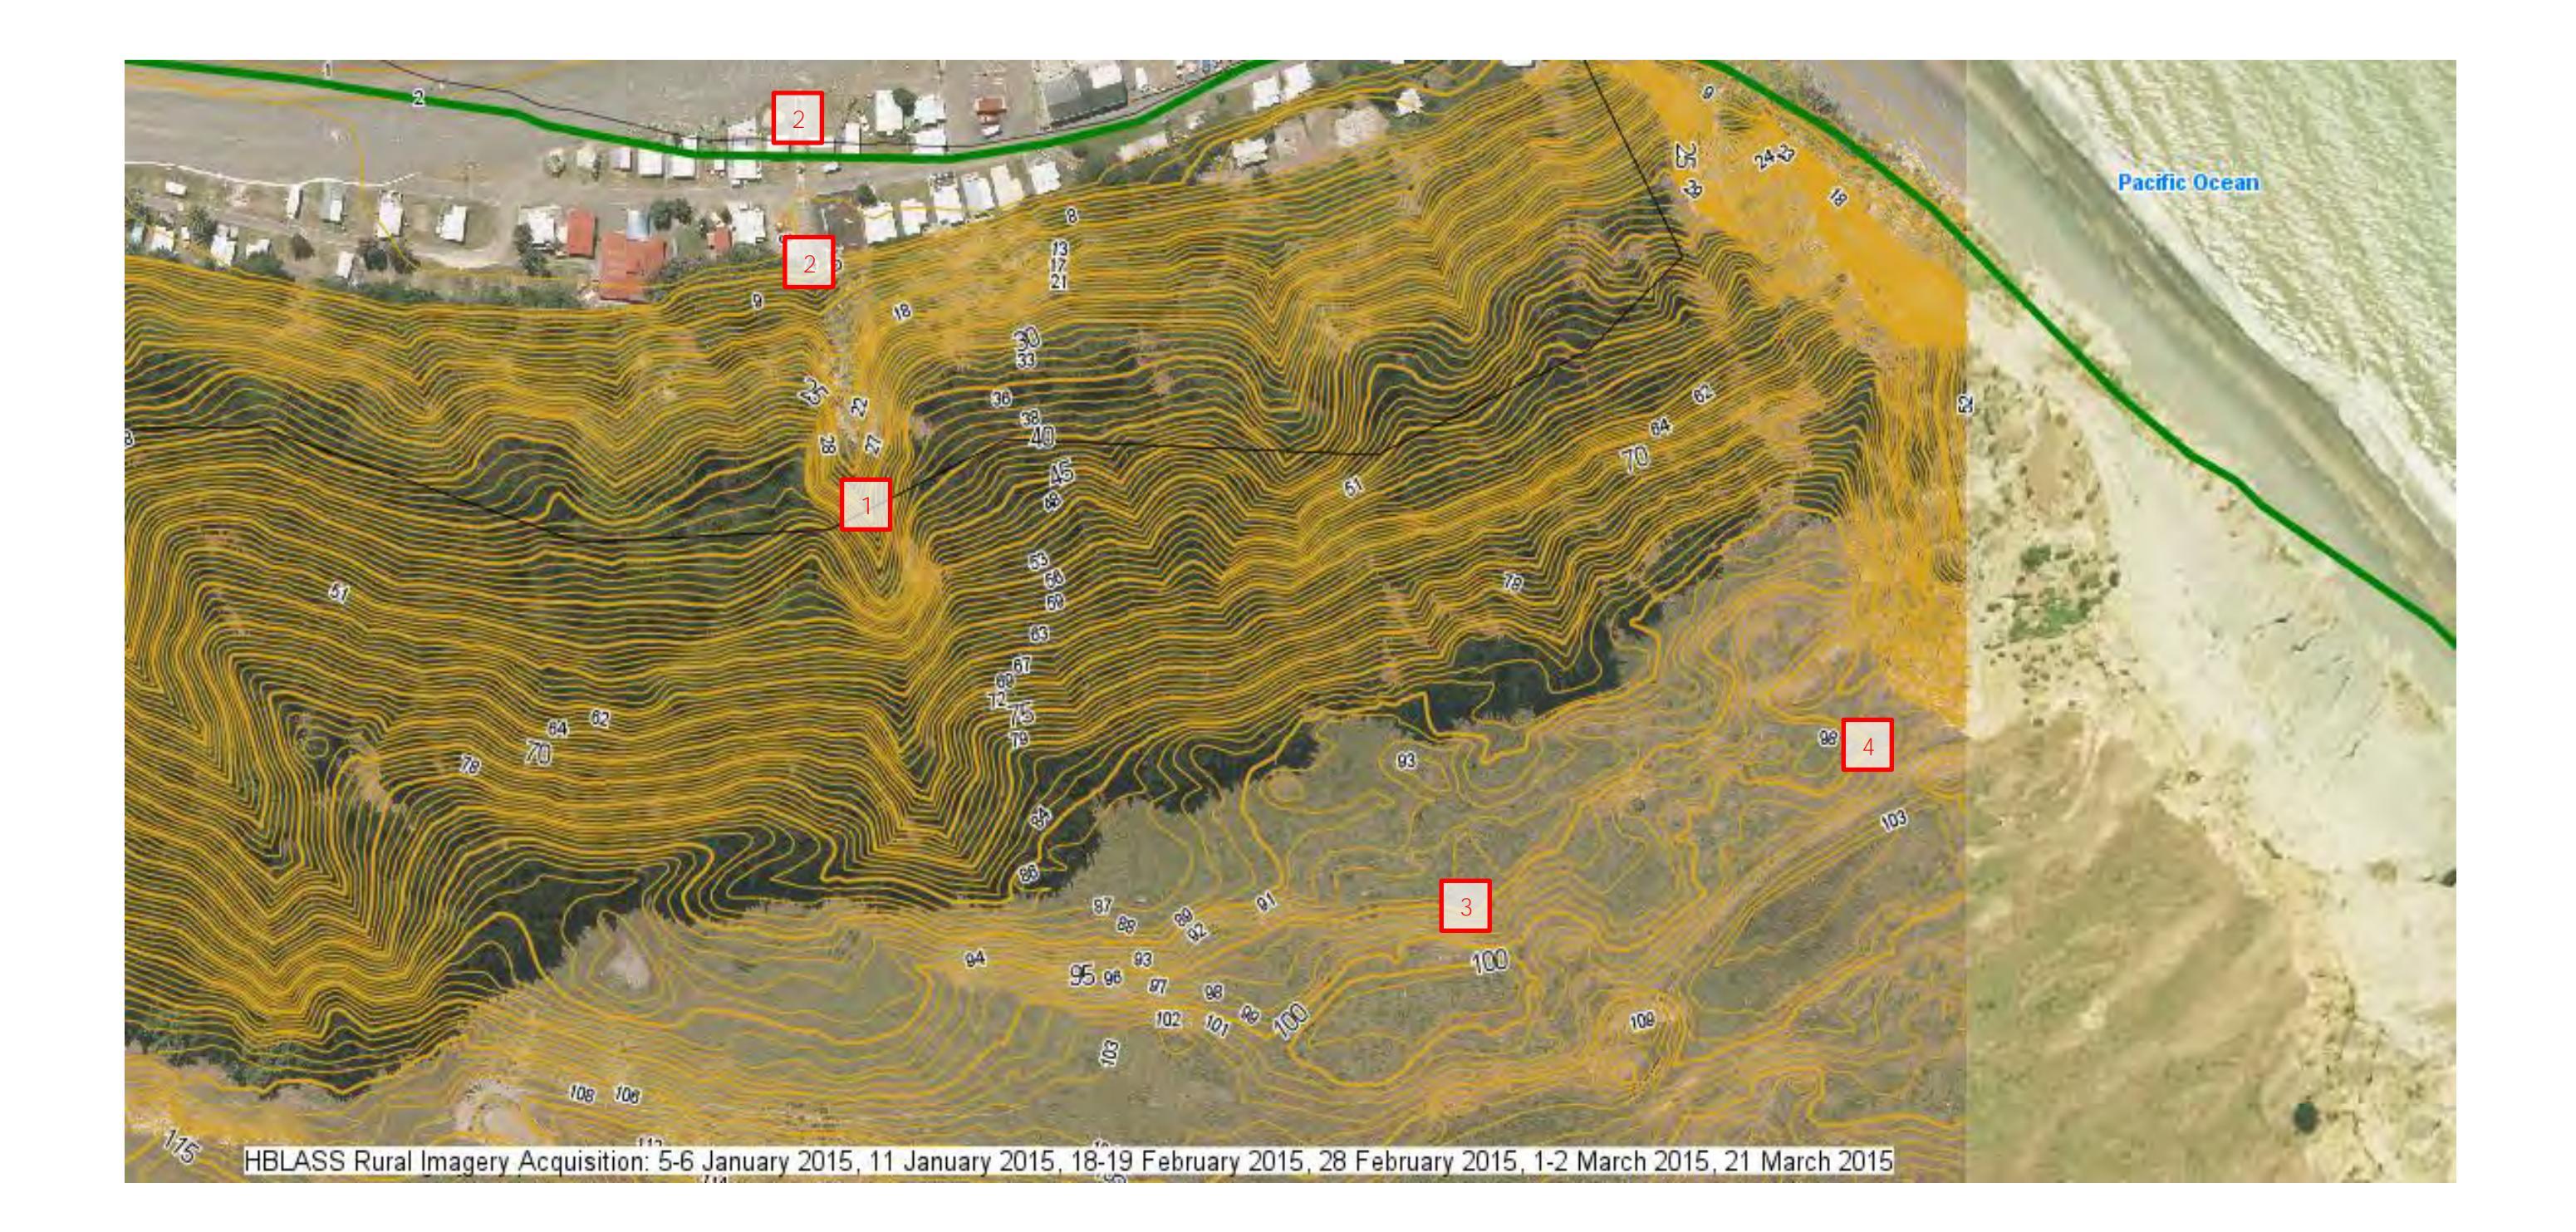
Ref	Description	Photo (s)
1.	The remediation of the gully or other stormwater control options should be investigated. The stormwater gully was in similar condition to previous years with damaged pipe sections and concrete blocks. The damage was caused by flooding in April 2011. The full length of the previous pipe was traversed. Section of corrugated metal pipe, concrete blocks, concrete manhole, etc remain in the gully. These could be mobilised further down the gully in future flood events. Flood flows from the catchment and flood detention dams behind the camp will flow down this gully without the control of the manholes/culvert system that was previously there for this purpose.
