# Havelock North – Mangarau Stream 2c Affected Landowners Meeting

**13 December 2023**

## Findings of the T&T report/ flood mitigation options report

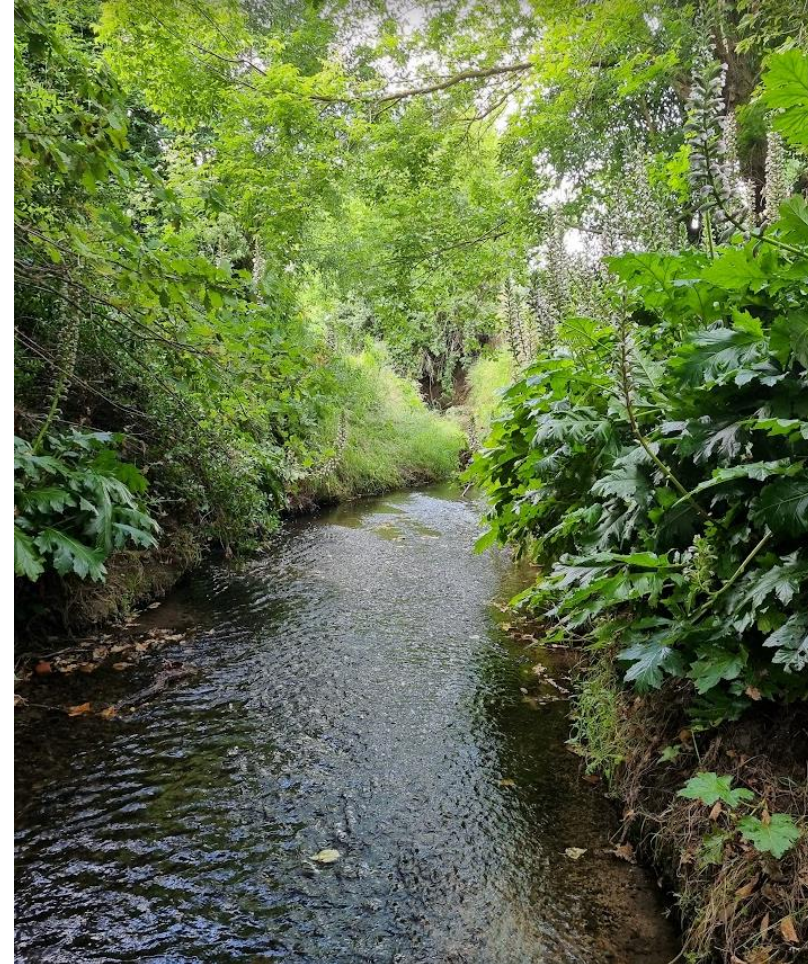
- Improved maintenance including access provisions
- Stream widening where feasible (including channel widening, rock armouring and retaining walls)
- Partially remove old weir structures and headwall.

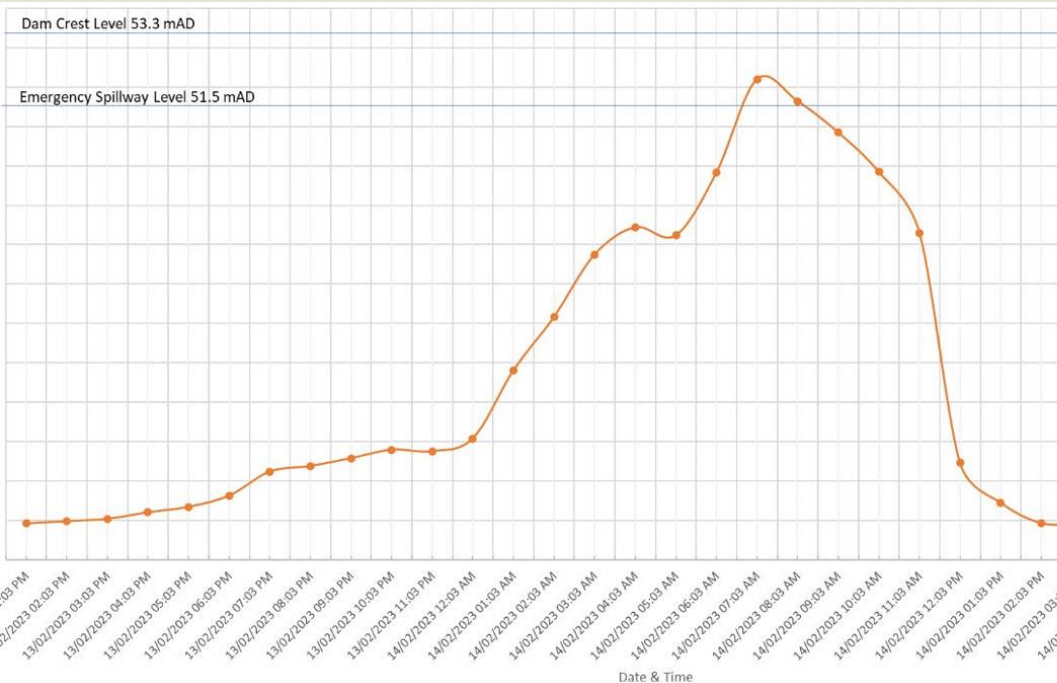
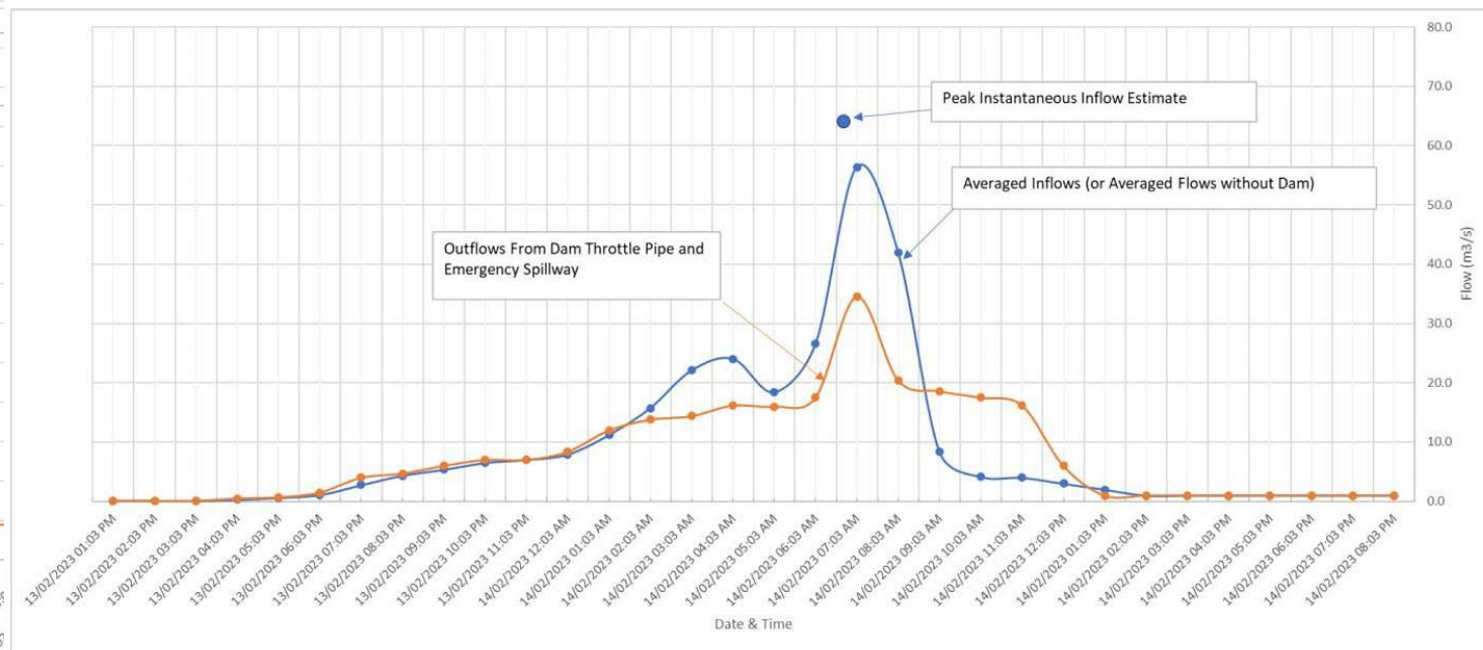
Average Outflow and Estimated Inflow Hydrographs for Mangarau Dam

Dam	Peak Estimated Inflow (m <sup>3</sup> /s)	Peak flow through Throttle Culvert (m <sup>3</sup> /s)	Spillway Overflow (m <sup>3</sup> /s)	Combined Flow (m <sup>3</sup> /s)	Peak Volume Stored (m <sup>3</sup> )
Mangarau	70.0	19.7	14.8*	34.5	300,000
Herehere	37.0	11.9	0	11.9	205,400
Te Kahika	9.0	3.4	0	3.4	40,950
School Stream	3.6	1.2	0	1.2	22,750
Karituwhenua	5.2	3.0	0	3.0	8,300
