Land Categorisation Review

Havelock North- Mangarau Stream

Hawkes Bay Regional Council

Tonkin & Taylor Ltd

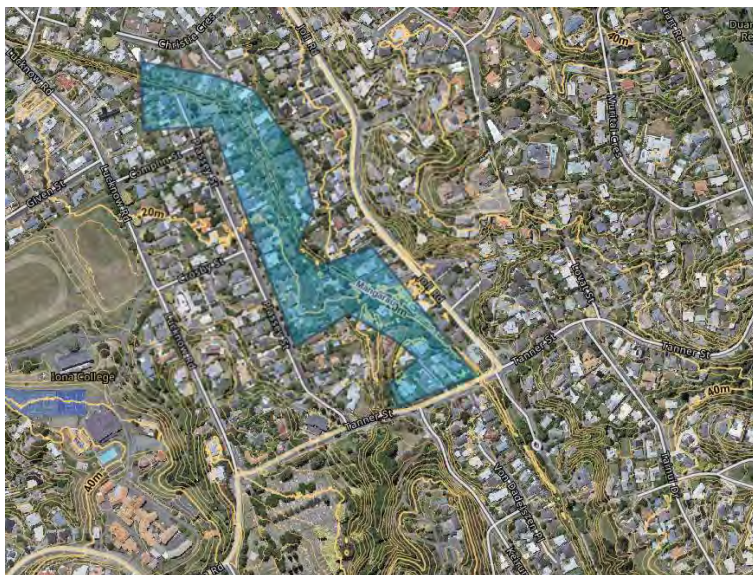
Figure 2.1-Lower Mangarau catchment area and topography, showing approximate extent of 2C area.

Figure 2.1 shows the general topography of the Mangarau lower stream area, including the tributary catchments from Keirunga Gardens, to the southwest and Tanner St Reserve to the southeast. Generally, the residential area lies about RL 16 to 20 m. The stream banks are typically 2-3 m high along most of the stream alignment, in places deeply incised.

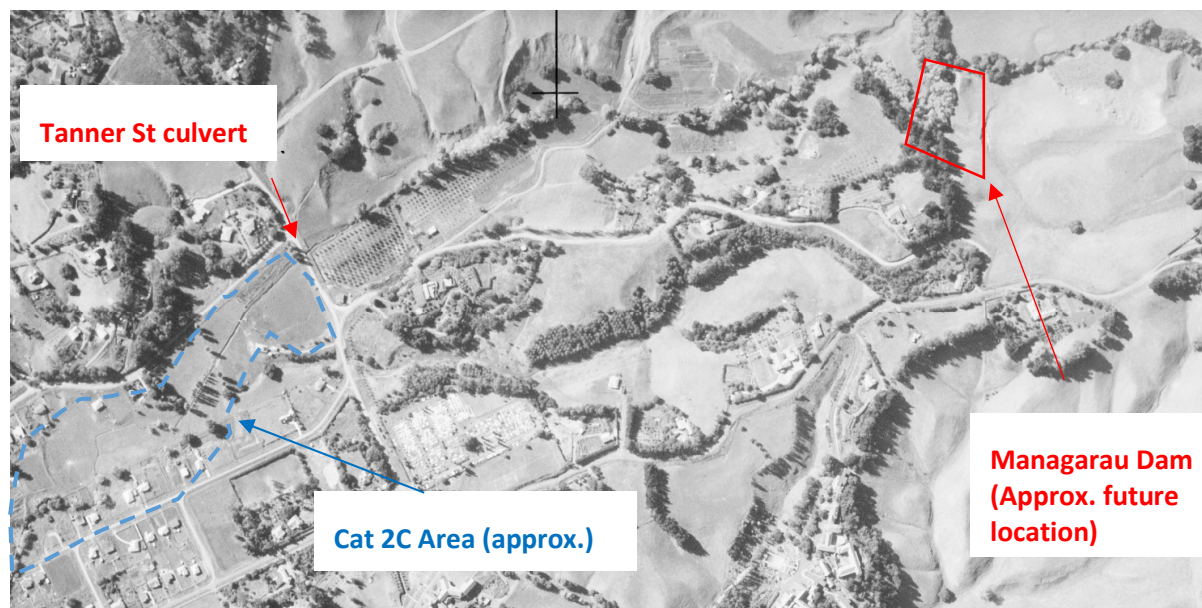
Figure 2.4- 1950s aerial showing Mangarau catchment and dam. Source (Retrolens)

This clear floodplain area is later re-aligned to make way for housing along Plassey St.

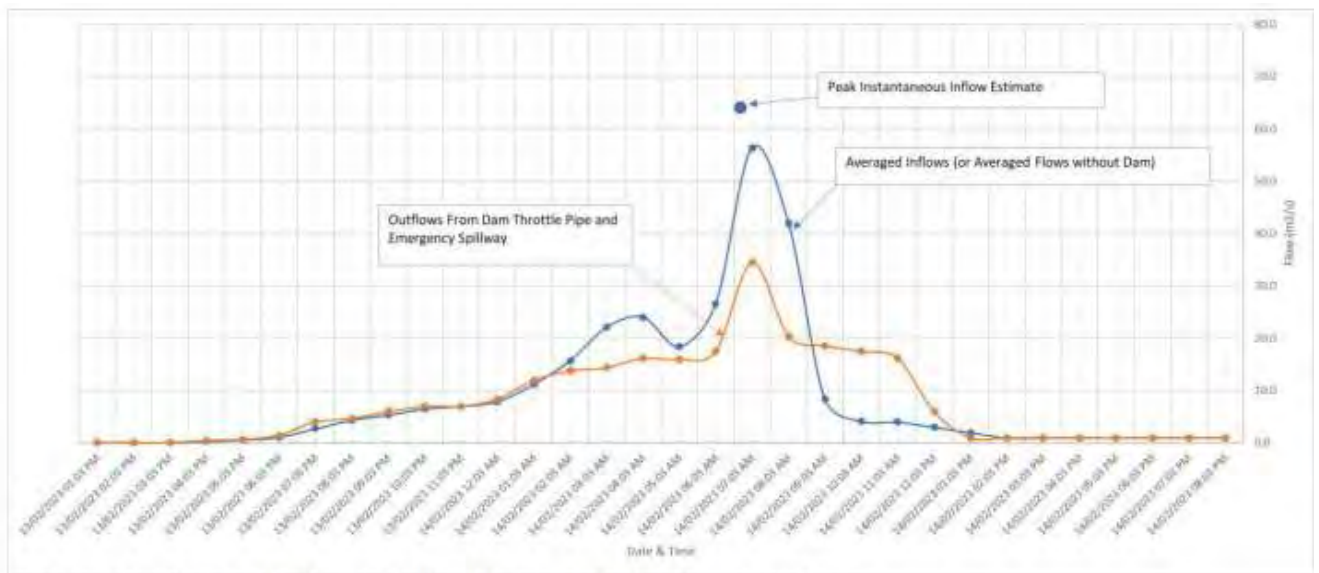
Figure 4.3- HDC provided dam inflow hydrograph, Mangarau Dam during Cyclone Gabrielle

Following Cyclone Gabrielle, HDC have provided a public update which contains some information on the dam inflows and outflows. The document notes a combined dam outlet flow about 35 m³/s (20m³/s through the low level conduit and 15m³/s over the spillway). Figure 4.3 below shows the HDC summary of inflows and outflows from the dam during the event. Note that the actual flows contributing to the Category 2C area will be significantly larger than this, due to inflows from surrounding tributaries in the reaches of the stream below the dam.

Average Outflow and Estimated Inflow Hydrographs for Mangarau Dam

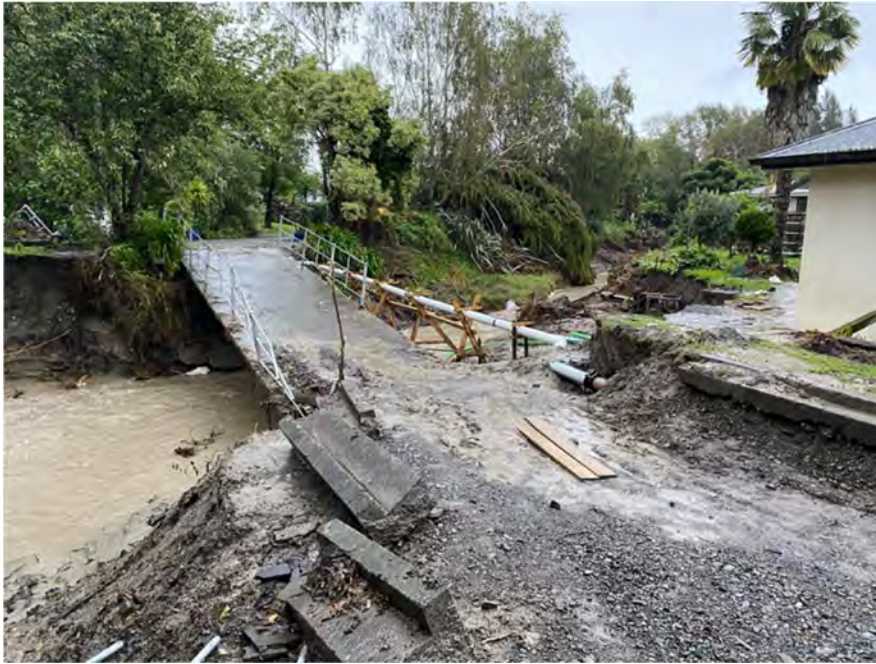
Figure 5.1- Private bridge crossing at 78 Joll Rd following the cyclone. Note the slump on the right bank and severe scour on left bank.

- 3 Below Tanner Street, local residents noted the presence of a large tree trunk within surrounding private property, which was washed into the stream below Tanner St. This was trapped against the private road bridge at 78 Joll Rd along with other debris such as fencing, trees, shrubs and detritus from surrounding streambanks. The damming effect of the debris pushed the bridge off its abutments and blocked the channel, resulting in water flowing around the banks, through the adjacent properties, this fed back into the Mangarau Stream below 74A Joll Rd. The blockage at the bridge is understood to have resulted in the most severe flooding around these properties along Joll Rd. Figure 5.1 shows the damaged bridge after the Cyclone.

- Complete a detailed design to support Building Consent for retaining wall or bridge elements. The permanent replacement of the 78 Joll Rd bridge will require a further design input and confirmation of suitable freeboard above 1% AEP flood levels.

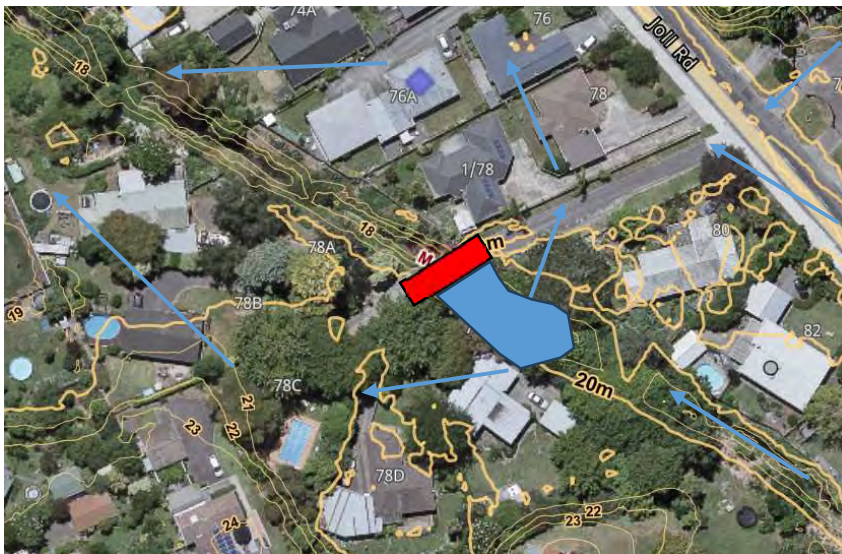
Figure 5.2- Schematic of bridge damming effects and flows into surrounding residential area.

- 4 Residents along Joll Road also note significant inflows from the overwhelmed stormwater network along Joll Road and overland flow from Laing Cove, (a small cul-de-sac) east of Joll Road. Figure 5.2 outlines a generalised schematic of the flood impacts that morning based on our interpretation.

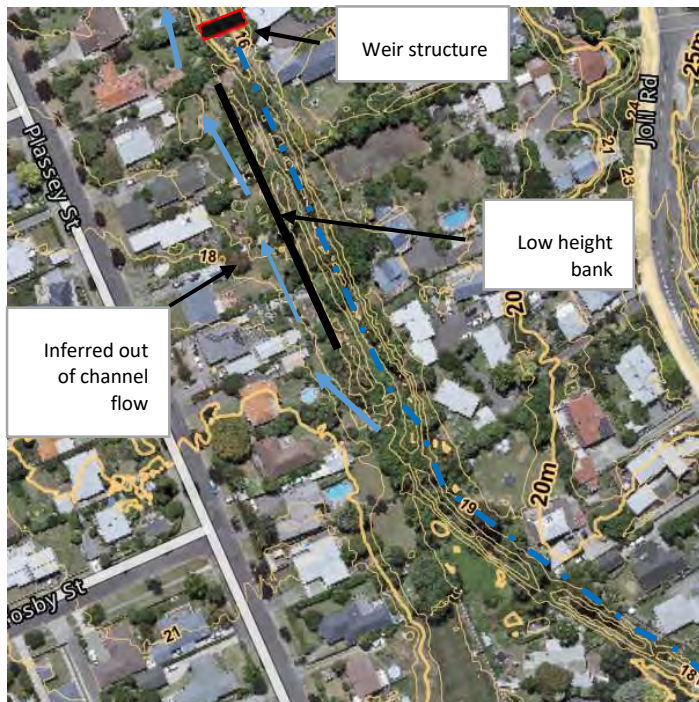
Figure 5.3- Out of channel flows on lower Mangarau during cyclone Gabrielle.

- 5 Further down the Mangarau stream, local residents describe out of channel flood flows along the Plassey St side of the stream. Based on a site walkover and initial review of topography, these flows may be as a result of:
 - a Constriction in the modified channel just above the weir and waterfall structure. The channel is confined around the weir and waterfall headwall.
 - b The low height informal bank adjacent to the channel (possibly the heaped spoil from the channel re-alignment works in the 1960s) may have limited channel width and ability for out of channel flows to re-enter the stream.
 - c Water then flowed between properties, knocking over fence lines and causing property damage to the properties on the true left of the Mangarau Stream, on Plassey St.

- 6 Below Plassey St, the water was just below the soffit of the footbridge and debris was kicked away by members of the public. There were minor out of bank flows below Plassey St but these were generally limited to where the channel was narrowed around bridge structures. These areas were generally cleared by later that morning.

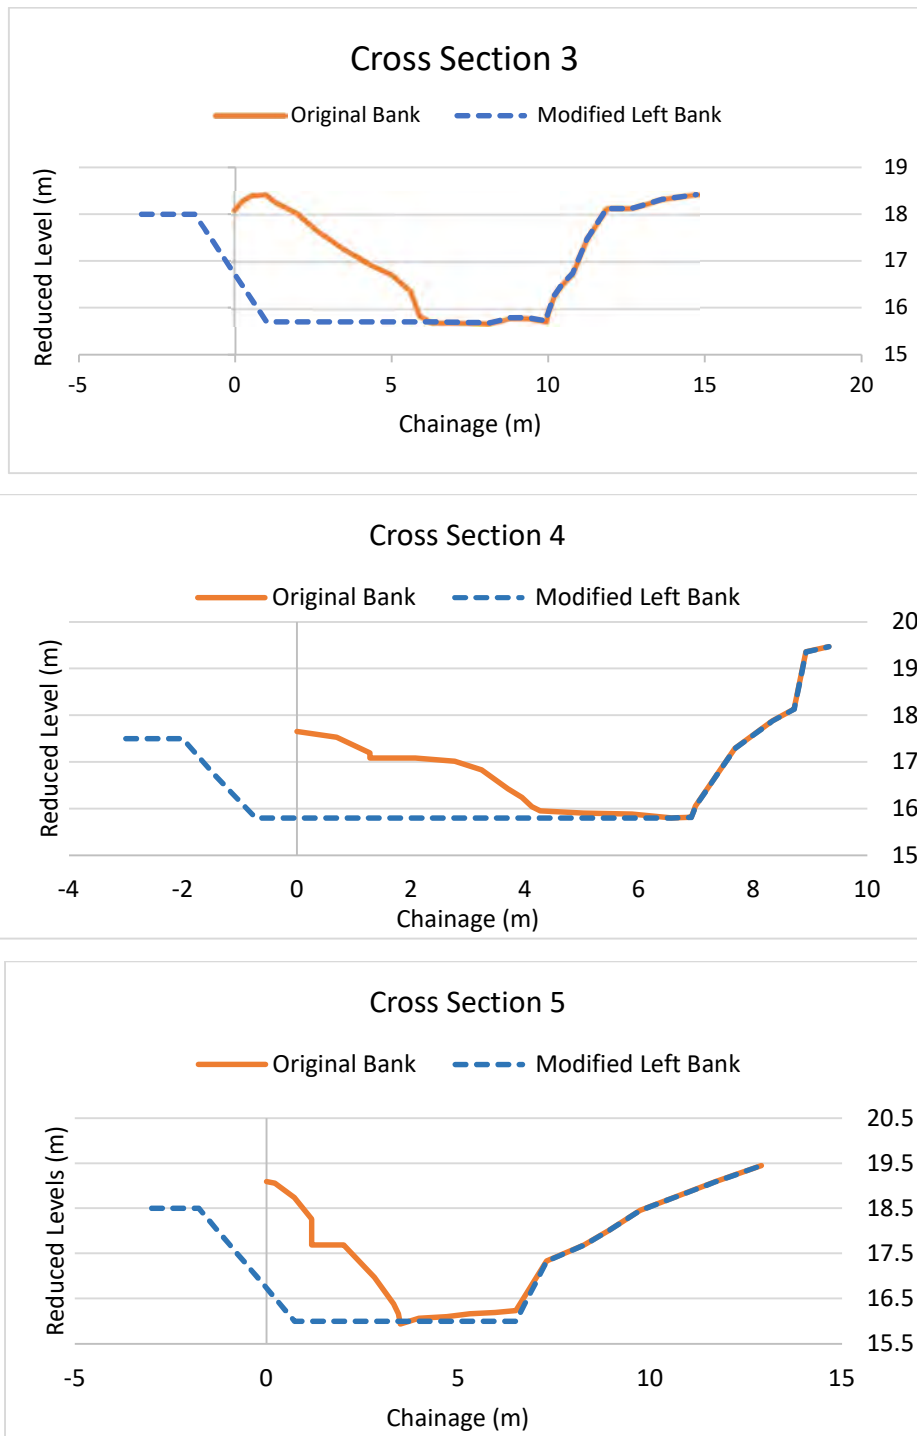
Figure 7.2- Channel cross sections- XS3-5 Mangarau Stream

Where channel modifications had been made to the left bank, the Mannings coefficient was reduced to 0.05, reflecting improved flow conditions. Additionally, in sections where retaining walls were proposed, the coefficient was further decreased to 0.04, indicating significantly reduced resistance and enhanced flow efficiency. These coefficients are initial estimates only and we recommend further review during detailed design. These estimates also assume that the channel will be maintained in future.

along the Plassey St left bank, so consultation and land acquisition will be needed. Further survey, hydraulic modelling and design work would be needed to refine the proposed alignment.

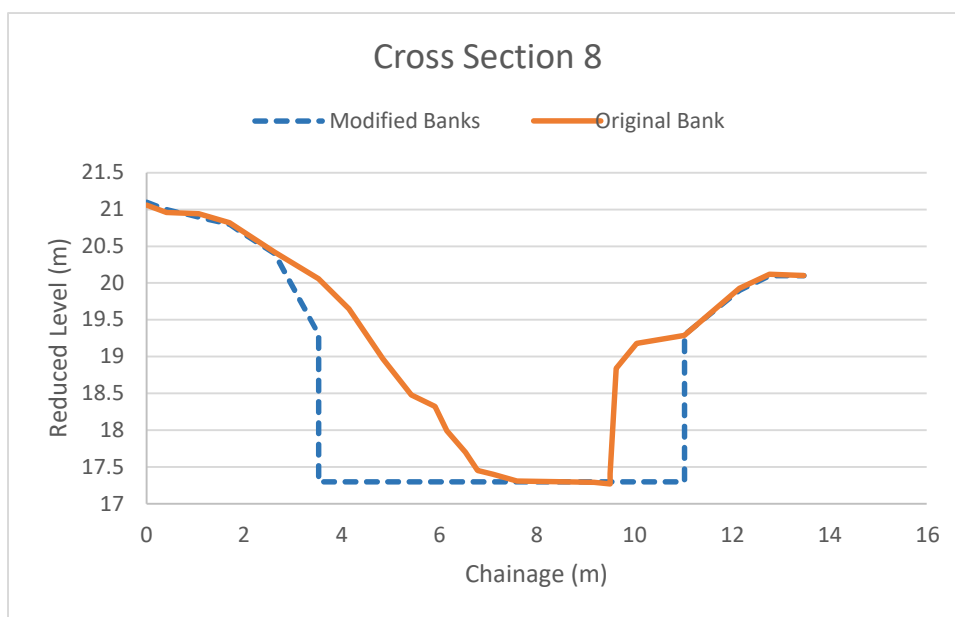
Figure 7.3- Cross section 8, Mangarau Stream

While the flow capacity in Cross Sections 6 and 7 are less of a concern than areas below, this section appeared to suffer from debris build up, which subsequently caused the damming and collapse of the 78 Joll Rd Bridge. Sections of the stream here are slightly wider than below reach (XS3-5), but with isolated pinch points. Cross section 8, upstream of the bridge, at 84 Joll Rd, appears to be narrow and steeply incised.

Care will need to be given to providing sufficient construction access and safety railings to provide fall protection for local residents if this option is considered further. A building consent will likely be required for the retaining structures. We also note that consideration of scour depth on the passive support for the wall and the transition from channel to pile wall will require specific design. Toe armouring and planting should also be considered. Other retaining solutions may need to be considered.

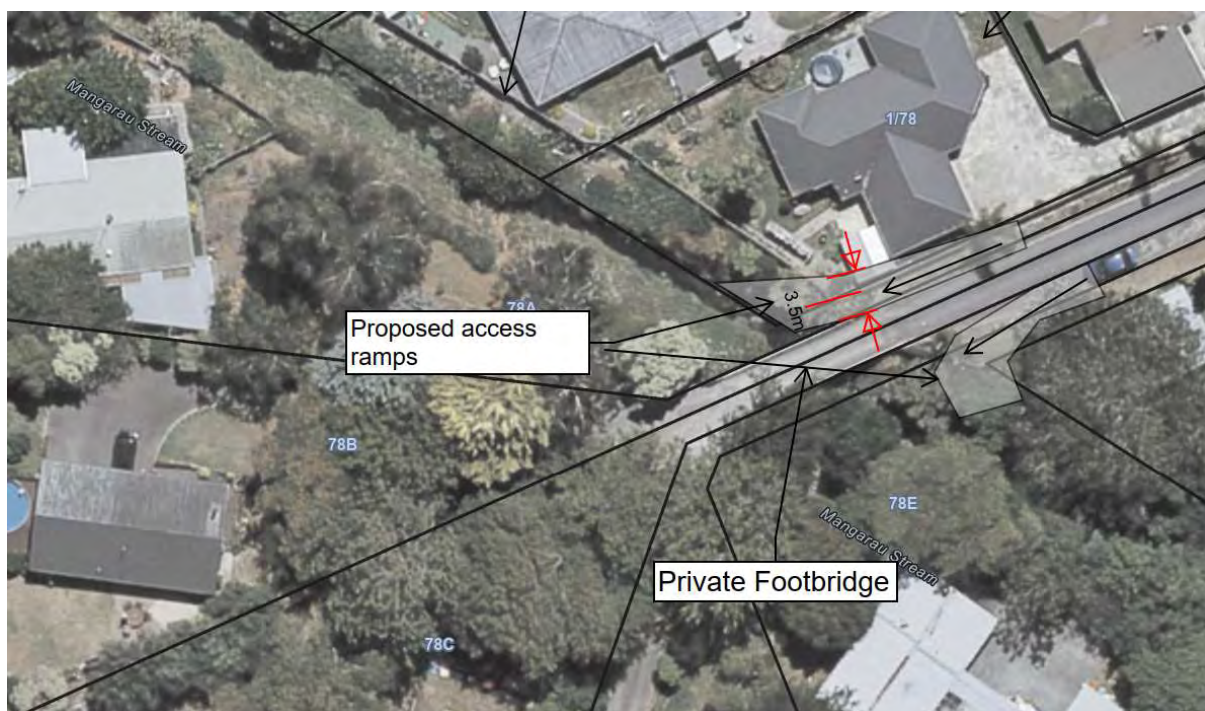
Figure 7.4- Proposed upper access ramp locations

The property at 1/78 is understood to have been significantly damaged and may require demolition (TBC by others). Consideration could be given to acquiring part of this property to construct an access ramp down to the stream across the slumped section adjacent to the bridge abutment. The upstream access point could be used to get machinery up to the reach up to the Tanner St Culvert and would also require property acquisition.

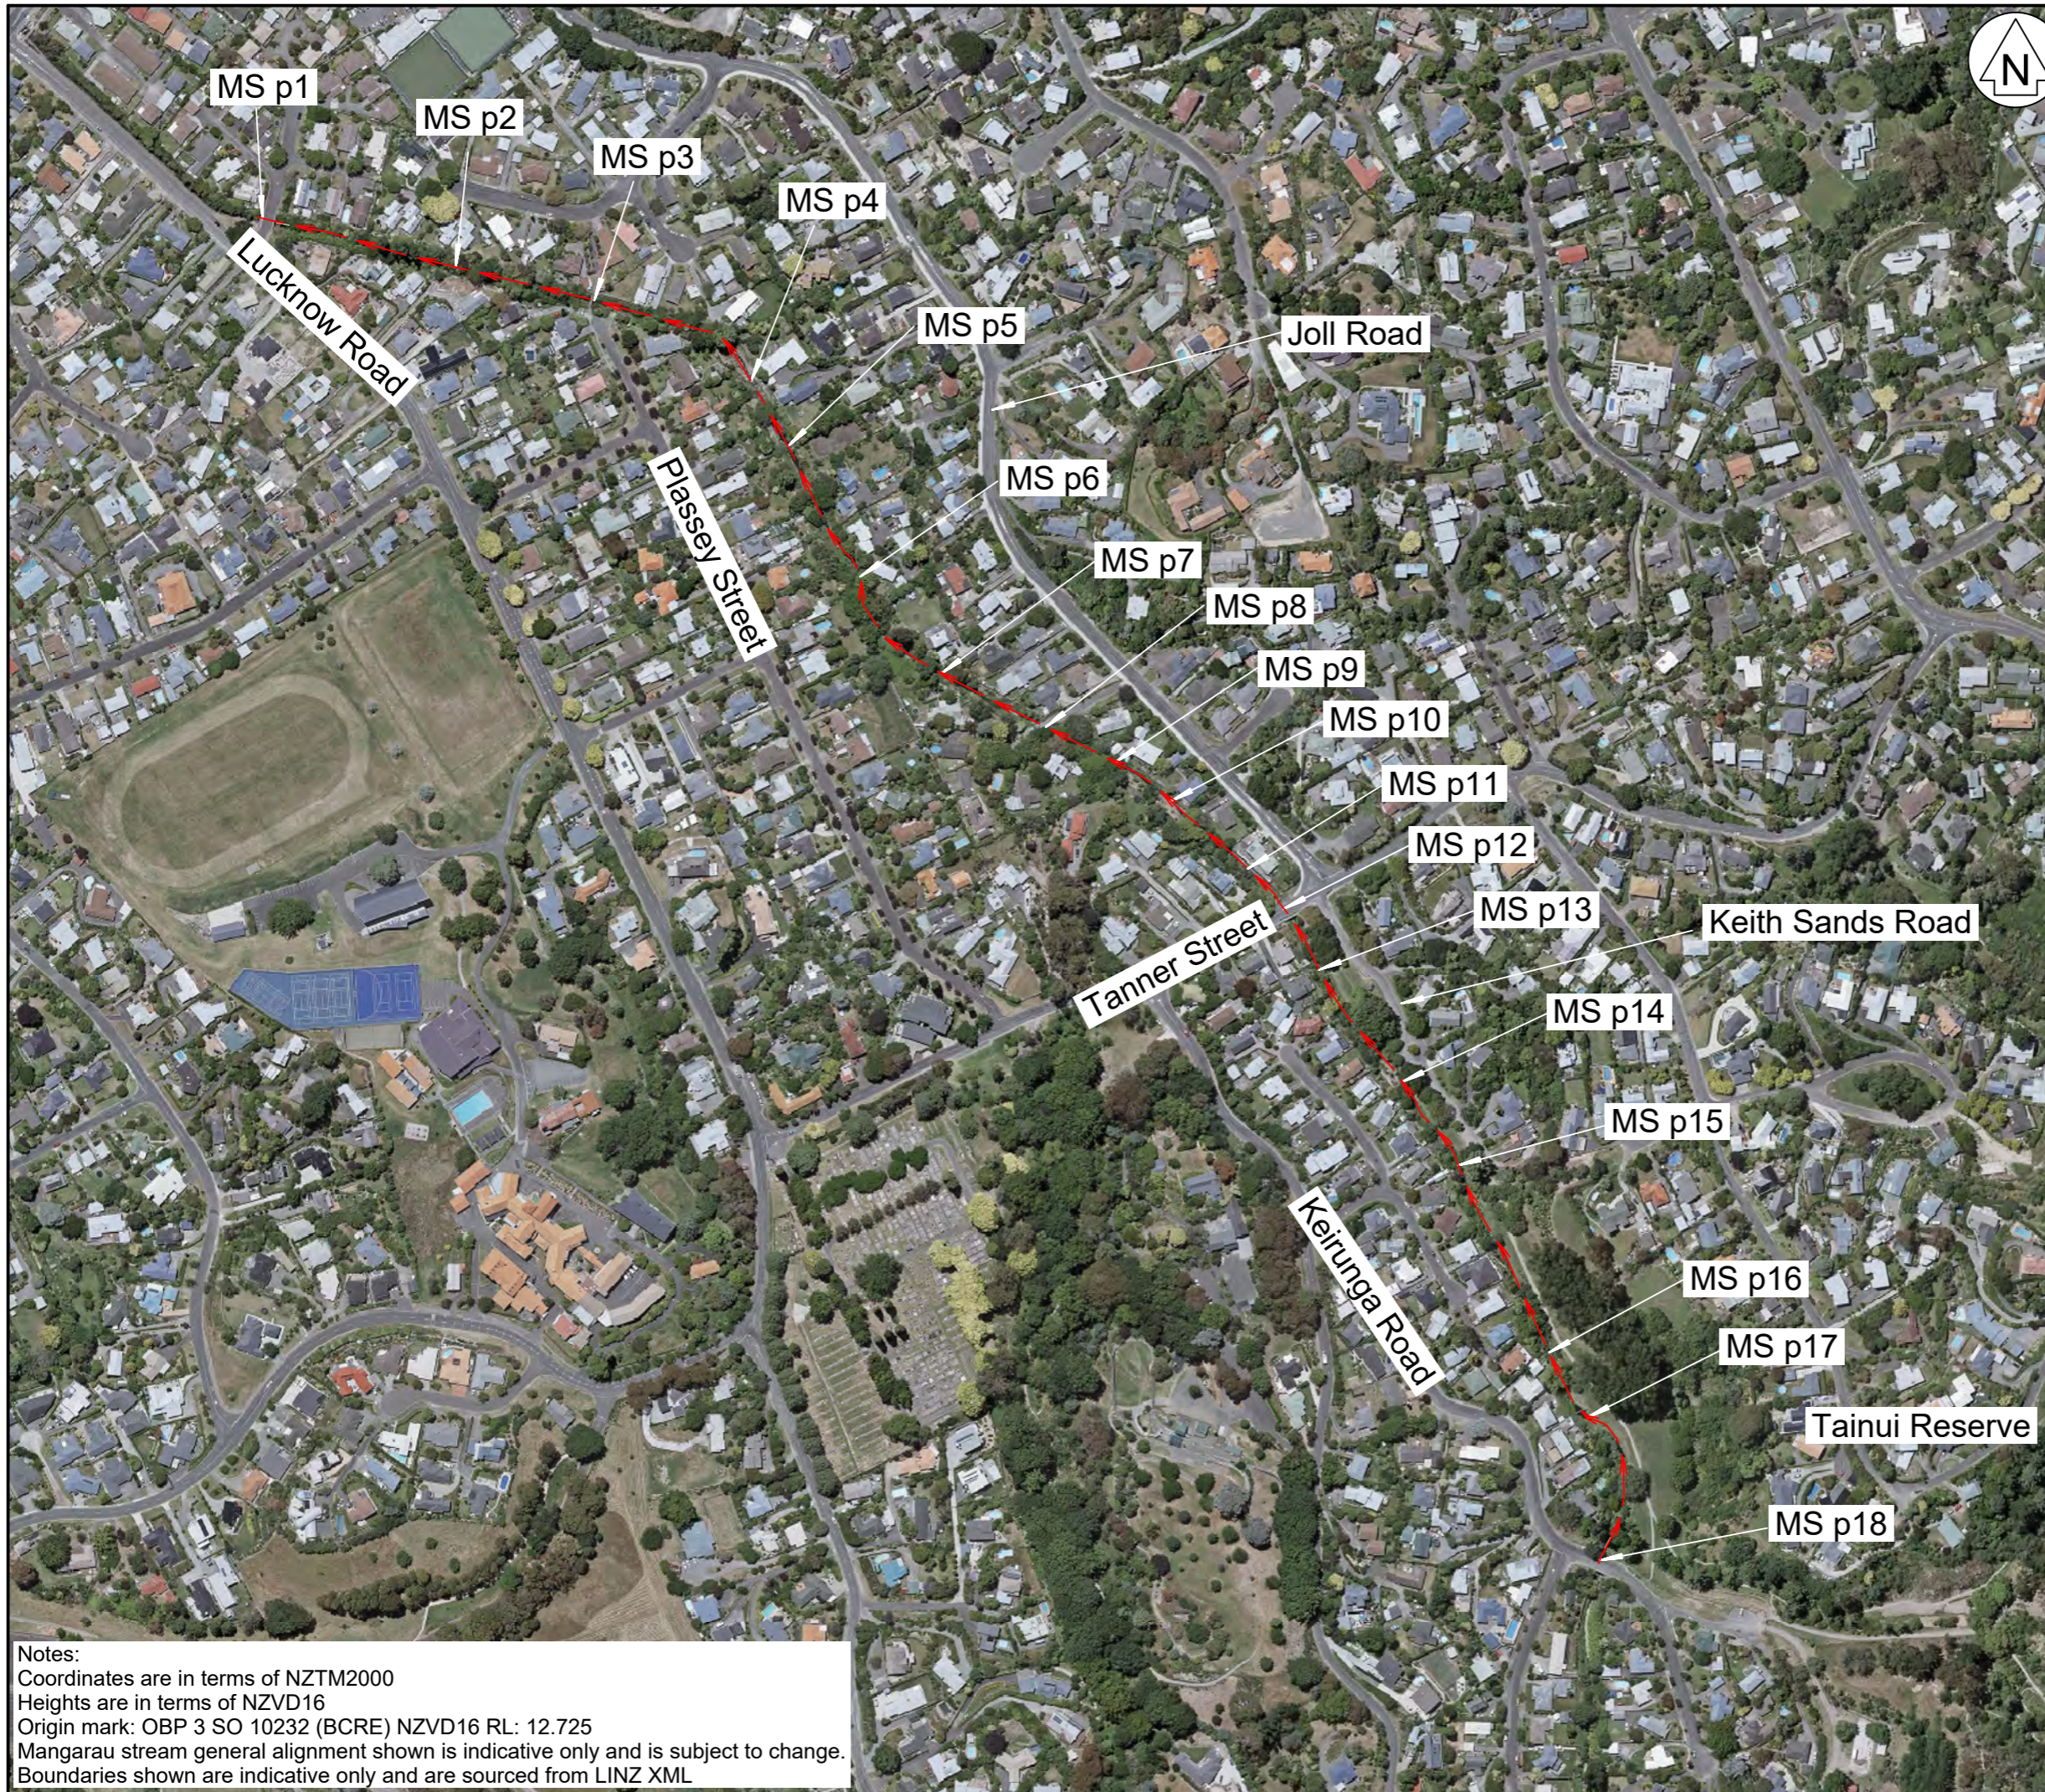
DATE : 06-09-2023
 SCALE : 1:4000 @ A3
 DRAWN BY : JW
 JOB NO. : J002088
 PLAN NO. : MS Overall

Project Overview
Mangarau Stream
Havelock North

Notes:
 Coordinates are in terms of NZTM2000
 Heights are in terms of NZVD16
 Origin mark: OBP 3 SO 10232 (BCRE) NZVD16 RL: 12.725
 Mangarau stream general alignment shown is indicative only and is subject to change.
 Boundaries shown are indicative only and are sourced from LINZ XML
