**Irongate Industrial Plan Change
Preliminary Geotechnical Assessment**

Prepared for Hastings District Council

JUNE 2009

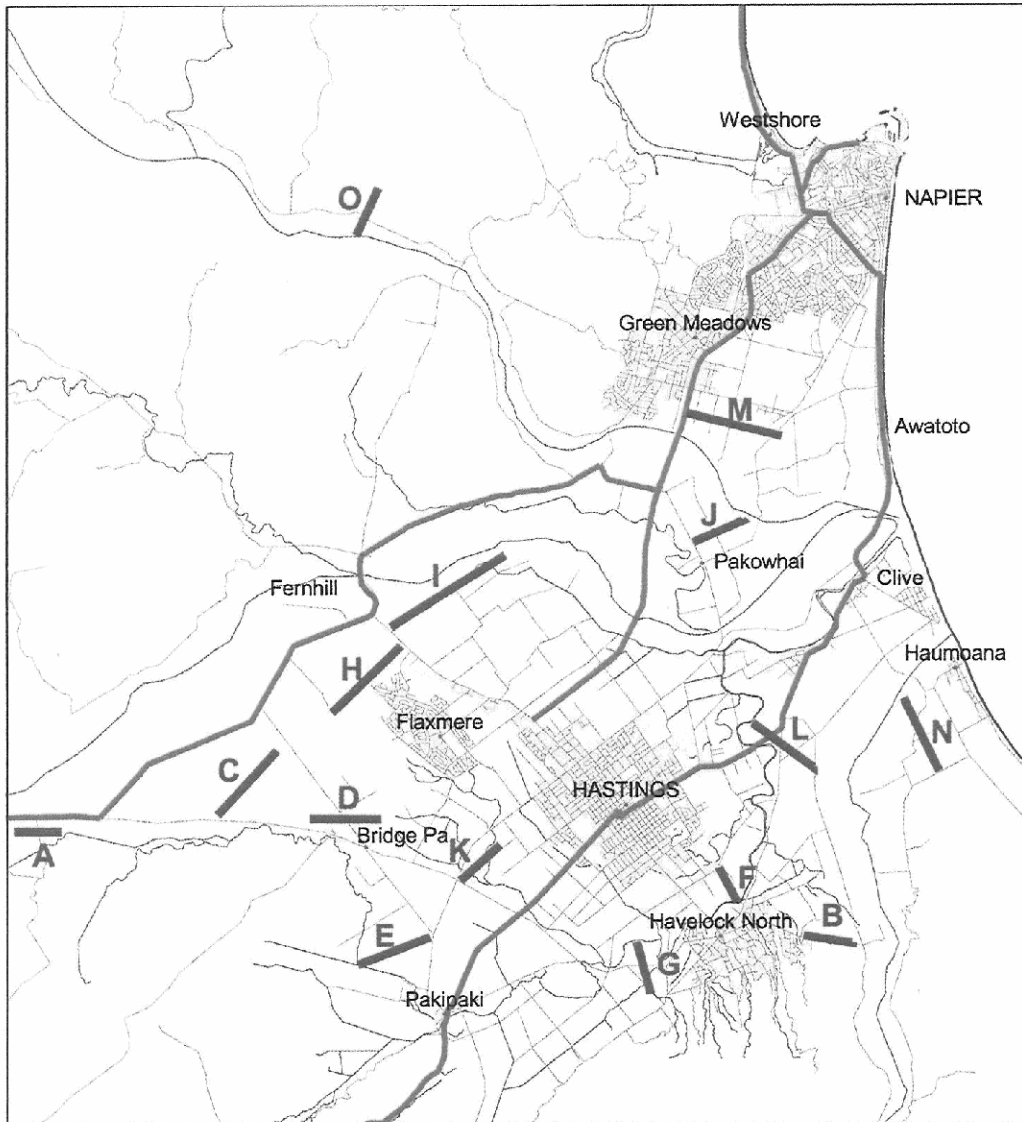
Figure 5: Locality of Soil Landscape Profiles

Griffiths provides typical sections through parts of the Plain, as shown in Figure 5 on the following page.

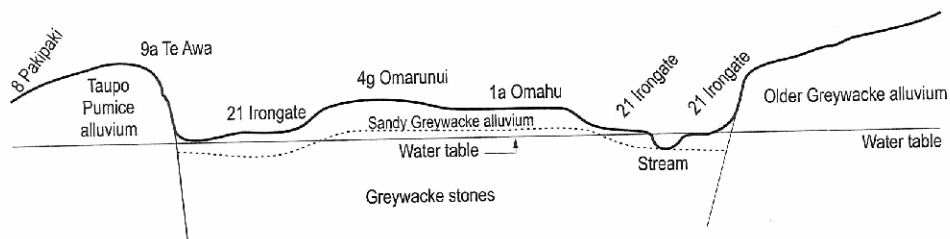
Section K, below, shows the typical soil profile in the vicinity of the proposed new industrial area.

Irongate soils (21) typically occur on low terraces adjacent to flood channels which have cut into the older plain. Omahu soils (1 and 1a) occur within the flood channel of the Ngaruroro River after the 1867 flood event and Oamaru (4s and 4g) soils form the flood plain remnant which escaped erosion by floods.
