## ARCHAEOLOGICAL SCREENING: FRIMLEY PARK

### ARCHAEOLOGICAL RISK SCREENING

Archaeology Hawke's Bay Ltd was approached by Alex Mabin (HDC – Parks & Reserves) to provide archaeological advice regarding the ongoing management of Frimley Park, Hastings, Hawke's Bay. Whilst there were no recorded archaeological sites within the Park it does lie within a wider environment of potential cultural and archaeological importance.

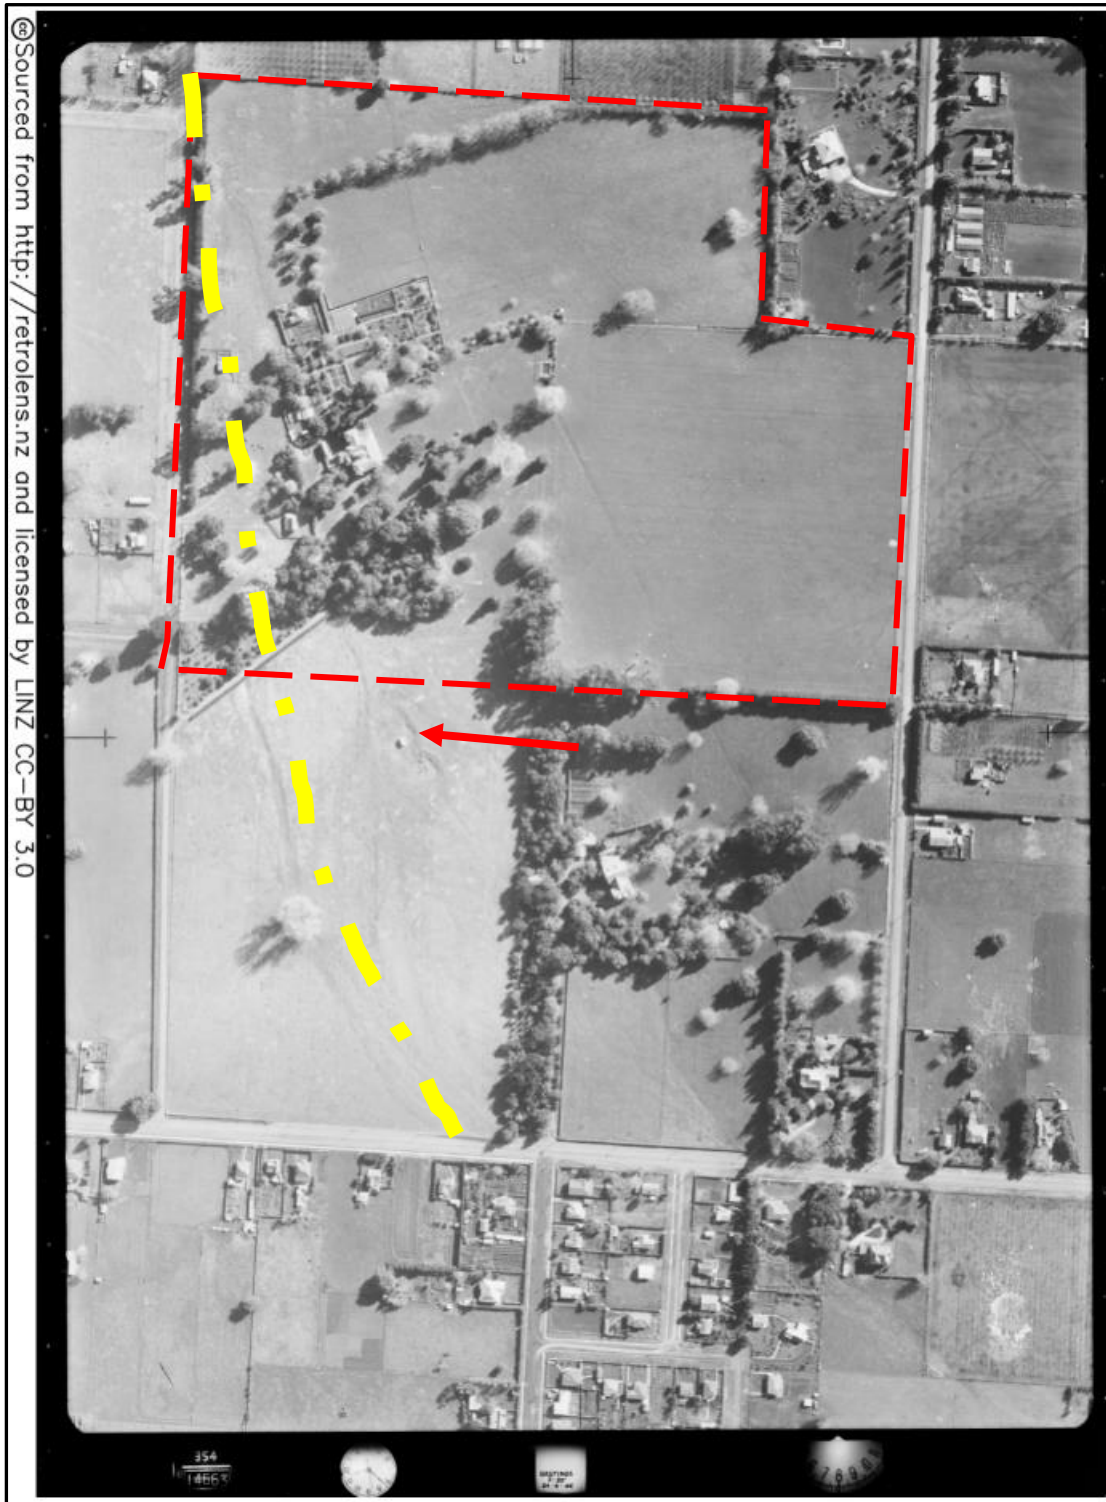
The earliest Retrolens publically available aerial images for the area date to 1945 and are of exceptional quality. The image selected clearly identifies a natural feature of paleochannel meandering along the westerly extent of what is now Frimley Park and the adjacent schools. There are several large depressions associated with this but it is unclear if these are natural features associated with the watercourse, or are made features associated with activity occurring in the vicinity of the water course. The wider landscape at this time is largely rural and is dominated by grazing with pockets of horticulture.

A Retrolens 1945 aerial showing the full extent of Frimley Park (red dash) with an apparent paleochannel (indicative dashed yellow route) and associated large depressions (red arrow) (Source: Retrolens).

There are currently no recorded archaeological sites within Frimley Park, nor have there been any indicators of unrecorded archaeological sites identified or reported to date. Potentially the area with the greatest inherent archaeological risk is near the possible paleochannel on the western edge where evidence of fishing, gardening and other activities may still survive subsurface. However, at present there is no direct evidence that such activities were occurring, or that any evidence of them survives. Evidence for other resource gathering or processing activities such as postholes, pits and hearths could theoretically lie preserved beneath the alluvial silts across the wider area of the park. Again there is no evidence to date suggesting that this is the case, or if so that they are within 500mm of the current ground surface (as would be encountered during planting and other minor earthworks noted around the park).

Therefore it is recommended that from an archaeological perspective Frimley Park be managed under an Accidental Discovery Protocol (ADP) approach in the first instance. This

would be sufficient for all minor earthworks across the main park area such as plantings and other earthworks < 300 mm in depth. Any future proposal that potentially affected the western side of the Park, or more extensive excavations for building foundations, access roads or service installations should be subject to a project specific screening to determine whether an ADP remains an appropriate management approach on a case by case basis.

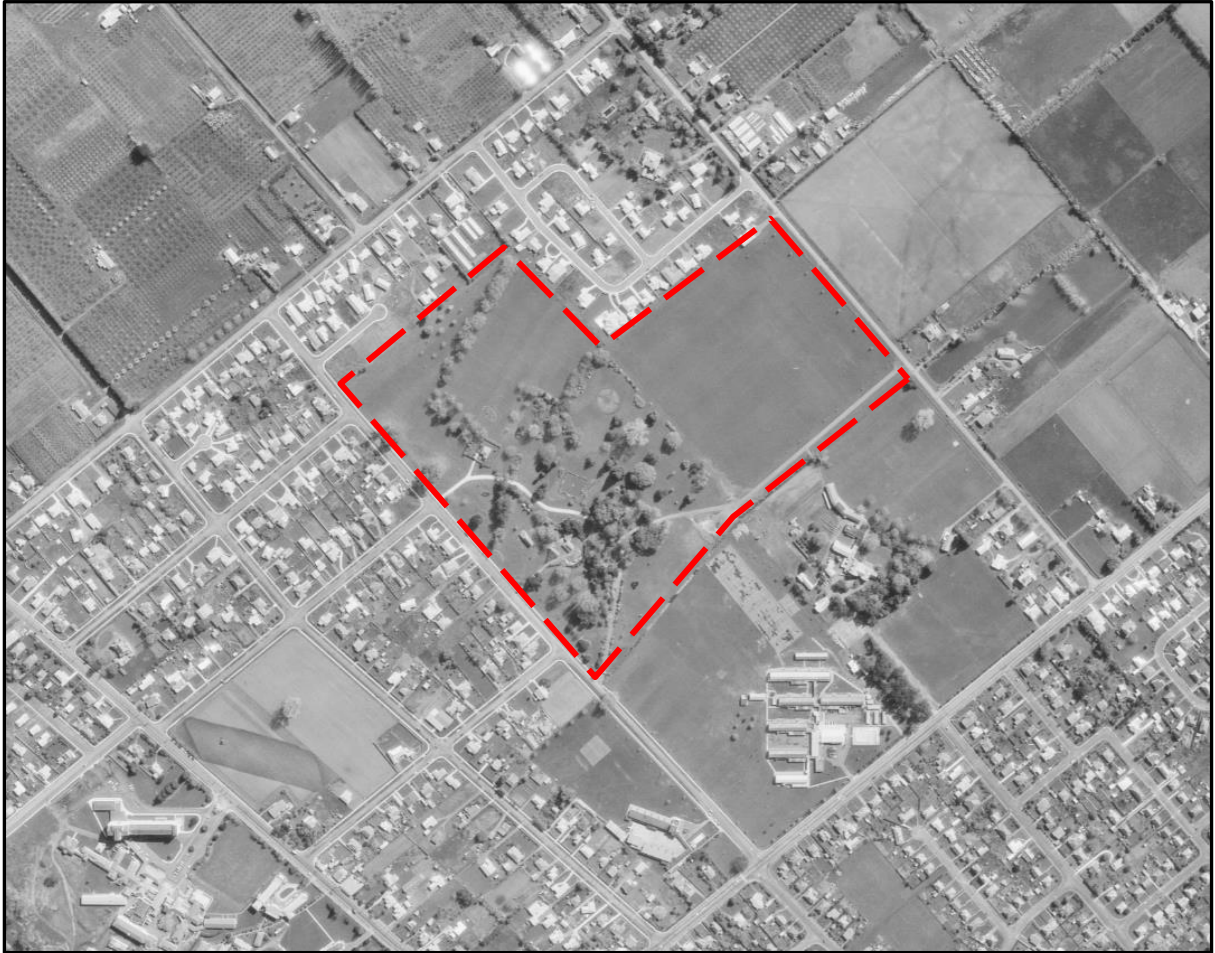
By 1964 the wider landscape is becoming much more residential in use, the schools are becoming established and modifications to the ground surface appears to have destroyed or obscured the evidence of the possible paleochannel and associated features across both the school and park areas. Also by this time the previous buildings evident in the 1945 imagery have been removed and the park is beginning to take on a form and layout similar to that seen currently. A 1969 image shows the park laid out largely as it currently is, and that the pool complex has been constructed.

An excerpt from a Retrolens 1964 aerial showing Frimley Park (indicative red dash) within its increasingly residential environs – note evidence of paleochannel has now disappeared (Source Retrolens, image oriented to match previous).

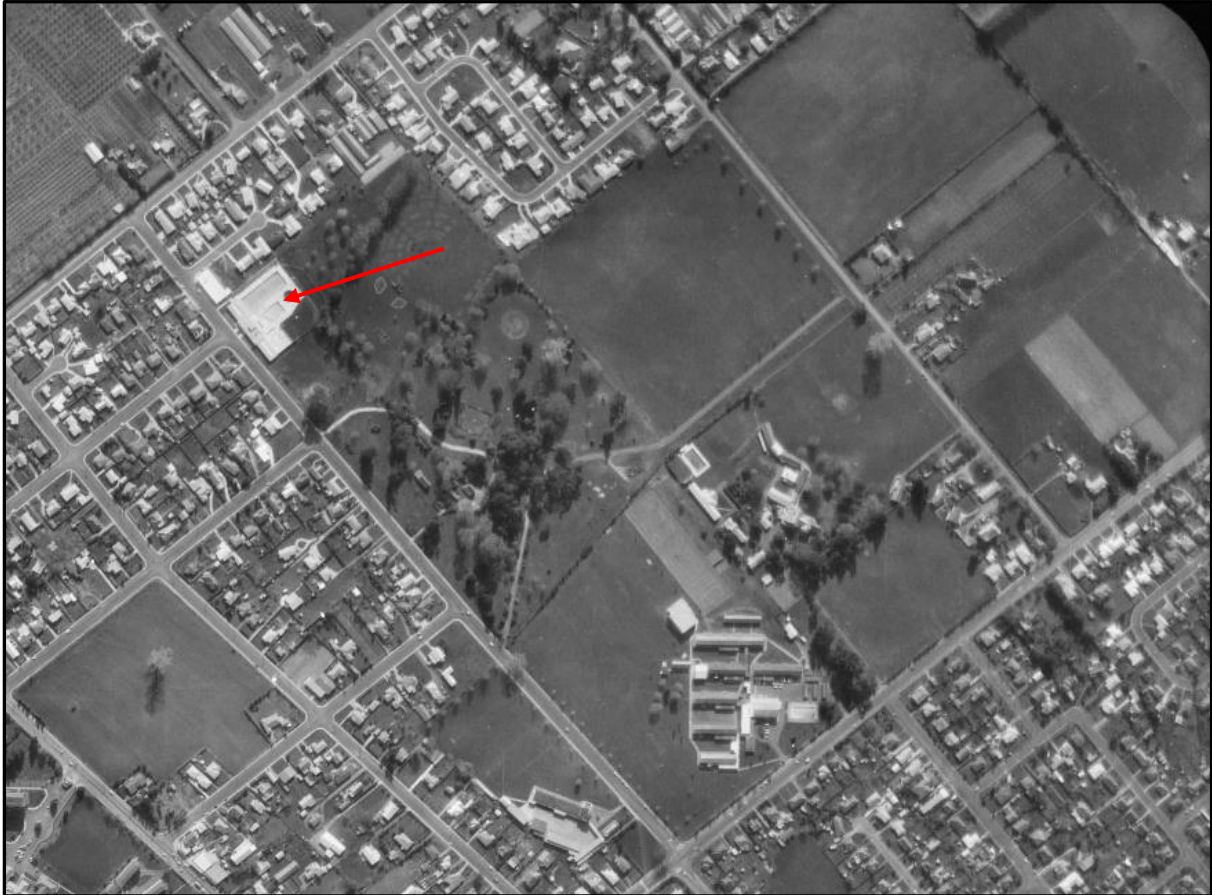
An excerpt from a Retrolens 1969 aerial showing that the pool complex had been built (arrowed).

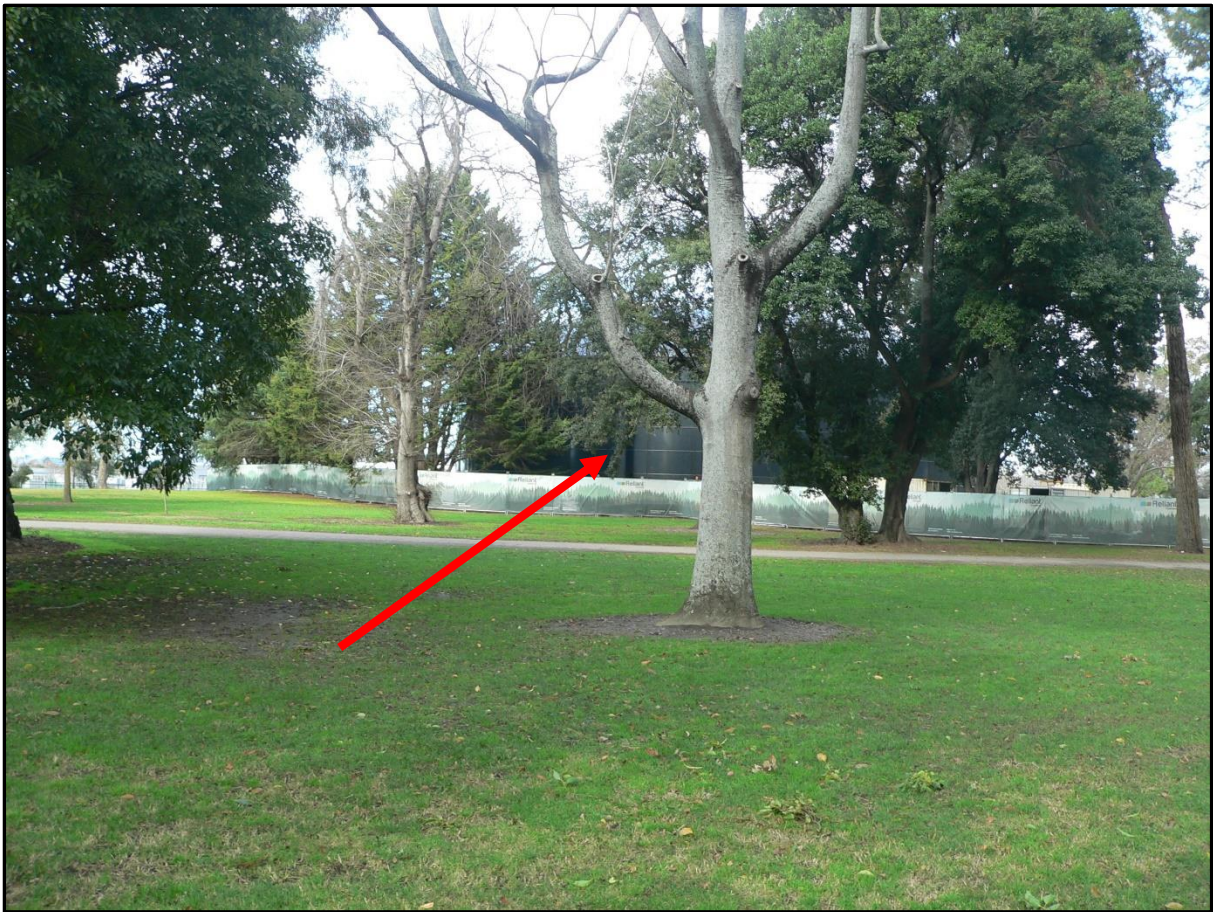
It was apparent that the main park area is a heavily modified environment in terms of ground surface and ornamental plantings. There were indications that extensive earthwork has recently occurred in the form of the installation of water reservoirs, this can be seen in Google

Ongoing water reservoir associated construction area
