Hawke's Bay Farmers Co-operative Garage, Queen Street, Hastings

Inventory Number 12; Property ID: 25706; TRIM Reference 25706#002#0005

Report by Michael Kelly and Chris Cochran, with NZHPT, 10 October 2005; Final Report August 2012, Updated 2015 by the HDC Environmental Policy Team

Hastings CBD Heritage Inventory Project

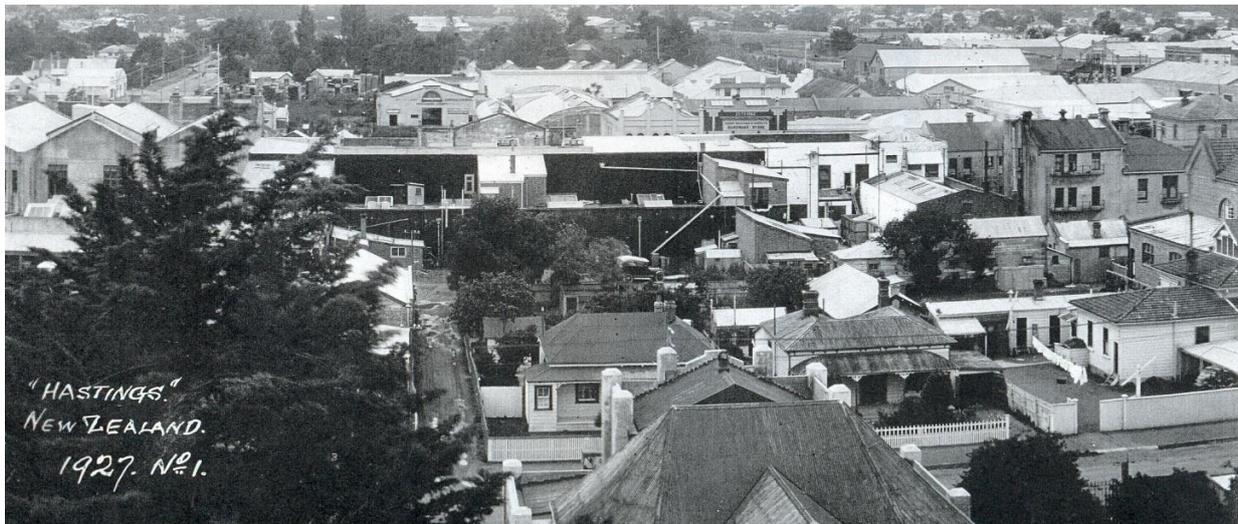
This panorama of Hastings shows the rear of the Hawke's Bay Farmers' Co-op Garage. The Garage is shown in the upper portion of the photograph near the centreline. The barrel-vaulted roof, and the false shop front can be made out. This photograph confirms that the building was constructed by 1927. (Robert Percy Moore, 'Hastings', New Zealand, 1927, vol.1, PA^216, Alexander Turnbull Lib.)

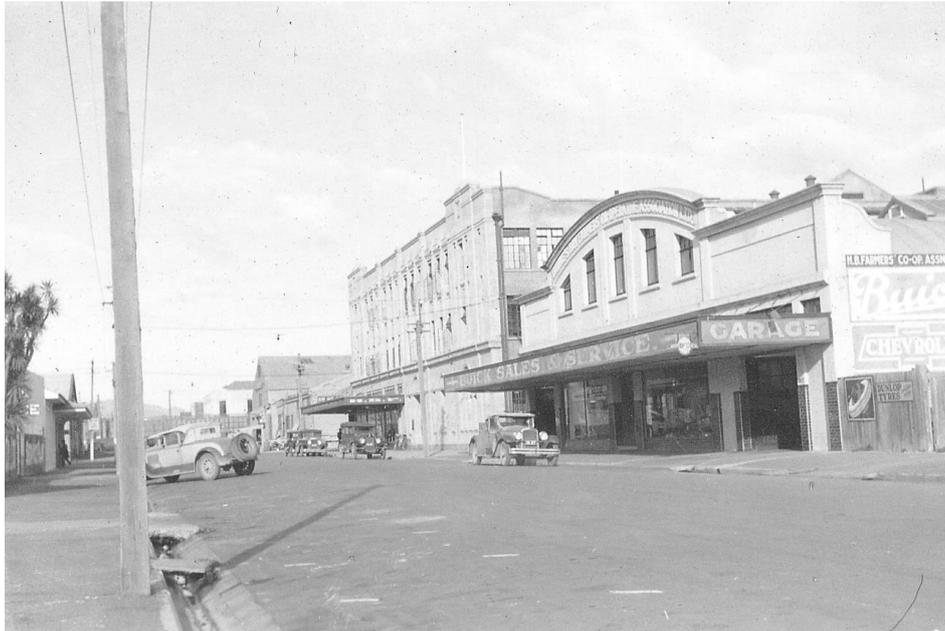
This picture shows the Garage in operation in the 1930s. Note the sign 'Buick Sales and Service'. (The Dave Williams Collection of Photographs, W204, Hawke's Bay Museum)

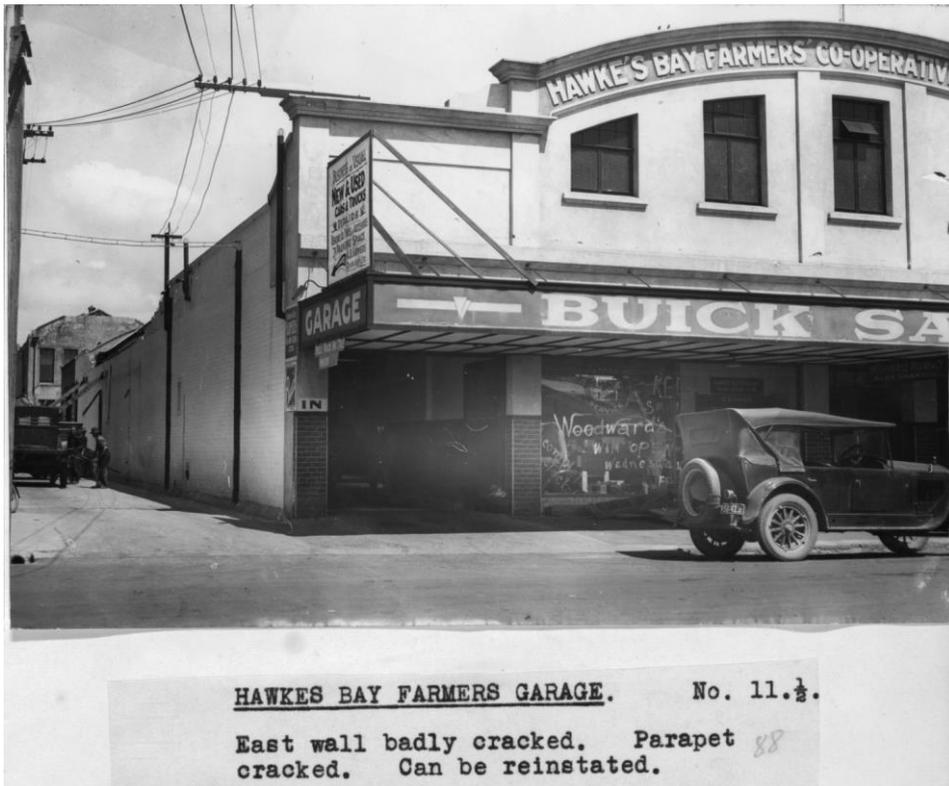
This photograph shows the Hawke's Bay Farmers' Garage after the earthquake. ('Insurance Council of New Zealand album relating to the Hawke's Bay earthquake, PA1-f-145, Alexander Turnbull Library, Wellington)

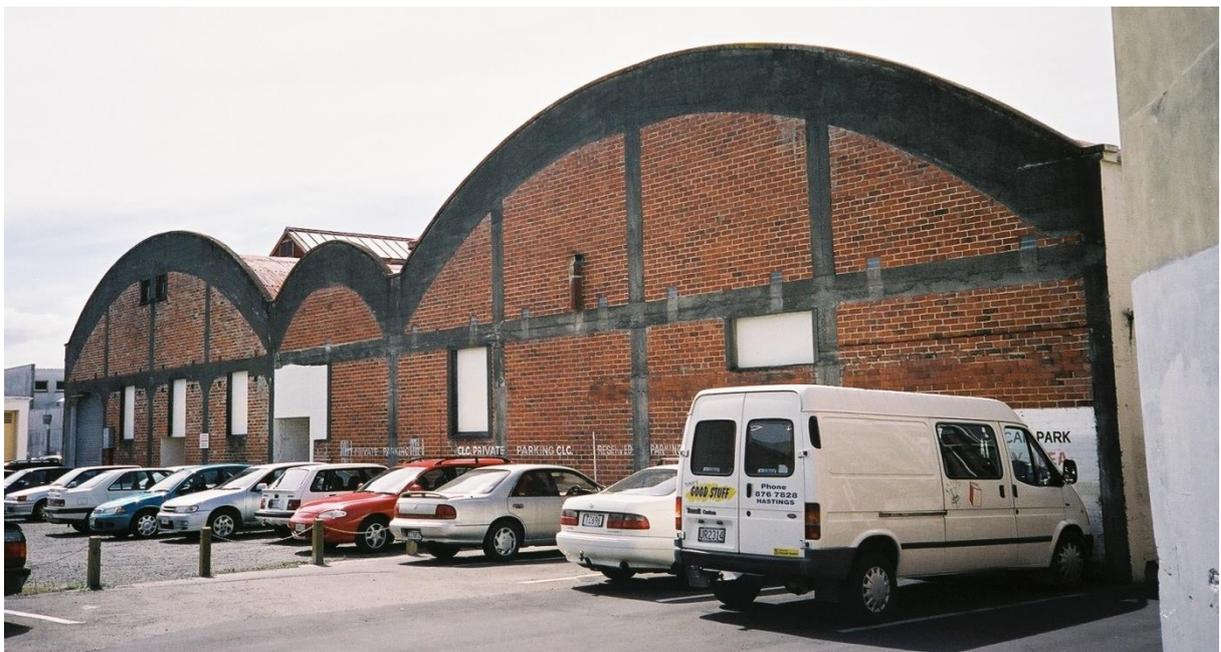
Rear elevation showing the barrel-vaulted form of the building; the far bay is the one added in 1934. (Chris Cochran, October 2004)

Description: The Hawke's Bay Farmers' Co-operative Association building, on the south side of Queen Street West, has an unusual vaulted form, most clearly evident on the rear elevation. Here, the reinforced concrete frame of the building is exposed, with columns, a horizontal beam at eaves level, and arches above. There are two wide arches (the west one is a later addition of 1934, confirmed by the details and materials being slightly different) with a small arch between. The infill material is unpainted brickwork.
