Commercial Bank of Australia Building, 100 Queen Street East, Hastings

Report by Chris Cochran and Michael Kelly, November 2005; Final Report: November 2012, updated 2015, Environmental Policy Team.

Hastings CBD Heritage Inventory Project

COMMERCIAL BANK OF AUSTRALIA BUILDING

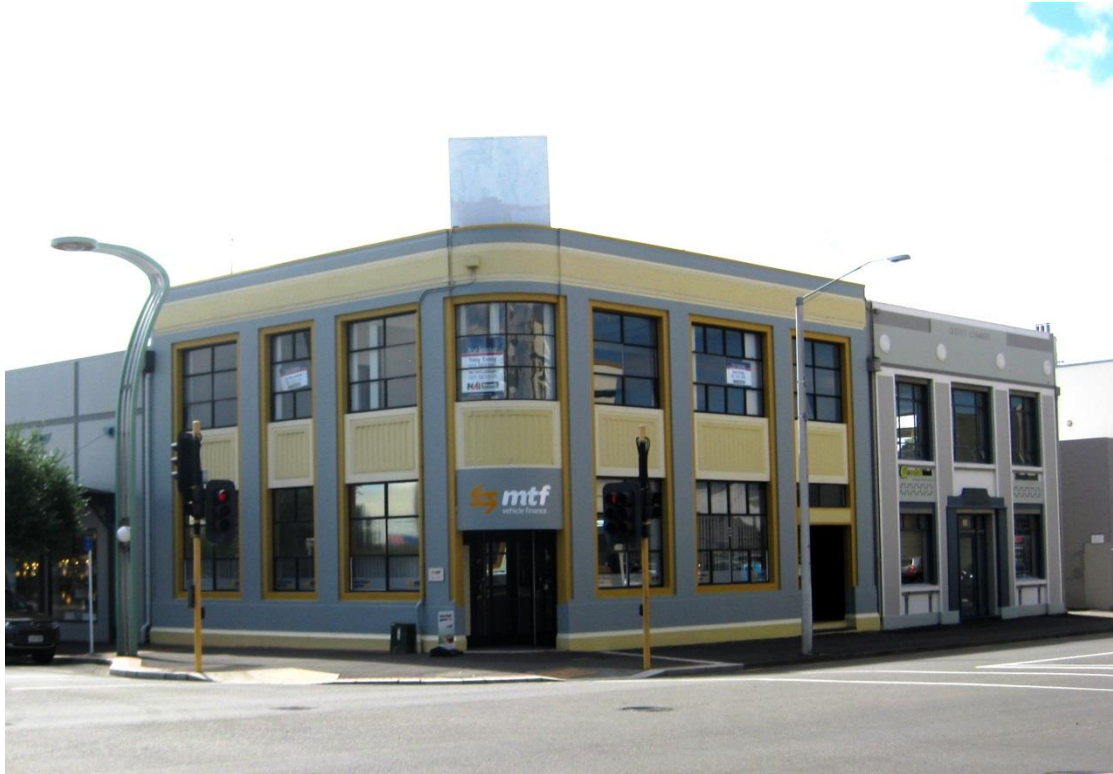
Photo: P. Huddleston, 2015

Description: The former CBA Bank is a two-storey, reinforced concrete building, standing prominently on the north side corner of Russell Street and Queen Street East. All major structural elements of the building – foundations, exterior and some interior walls, and the ground and first floors – are in-situ concrete, while some interior partitions and the roof framing are in timber. The building is stripped Classical in style, devoid of decoration but for fluted panels between the ground and first floor windows; these are recessed from the grid of columns, which rise through both storeys. The columns stand on a solid plinth, and support a plain parapet. These elements define the simple but bold geometric form of the building.

There are three bays to each elevation, of varying widths and with large windows, with a central bay on the corner; this has the main entrance at ground level and a window with curved frame and glass above. There is another entrance at the end of the Queen Street East façade, with terrazzo finishes to the porch; inside this entrance there is a terrazzo staircase with the original wrought iron balustrade giving access to the first floor. The original ground floor plan shows three entrances (one on Russell Street, the main one on the corner, and the third on Queen Street East, making full use of the corner site); a public space, offices and a strong room, while the first floor had a surgery, waiting room and offices.
