Bank of New South Wales Building, 129 Heretaunga Street West

Inventory Number: 45; Property ID: 21303; TRIM Reference: 21303#002#0011

Hastings CBD Heritage Inventory Project

BANK OF NEW SOUTH WALES BUILDING

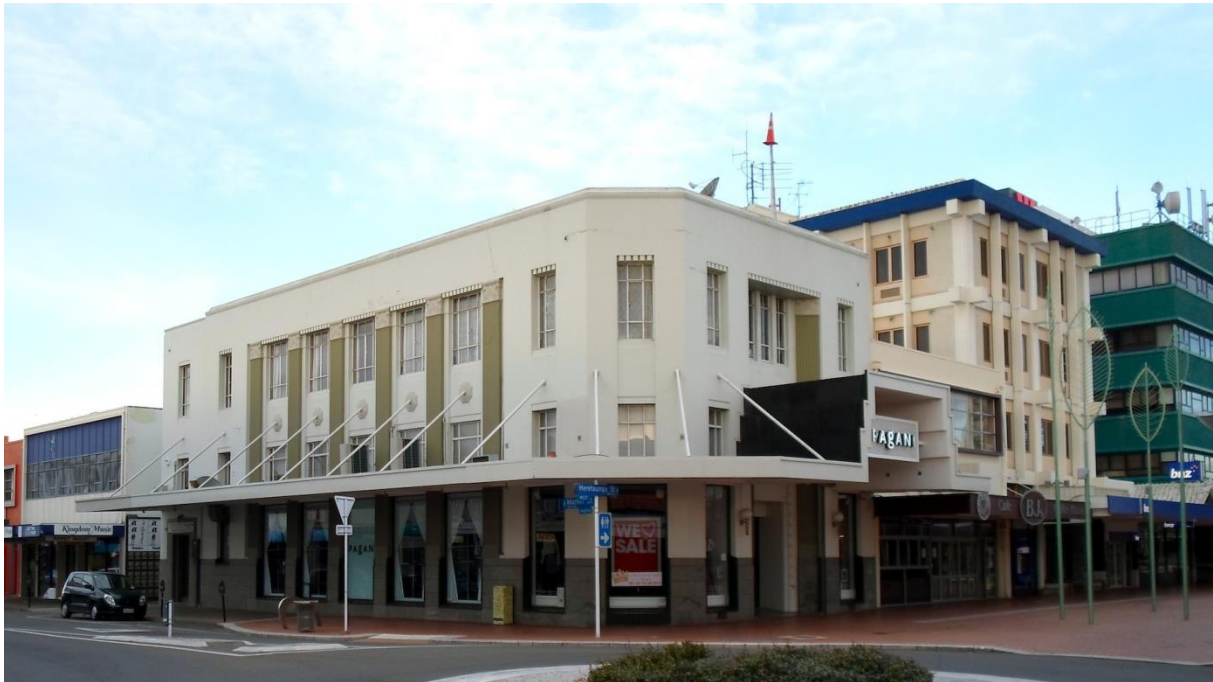
Photo: R. Murray, 2012

Description: The Bank of New South Wales building is a large and imposing commercial building, of a scale and finished quality commensurate with the aspirations of the bank, a very successful business. It occupies a prominent corner site in the core of the Hastings CBD area.

The building is a tall three-storey structure, with a double-height banking chamber. It is a well mannered and accomplished piece of architecture. The design is best characterised as a severe version of Stripped Classical, with very little ornament but traditional vertical proportions and a well-considered and balanced composition. The building is clearly articulated; its chamfered form neatly addresses the street corner and marries the two main elevations, which are quite unequal in length. The main elevations are fairly austere with simple planar surfaces. The building rises off a granite-faced plinth at the base straight to the flat parapet, which is distinguished only by a small cornice.

Overall, the building retains a high level of authenticity, particularly above the verandah. The façade below the verandah retains original features, such as the paneled timber service door and granite-faced plinth, although the latter has been heavily cut into for the modern shop windows. The main visible changes include the ground level doors, the large aluminium-framed shop windows and the raised verandah (if not all the verandah).

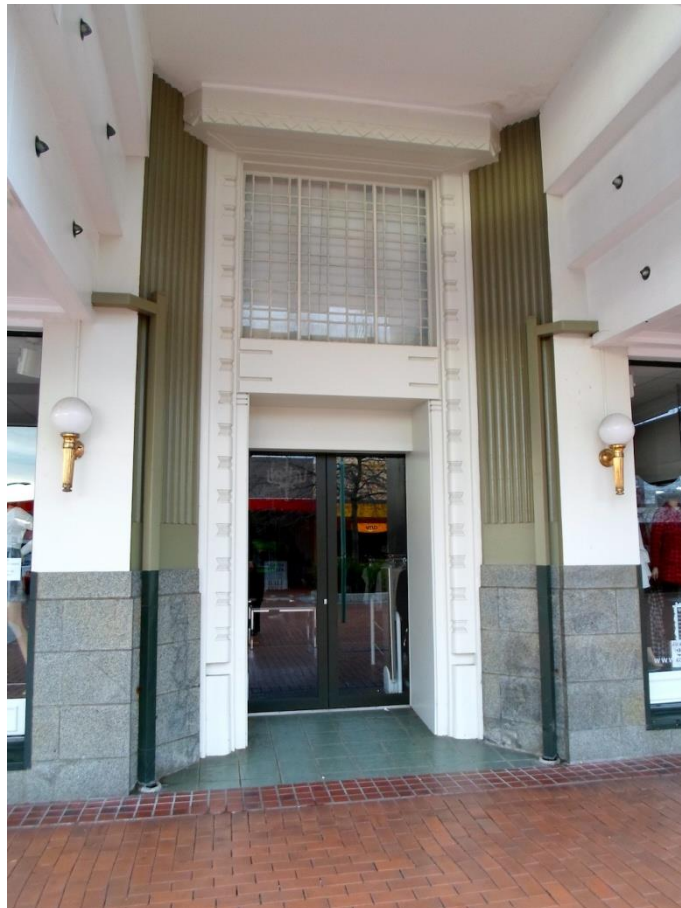
The principal façade is to Heretaunga Street and contains the main entrance to the building and the former banking chamber, a large double-height space. It is symmetrically arranged about the centre with the primary emphasis on the main door location. The entry is recessed into the plan of the building, framed by a pair of fluted pilasters that are angled in plan and rise up to the second floor window head, with decorative capitals and dentil mouldings above the windows matching the Market Street elevation.

Main entrance, 2012

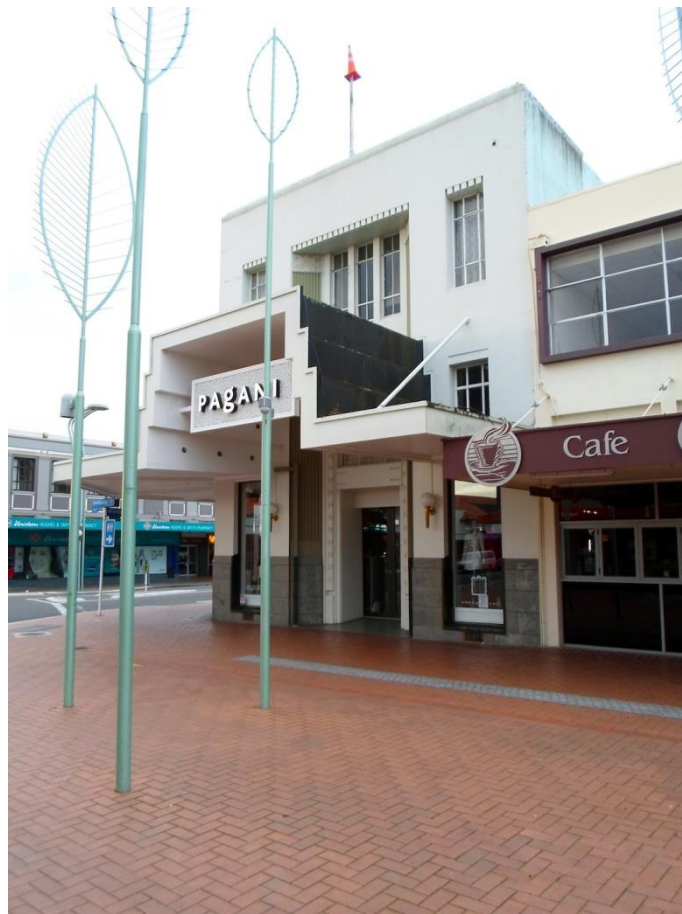
It is not known when the present verandah was added to the building – while it is possibly original, it does not appear on the original design drawings, which show a verandah-less building, all the more imposing for the lack of visual interruption to its tall vertical lines. The verandah has an elegant panelled soffit trimmed with a small step mould, and is stayed off the spandrel line of the second floor via large octagonal bosses at the spandrels and small bosses elsewhere. It steps up dramatically at the Heretaunga Street entrance¹⁵, but in doing so obscures the original neat lines of the building and somewhat reduces its visual impact.

Heretaunga Street elevation, 2012

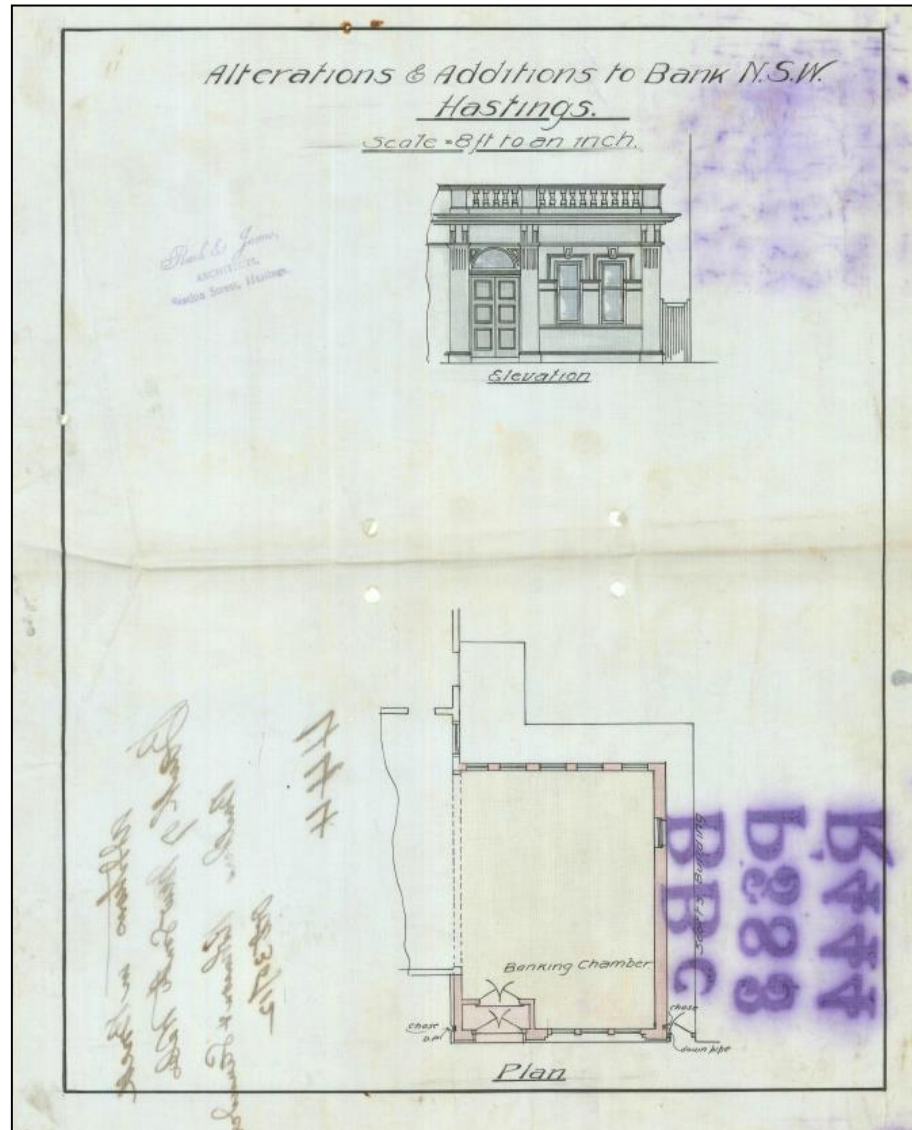
Alterations & additions to Bank N.S.W, Hastings, Rush & James Architects (1912) (TRIM Ref: 21303#0018)
