Irongate Industrial Plan Change Stream Ecological Valuation Assessment

Prepared for Hastings District Council

NOVEMBER 2008

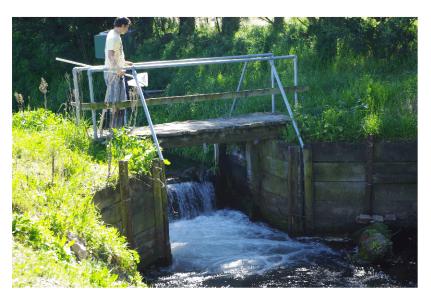
Figure 2-3: Clarke's Weir.

With the development of the suburb of Flaxmere in the 1960s, the Irongate Stream channel between Portsmouth Road and State Highway 2 was enlarged and straightened. Further channel upgrading was carried out in 2002. Clarke's Weir (refer Figure 2-3 below) was installed in a position immediately upstream of the Upper Southland Drain outlet (HBRC, 2004).

Some variation was noted between the channel form in areas upstream and down-stream of Clarke's Weir. Presumably this difference is the result of areas of the Irongate Stream being subjected to different degrees of anthropogenic channel modification, and the consequential effects of modification.

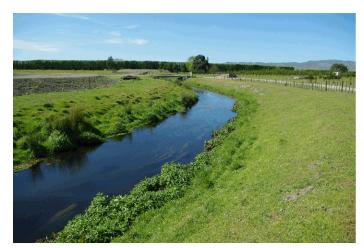
Figure 2-5: One of the more vegetated riparian areas

Typically within 20 metres (laterally) of each side of the wetted stream channel, riparian vegetation is dominated by exotic grasses (refer Figure 2-4). Also present are occasional exotic trees and shrubs (refer Figure 2-5 below).
