CONTAMINATED LAND ASSESSMENT
WITH NATIONAL ENVIRONMENTAL
STANDARD FOR ASSESSING AND
MANAGING CONTAMINANTS IN SOIL
TO PROTECT HUMAN HEALTH

PROPOSED WHAKATU ARTERIAL LINK HASTINGS, HAWKE'S BAY

PROJECT NO. EAM361-REP-V4

MAY 2014

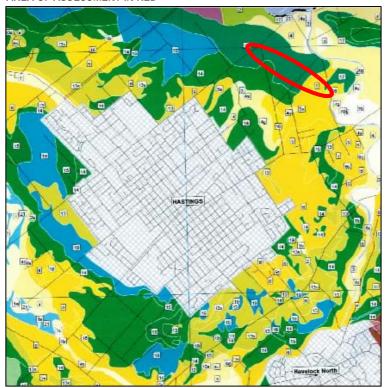
The topography of the site and surrounds is low gradient flat land. A review of the soil map of the Heretaunga Plains (Griffiths, 2001) shows that the soils are of imperfect drainage with a depth to the water table (after wet periods) of between 30 to 60 centimetres (Figure 2).

FIGURE 2: EXCERPT OF THE SOIL MAP OF THE HERETAUNGA PLAINS (GRIFFITHS, 2001) SHOWING GENERAL AREA OF ASSESSMENT IN RED

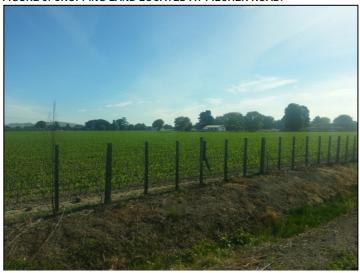
FIGURE 3: CROPPING LAND LOCATED AT PILCHER ROAD.

Land use immediately surrounding the site is predominantly industry, orchards and cropping with associated residential dwellings (Figures 3 to 5).

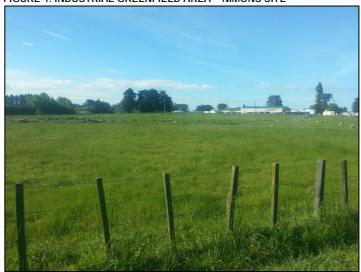
FIGURE 4: INDUSTRIAL GREENFIELD AREA - NIMONS SITE

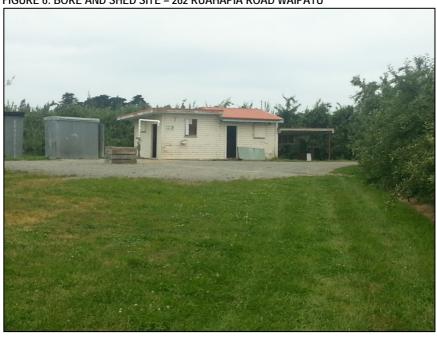
During the site sampling exercise it was noted that at two sites (Figures 6 and 7) the WAL route will result in the disturbance / relocation of sheds with bore/well heads. Both these sheds appear to be areas used for the storage and preparation of agricultural/horticultural sprays and as such should be considered as likely hotspots with regards to soil contamination. These would require more detailed sampling to determine the extent of contamination (if any) should the WAL construction works encompass these sites.

FIGURE 7: CHEMICAL STORAGE AND PUMP/BORE AREA - 280 STATE HIGHWAY 2 NORTH

It is recommended that sampling of these shed areas be carried out prior to the start of construction of the WAL. Initial sampling would likely involve collecting individual soil samples from around the sheds as well as under the concrete pads.

It is envisaged that suitable holes could be punched through the concrete pads to allow soil sampling as this methodology would minimise soil disturbance and be considered a permitted activity under the NES.

The results of this sampling would determine whether or not a more detailed assessment and/or soil remediation is required. Should elevated contaminant concentrations be found in the soils around the sheds, a Remediation Action Plan (RAP) and appropriate resource consent will be required.

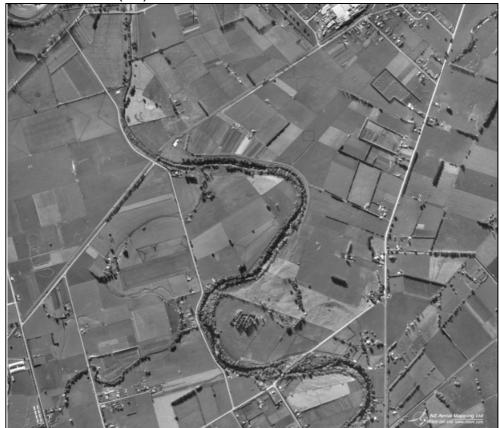
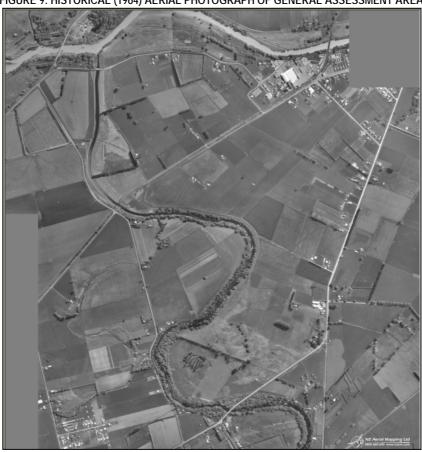
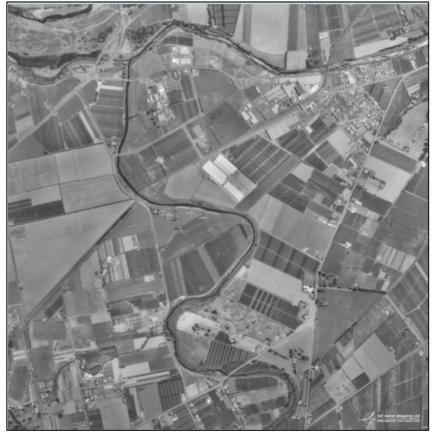
The most significant information came from historical photos (Figures 8, 9 and 10) sourced from NZAM. These images illustrate that orchards were relatively late to establish in this area (post 1964). Prior to this, the area was utilised for predominantly pastoral grazing.

FIGURE 8: HISTORICAL (1950) AERIAL PHOTOGRAPH OF GENERAL ASSESSMENT AREA

FIGURE 9: HISTORICAL (1964) AERIAL PHOTOGRAPH OF GENERAL ASSESSMENT AREA

FIGURE 10: HISTORICAL (1988) AERIAL PHOTOGRAPH OF GENERAL ASSESSMENT AREA
