**ARBORICULTURAL ASSESSMENT**

**FRIMLEY PARK**

**PAPER STREET TREE COMPANY**

**REPORT DATED:** 26.08.21

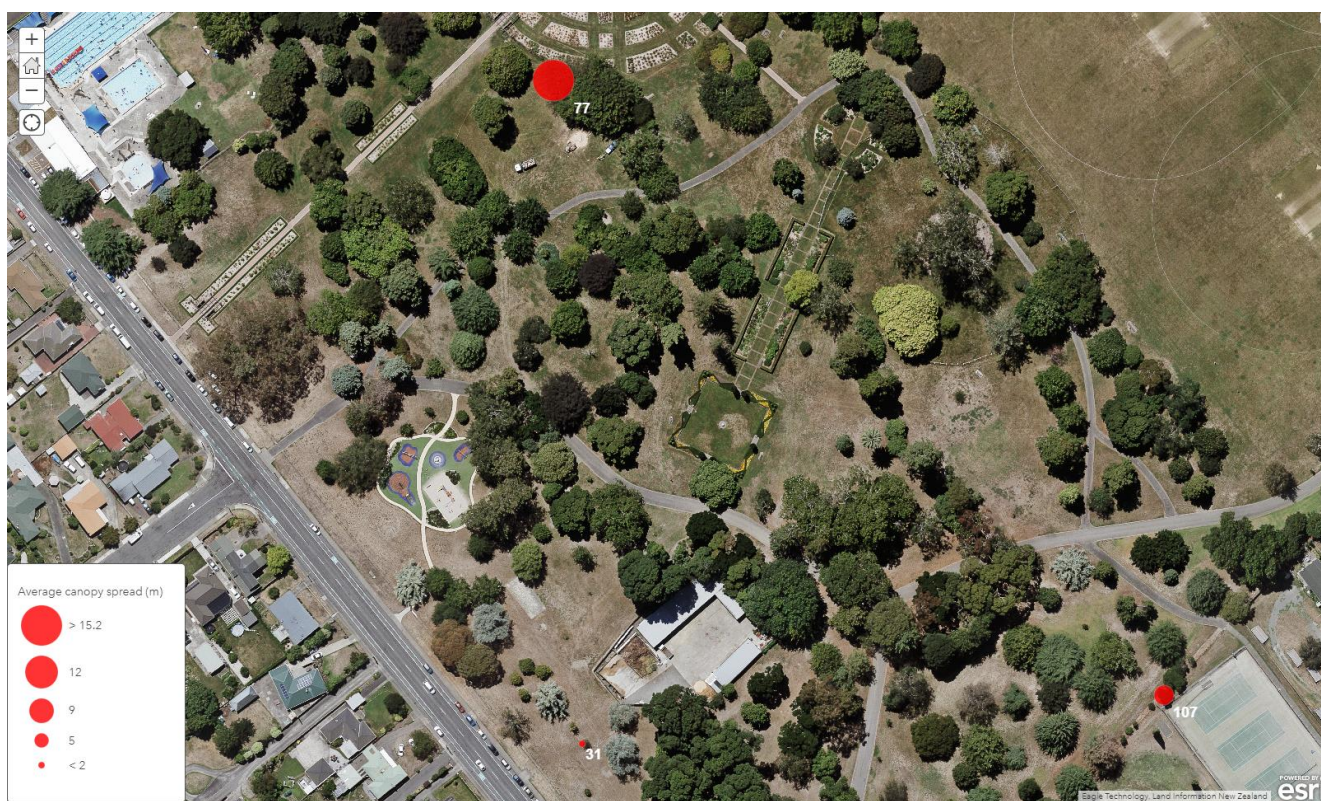
Fig.2 Aerial image of trees proposed for removal with average canopy spreads to indicate tree size

Tree loss has the most significant impact in the short term, and three trees are proposed for removal highlighted in the map below

Three trees (Trees 80,81 and 96) are likely to be in a state of irreversible decline due to biotic agents (cypress canker (trees 80 and 81) and phytophthora (Tree 96)). It's likely that these trees will require removal within the next 10yrs years due to their conditions. See below for tree locations.

Strategically replant and replace trees to ensure successive canopy coverage. Recommend that the beech tree is left as a high 2m stump for habitat creation. Opportunities should be sought where possible to create habitat creation and allow natural processes to take place whilst providing a learning opportunity for members of the public:

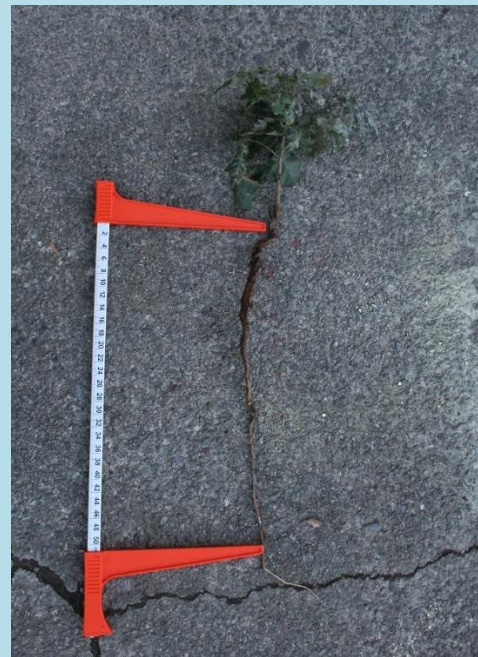
Fig.13 This is an example of how nature has evolved to do it. This is a self-seeded oak (*Quercus robur*). Typically a tree will send a tap root vertically down until it reaches an unfavourable medium, then it sends out horizontal roots primarily near the upper soil horizon as roots need oxygen to function. This creates a far more robust root system.

3.6.2 Fig 13 is a good illustration of the likely creation of additional costs from lack of contractor care. HDC provided clearance for the works, but canopy damage is apparent. This is the visible part of the damage; the root system responsible for nutrient uptake and stability is also likely to have been damaged during the works, which could lead to irreversible effects.
