FLOOD DETENTION DAMS - 2019 INTERMEDIATE DAM SAFETY REVIEW

PREPARED FOR HASTINGS DISTRICT COUNCIL

March 2020

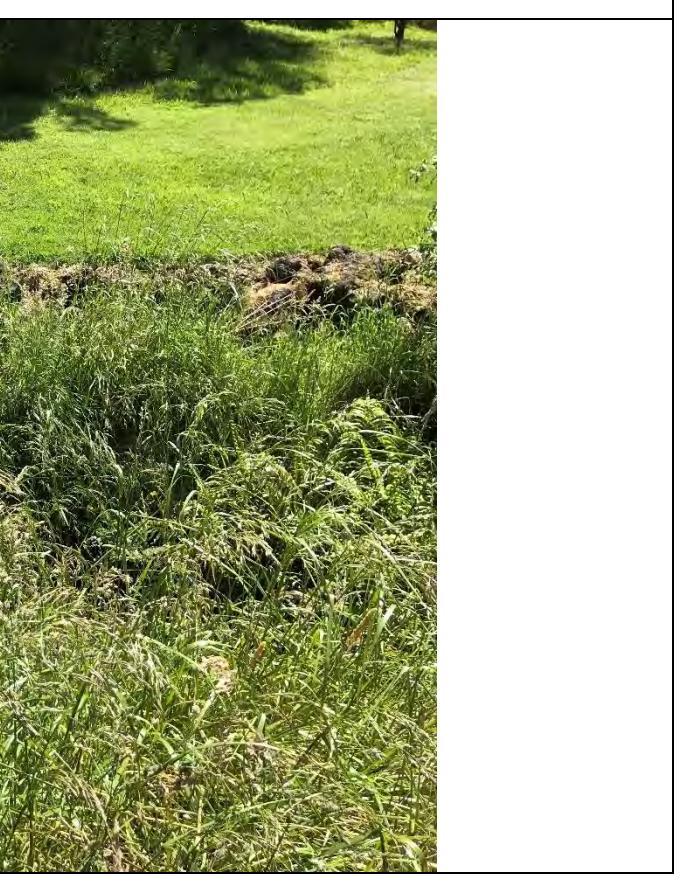
Outlet Culvert and Downstream Channel	The outlet culvert structure was in good condition and was clear at the outlet and within most of the stilling basin. The downstream channel, and part of the downstream section of the stilling basin had heavy vegetation. The channel should be significantly cleared.	Clear the stilling basin and downstream channel of all vegetation.

Ref	Description	Photo (s)
7.	Clear the stilling basin and downstream channel of all vegetation.

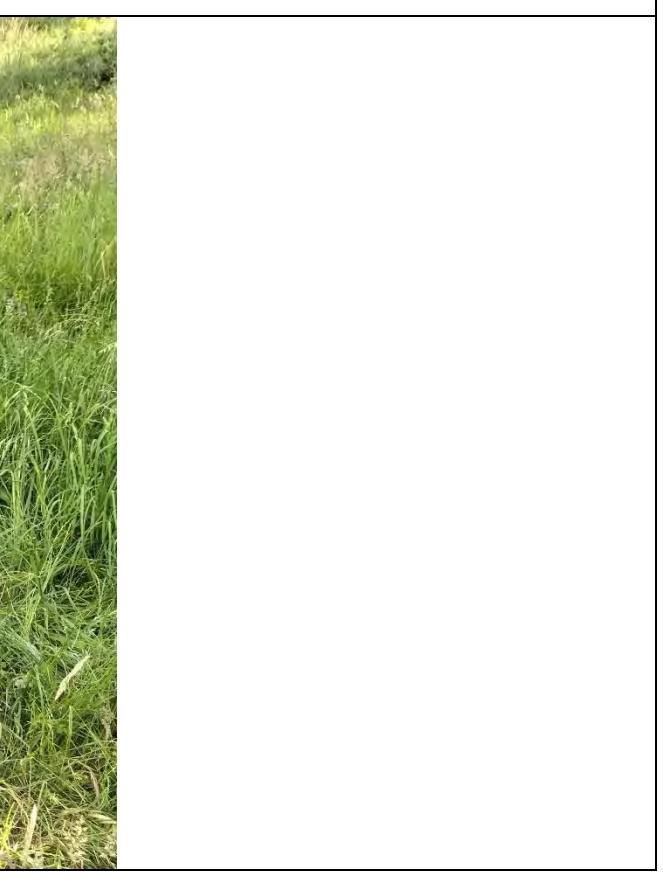
Outlet Structure and Downstream Channel	The downstream channel was generally clear and stable but contained long grass. The outlet structure was generally in satisfactory condition. A tree in the stilling basin should be removed. The stilling basin invert should be cleaned out and inspected for any issues. The iron flap gate (stock prevention) should be cleared as it was blocked up with debris. This gate should be removed and stock prevented from accessing this area by other means (fencing around outlet structure and downstream channel).	Remove the tree in and clear the invert of the stilling basin outlet structure. Remove iron flap gate from the culvert outlet.

Ref	Description	Photo (s)
9.	Remove the tree in and clear the invert of the stilling basin outlet structure.	
10.	Remove iron flap gate from the culvert outlet.	
11.	Clean out RHS toe drain pipe (exits into the outlet structure). Confirm whether blockage noted (0.7 m from wall) is related to pipe collapse (surface depression) previously noted.	
12.	Confirm whether embankment toe drain outlet pipes are free of sediment and functional.
