**FLOOD DETENTION DAMS - 2023
INTERMEDIATE DAM SAFETY REVIEW**

27 September 2023

Prepared for:
Hastings District Council

Prepared by:
Stantec

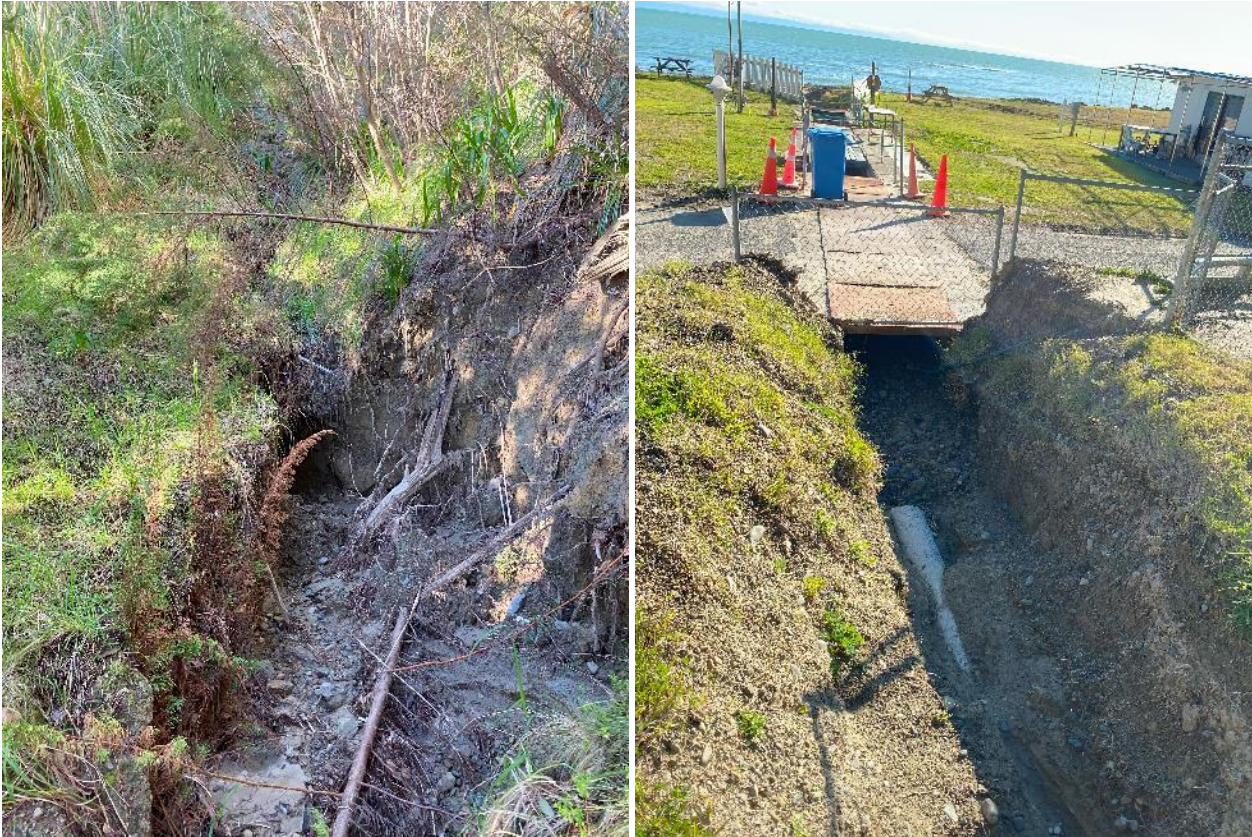
Figure 9-1. Channel through the motor camp (upstream and downstream).

| Dam or Appurtenant Structure | Key Site Inspection Observations | Dam safety issue | Photograph |
|---|--|---|--|
| <p>Clifton Motor Camp Stormwater Gully</p> | <p>Flood flows from the catchment and detention dams flow down the stormwater gully through the Clifton Motor Camp. There is no control over these flows, but the channel is defined through the motor camp to reduce flooding of campsites.</p> <p>The stormwater gully has been scoured out since last year due to heavy rainfall events. The scour has deepened the channel and exposed an unknown concrete pipe section upstream of the road (see top image). The concrete box channel still has some sediment but less than 2022 and is in about the same condition. There is now a picket fence protecting the public from falling into the channel downstream of the concrete box channel which has also been scoured deeper. There is no longer an earth plug at the bottom of the channel where it meets the beach and the boulders placed on the beach as erosion protection from waves have been displaced.</p> <p>The gully was not easily inspected due to fallen trees, overgrown vegetation and wet slippery slopes. Conditions were similar to previous inspections, albeit from limited inspection at the lower section of the slope.</p> | <p>The capacity, make up and remediation of the gully or other stormwater control options should be investigated (previous DSI).</p> <p>Clear the downstream gully stormwater channel upstream of the concrete box section, and within the concrete box section (previous DSI).</p> | |

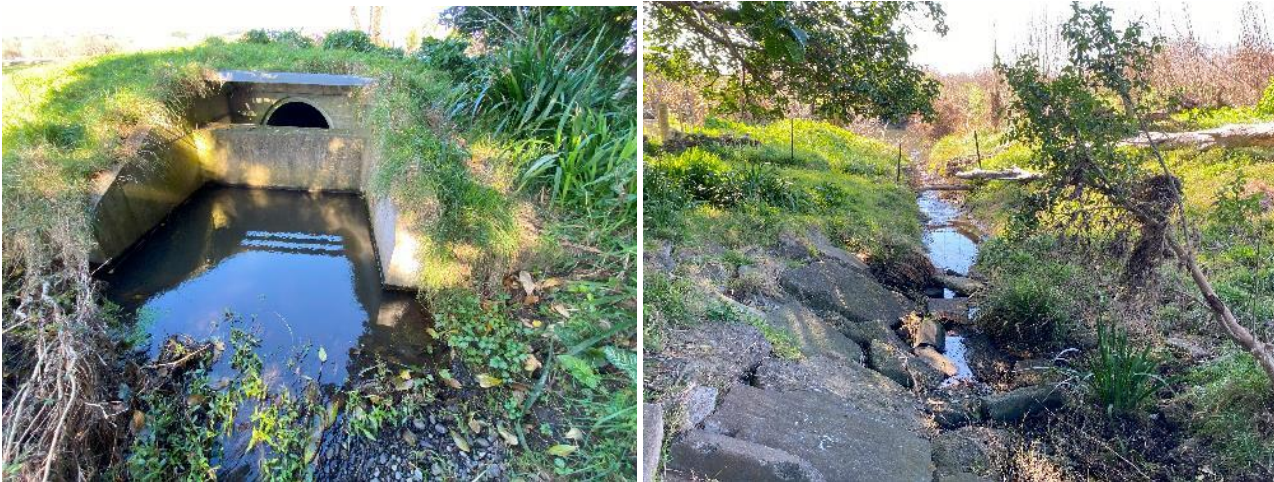
Figure 9-5. Lower: Outlet structure and channel to Maraetotara River.

| Dam or Appurtenant Structure | Key Site Inspection Observations | Dam safety issue | Photograph |
|---|---|--|---|
| <p>Pipe & Outlet</p> | <p>During Cyclone Gabrielle, a manhole lid along Clifton Road lifted due to high flows/pressure in the culvert (at a 90 degree bend). The manhole in front of 365 Clifton Road had steel plates to hold the manhole cover down but these had rusted so the manhole cover had limited effect against the ~10 m head of pressure within the pipe at this location. This manhole cover has since been replaced with a stainless steel cover. The other manhole cover in front of 367 Clifton Road still had plates holding the cover on. The pressure in the pipe was enough to lift the concrete manhole cover at the back of 367 Clifton Road property. This concrete manhole was covered in vegetation over the years and the flooding scoured the surrounding earth when the water pressure lifted the manhole, leaving depressions and holes which pose a risk to the public and livestock.</p> <p>The pipe outlet (see image), ~40 m upstream of where discharges into the Maraetotara River, appeared in satisfactory condition. The vegetation was becoming overgrown which hindered inspection and the riprap was partly disturbed.</p> | <p>Clear the vegetation from the concrete manhole at the back of 367 Clifton Road. Raise the manhole so that the manhole lid sits above the ground. Backfill the holes around the manhole.</p> <p>Clear the vegetation from the outlet to inspect rip rap and determine if repairs are needed.</p> | |

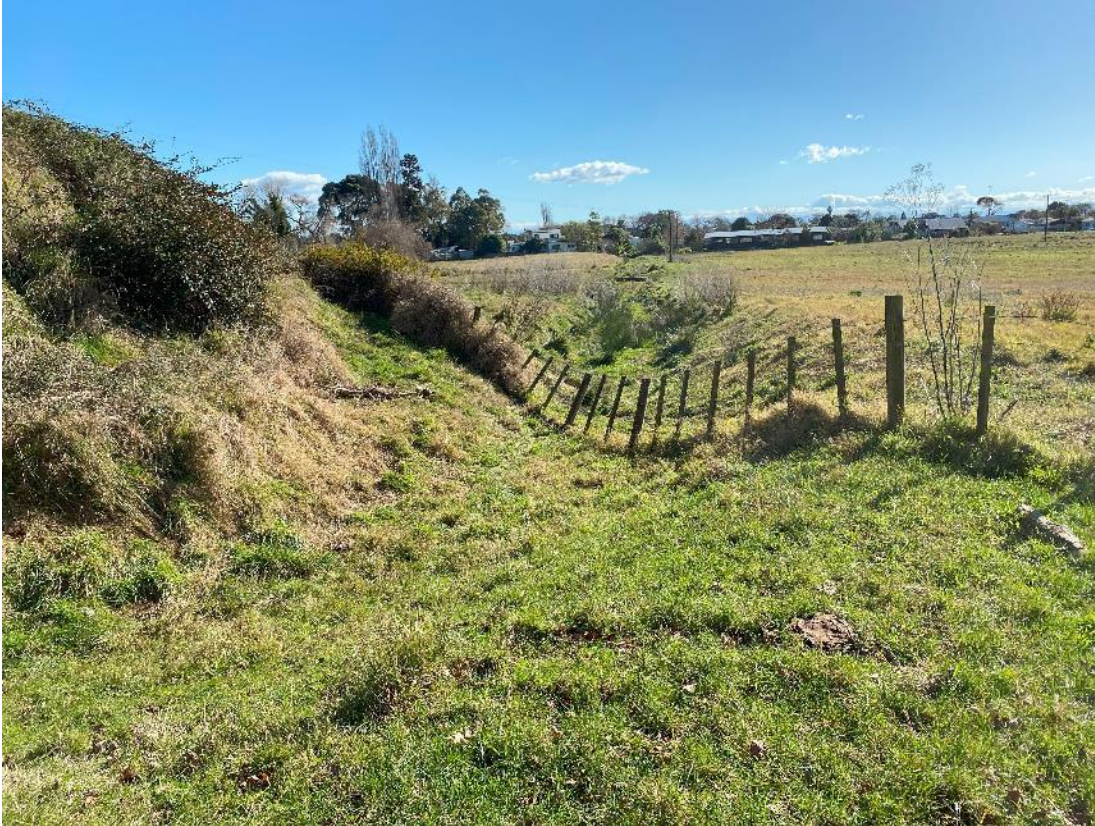
Figure 9-6. Lower: Spillway downstream channel below gabion walls.

| Dam or Appurtenant Structure | Key Site Inspection Observations | Dam safety issue | Photograph |
|---|---|--|---|
| <p>Spillway Channel</p> | <p>There are two gabion check dams at 20 m intervals downstream of the dam. These were generally stable even though there were clear bulges and holes at the base of the lower one.</p> <p>The gabion wall on the main spillway structure was in similar condition to 2022 but was covered in debris and large branches. The right side is still bulging and the left side now has a large dent.</p> <p>The upper concrete spillway structure was in satisfactory condition.</p> <p>The vertical inlet was in satisfactory condition. There was a small base flow passing through the culvert.</p> | <p>Repair the hole at the base of the lower gabion wall.</p> <p>Monitor the bulges in the gabion walls for movement / further disfigurement. Consider adding a second row of gabions for improved stability.</p> <p>Remove debris.</p> | |
