Project Number: 2-S5600.5A

# Hastings District Library

## Detailed Seismic Assessment

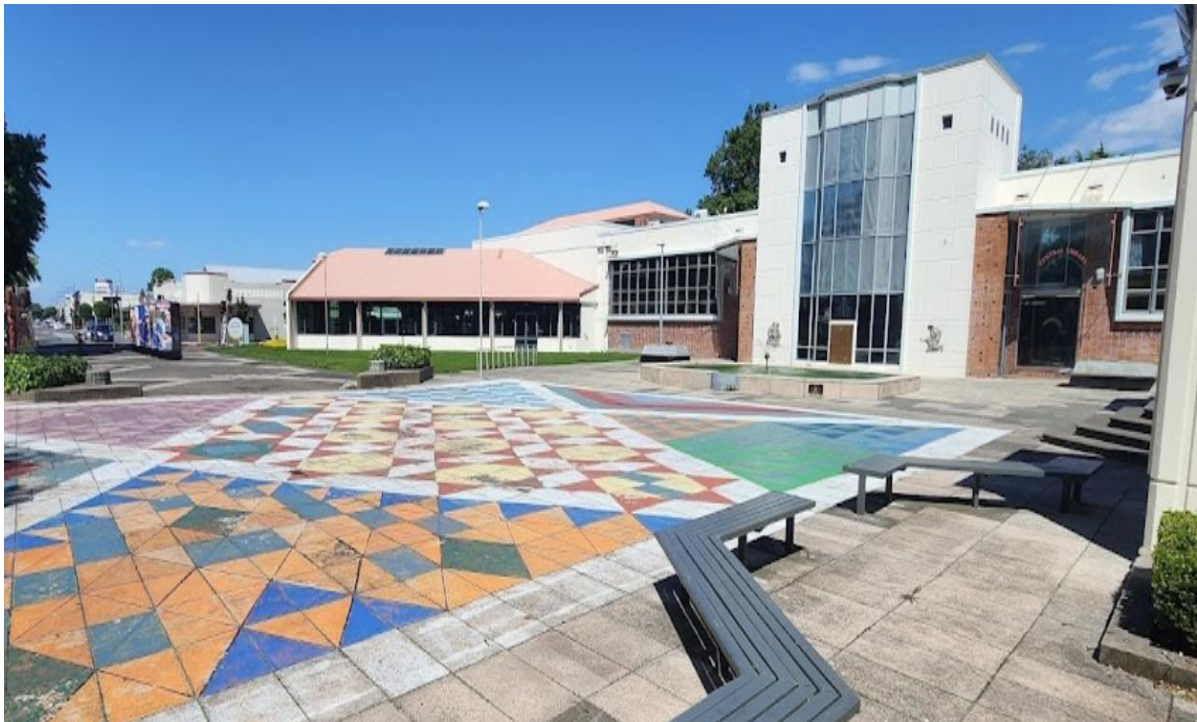
Figure 3: Elevation of Hastings Library, Looking East (Showing West Elevation)
