206 QUEEN ST
WEST and 223
HERETAUNGA
ST LANEWAY,
HASTINGS

Ann Galloway
Architect Ltd

December 2022

HERITAGE IMPACT ASSESSMENT

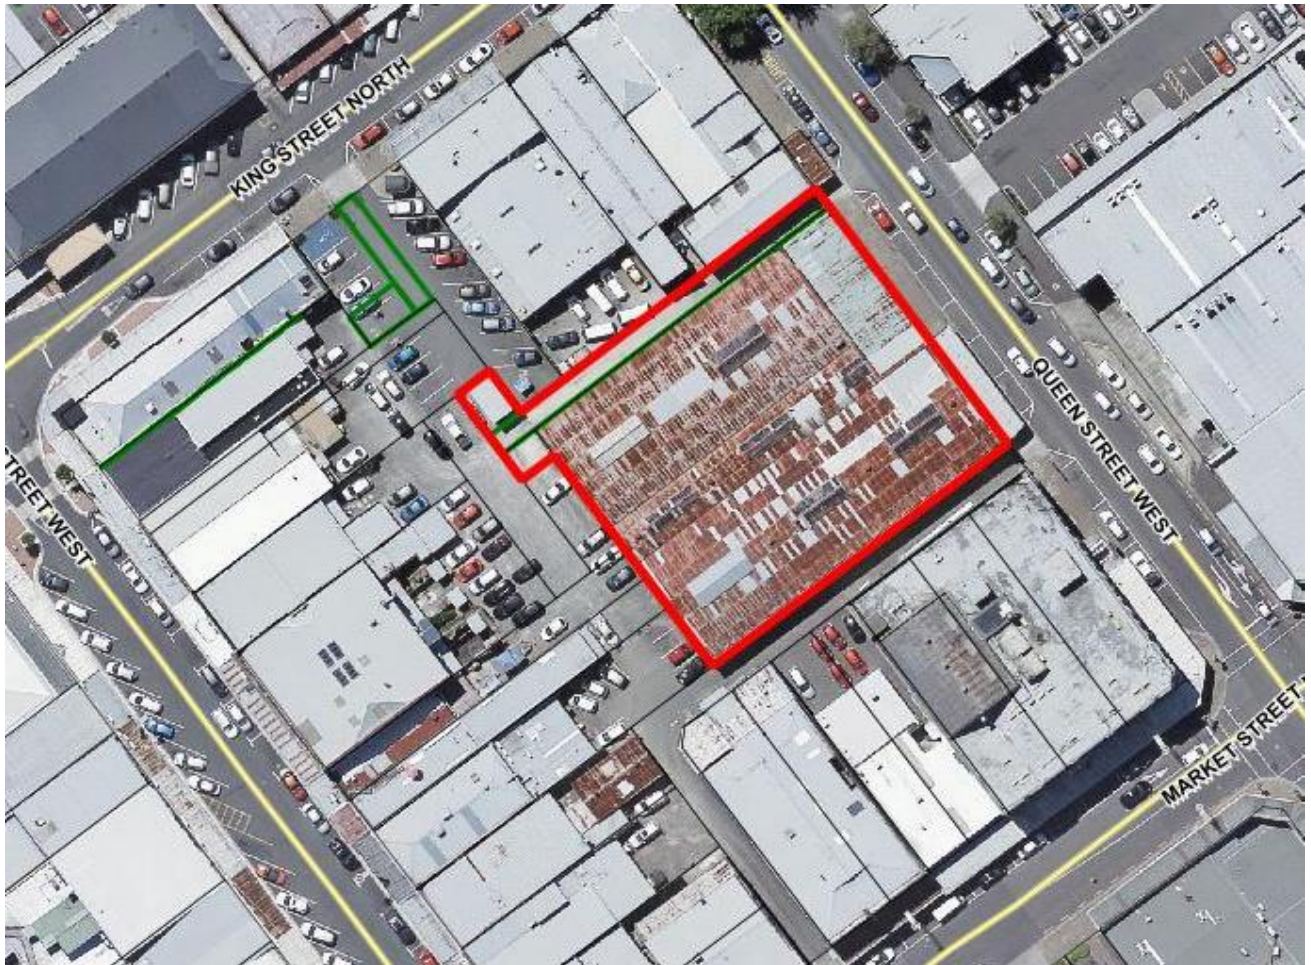
Figure 1: Site and location plan, 206 Queen St West (Source: HDC GIS maps)

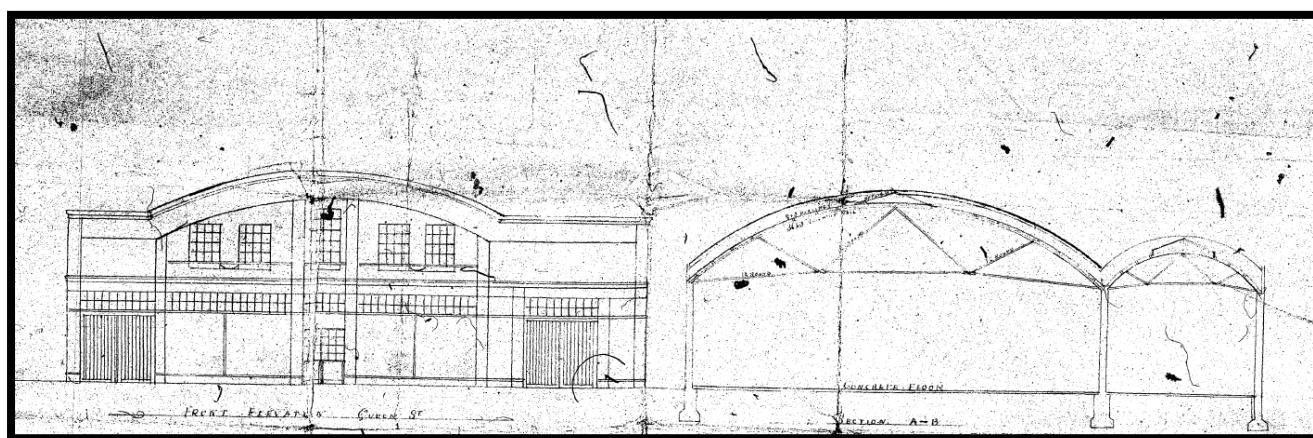
Figure 6: 1925 street elevation and section, showing asymmetrical facade. (Source: HDC property file)

The building was designed in the Edwardian Commercial style, with a reinforced concrete frame and unreinforced brick (URM) infill panels, a curved street parapet and an unusual double-barrel steel trussed roof structure. The parapet had a moulded capping, with the building name beneath (moulded in coloured cement). The façade was not symmetrical and the curve of the parapet does not align with the barrel-vaulted roof behind.

This was a very early 'drive through' premises; the double doors to the left of the elevation (Fig 6) were the vehicle entry and the doors to the right were the exit. The central doors accessed the showroom.

The curved steel roof trusses -one bay of 54 feet and one of 19'10" [16m and 6m approximately]- were fabricated from 32 lb railway iron by Vulcan Foundry, Napier. The railway iron is a lighter gauge than is used for main trunk railways. 1925 plans show the smaller trusses, with a 12'3½" [3.7m] radius, and detail the truss plates, struts and bolts. (HDC property file 25706#013 p 28). The engineering peer review report notes:

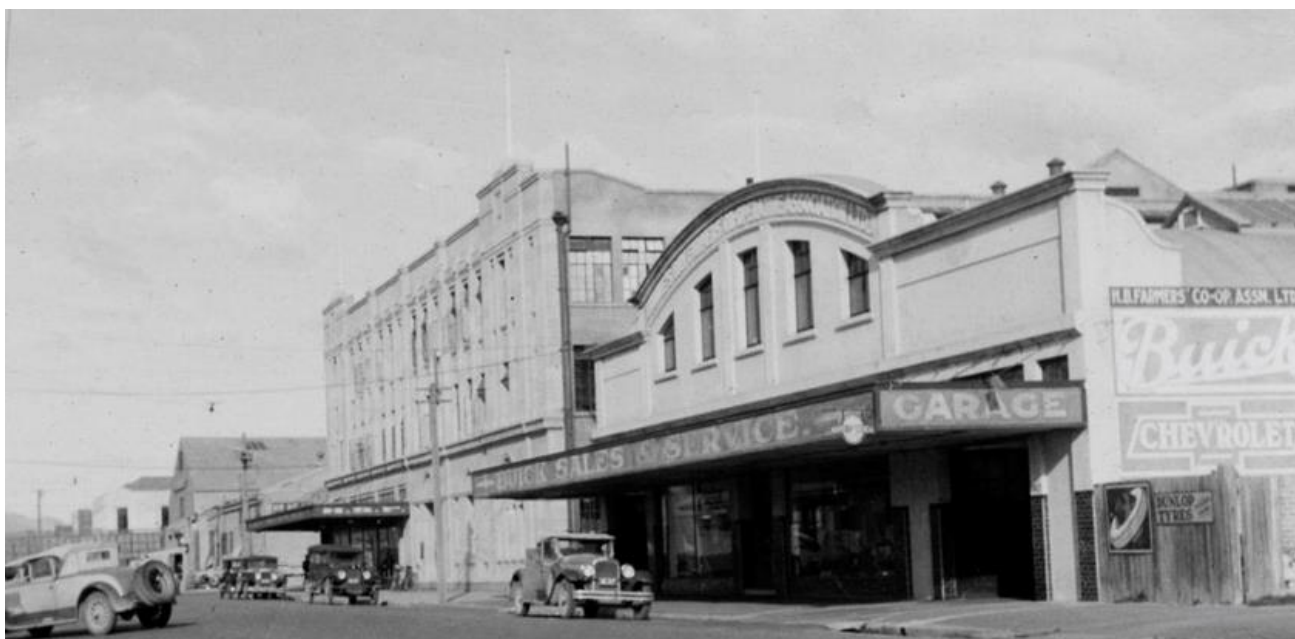
Figure 7: Street elevation ca 1930, showing asymmetrical façade and veranda. (Source: MTG 72305 -cropped)

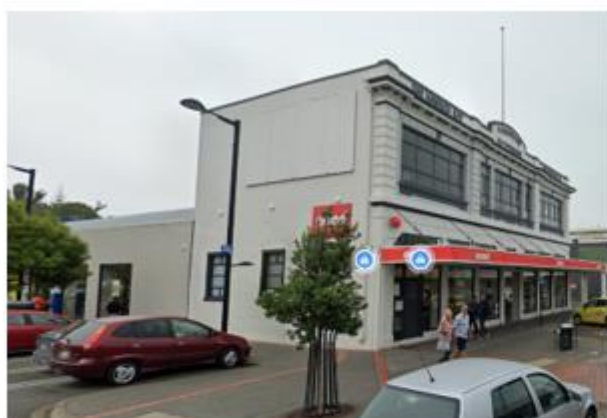
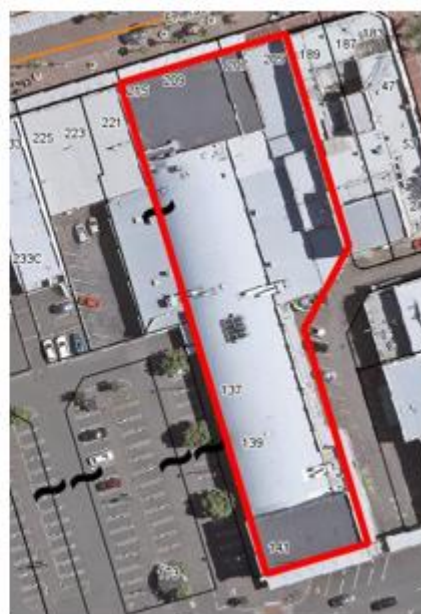
Figure 8: Former Hawkes Bay Farmers Co-op building in Dickens St, Napier. Left: street view with barrel-vaulted structure to left and two-storey Edwardian Commercial street frontage to right (source Google StreetViewMarch 2020); Right: aerial view (source NCC GIS)

For example, the former Hawkes Bay Farmers Co-op building in Napier (137-141 Dickens St) has a similar barrel-vaulted roof form behind a two-storey Edwardian Commercial frontage.

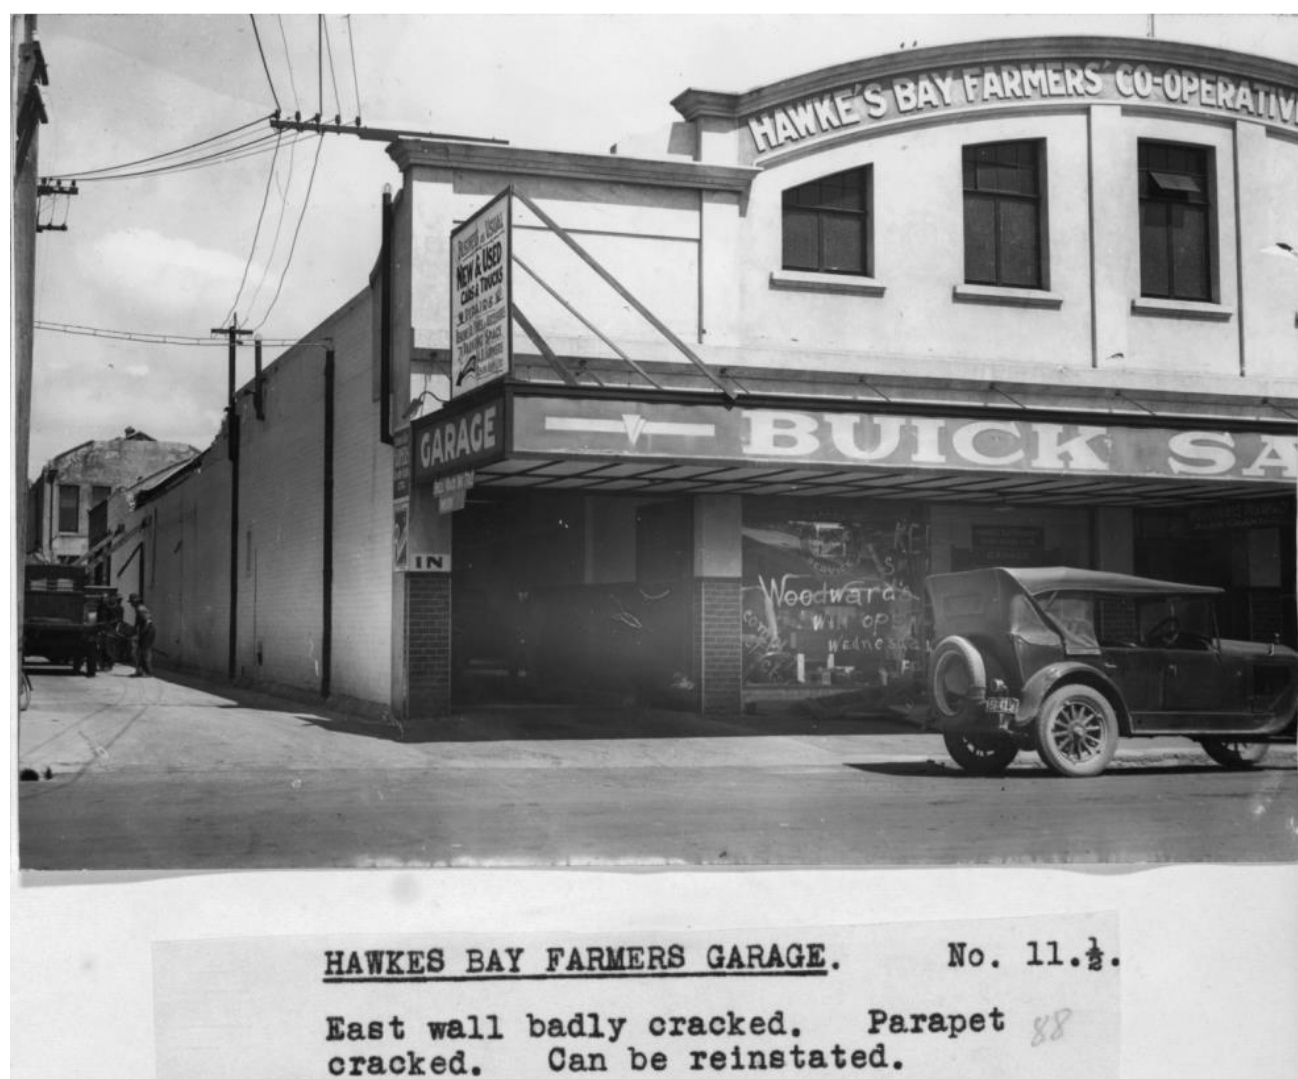
Figure 9: *Hawke's Bay Farmers' Garage after the earthquake.* [Source: Insurance Council of New Zealand :Photographs of people associated with Insurance Companies and Underwriters' Associations, and various related insurance activities. Ref: PA1-f-145-50-4. Alexander Turnbull Library, Wellington, New Zealand. /records/23037628]

During the 1931 earthquake there was some damage to the parapet and the East wall, but a week later the building was able to be used as temporary premises by other businesses, including Woodward's pharmacy, temporarily relocated from 219 Heretaunga St (Cochran, 2005), item 64 page 3] -see Fig 9.

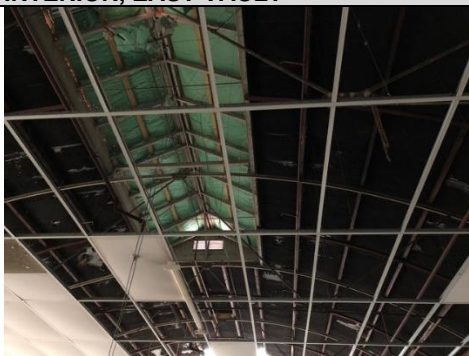
Barrel vault steel trusses, skylights, ventilators; building volume, pillars and truss seating details	HV1
	Remnants of mezzanine floor structure (columns, beams)	HV3
	Exposed brick exterior walls	HV2
	False ceiling	HV4
INTERIOR, CENTRAL VAULT		HERITAGE VALUE

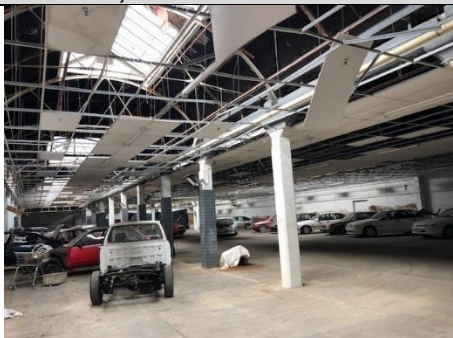
Barrel vault steel trusses, skylights, ventilators; building volume, pillars and truss seating details	HV1
	False ceiling	HV4
INTERIOR, WEST VAULT		HERITAGE VALUE

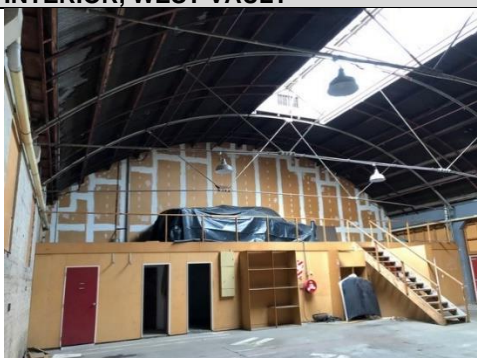
Barrel vault steel trusses, skylights, ventilators; building volume, pillars and truss seating details	HV1
	Exposed concrete floor revealing previous pit locations	HV2
	Timber framed partition wall, mezzanine, service rooms	HV4

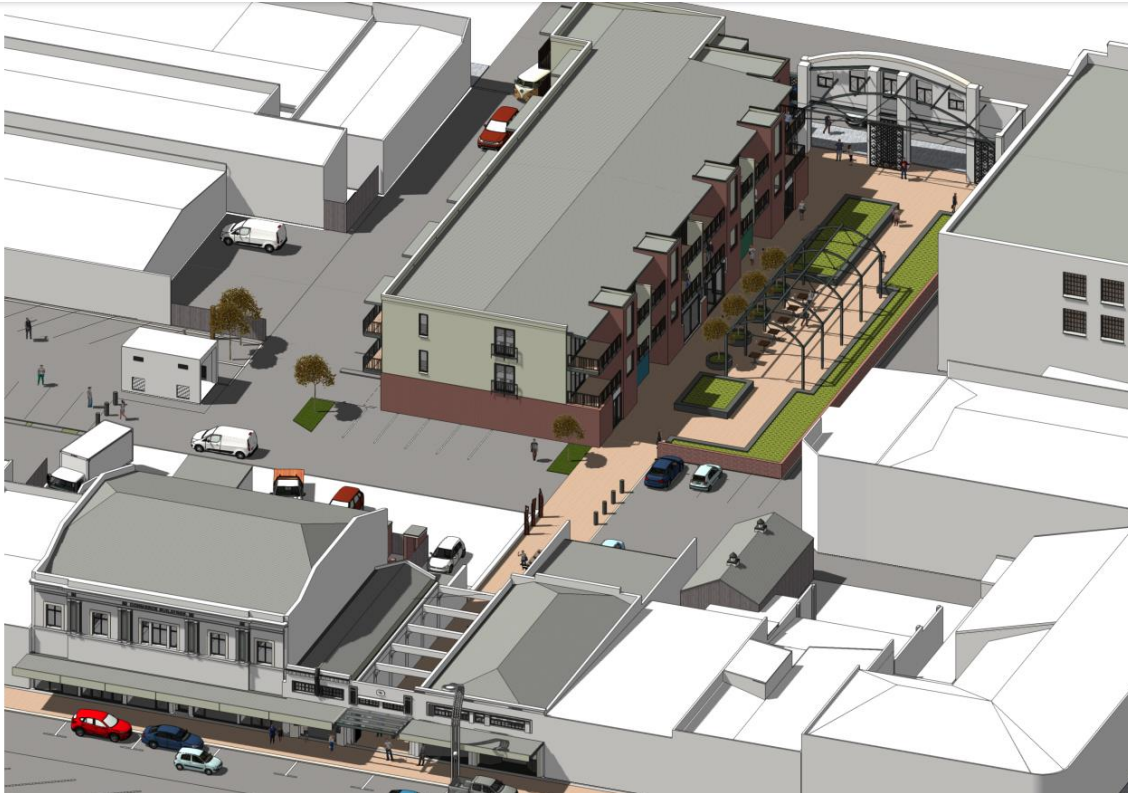
Figure 11: Public park connections. Heretaunga Street at bottom. (Source: Citrus Studio, Sheet PA11)

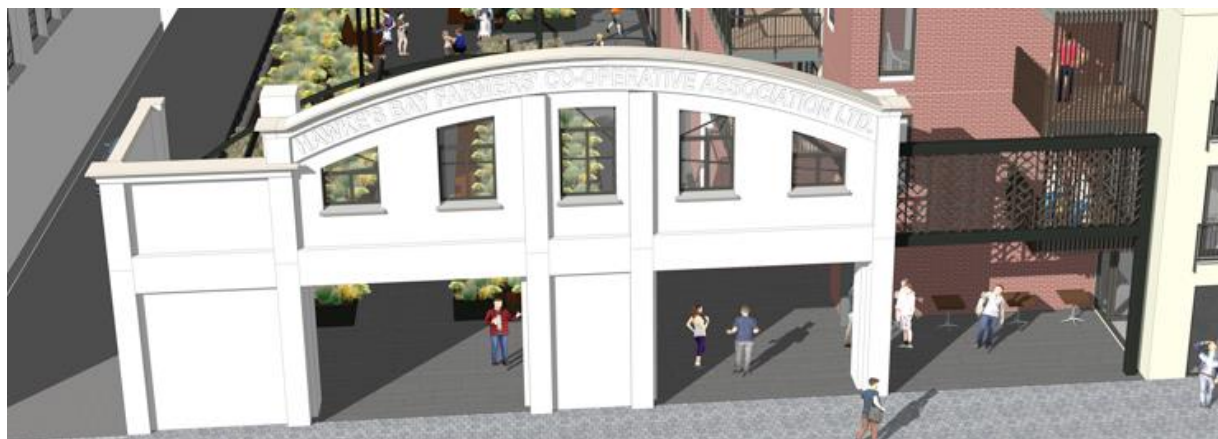
Figure 12: Proposed retention of façade. (Source: Citrus Studio, Sheet PA10)

- Strengthen the 1925 façade, retaining the parapet, cornice, upper fenestration and rhythm of original shop frontage
- Location of strengthening confined to existing structural frame, to minimise visual impact
- One 16m steel truss from the barrel vault roof structure of the existing building is to be re-used, set 3m behind the facade acknowledging both the original form and the heritage of the site,
- Demolish remainder of building.
- Establish a separate title for the façade to remain in HDC ownership, facilitating future maintenance.
- New non-structural frame referencing the original 6m-wide parapet of the 1925 building and providing a visual separation between the façade and the new apartment building (see below)

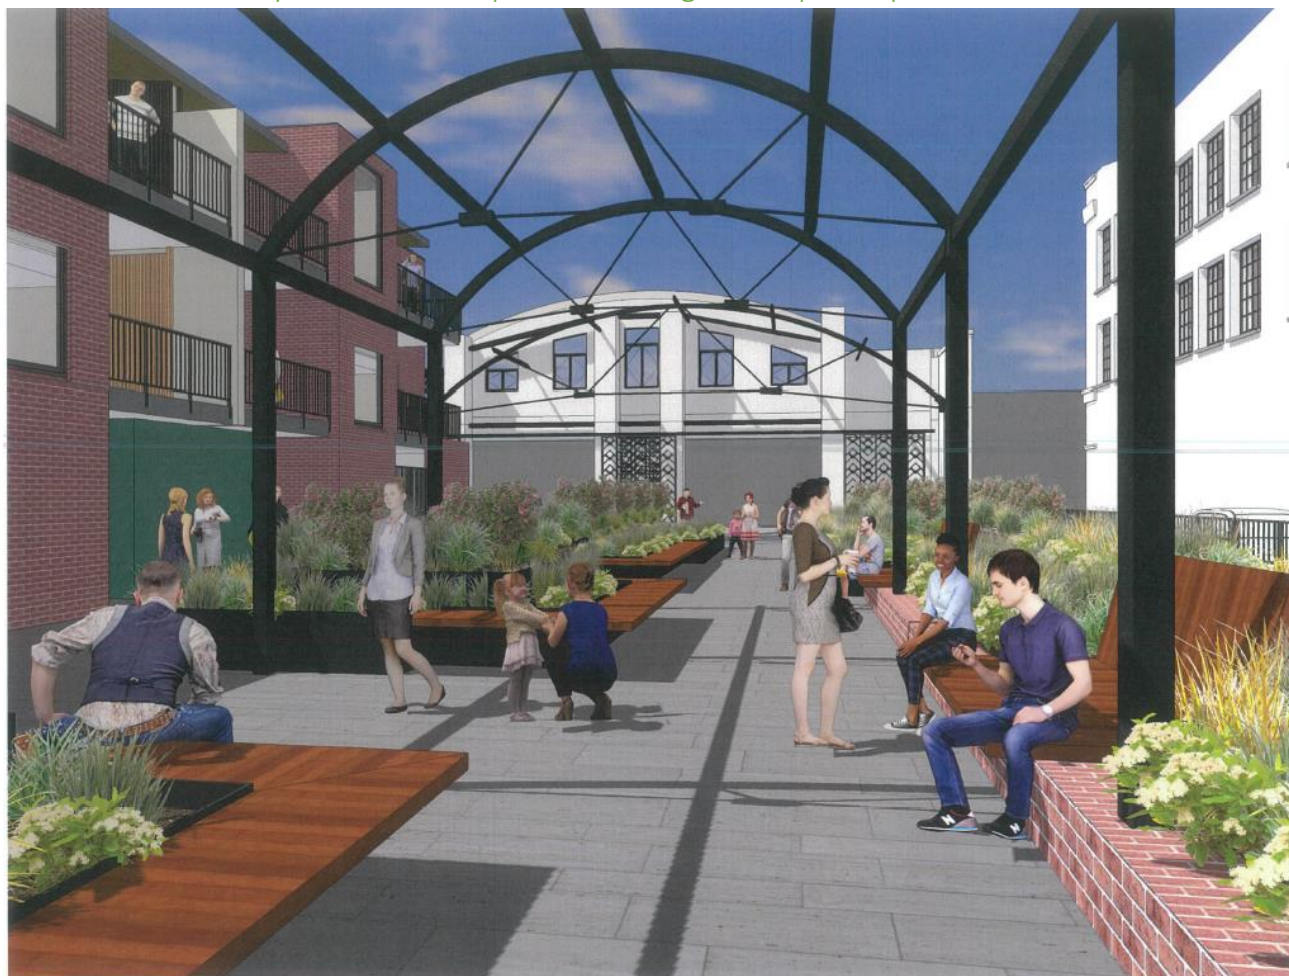
Figure 13: Public park connections. (Source: Citrus Studio, Sheet PA16)

- Entry from Queen Street to the new park is through repurposed (original shop front) openings in the retained heritage facade.
- Screen elements provide security at night and allow visual connection into and out of the park.
- Re-purpose a number of the 6m wide steel barrel vault trusses within the park, (new location, existing orientation) to frame the pedestrian route through the park, provide a visual focus for the park and define a place to pause as an alternative to the more direct route through the site.
- Design themes for park elements will recognise the original building (architectural and social heritage).
- Design elements and materials reuse the original building materials (bricks)
- There is a linear spatial progression from Heretaunga Street to Queen Street, through the new park.

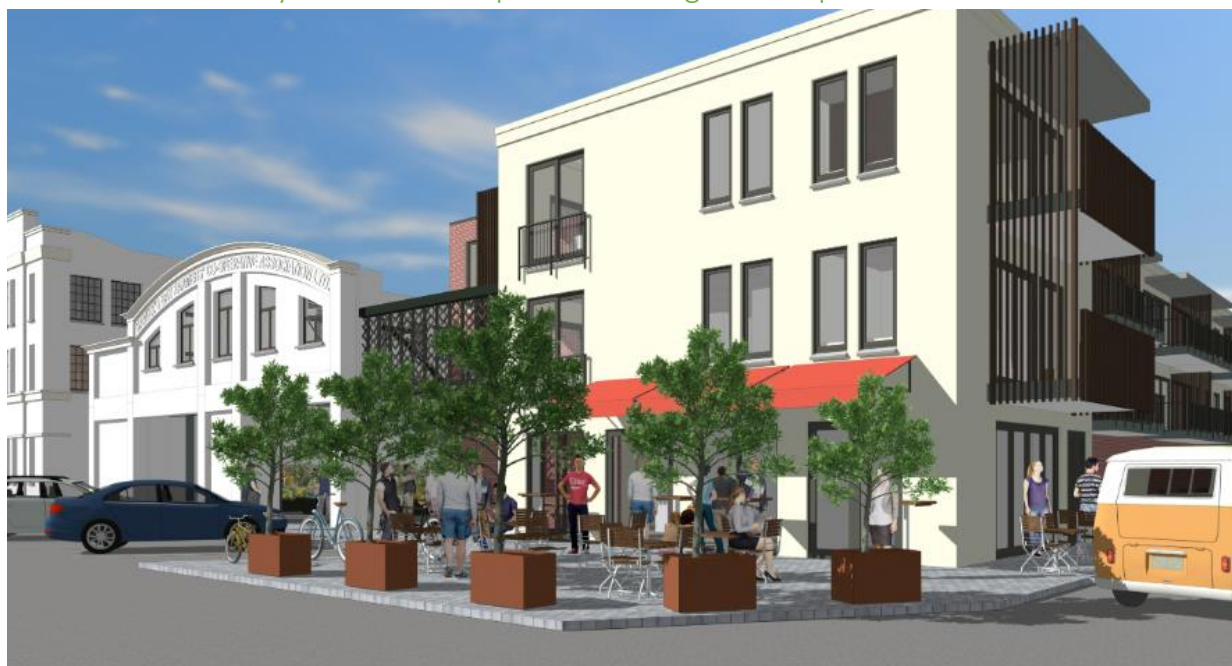
Figure 14: Queen St apartments. (Source: Citrus Studio, Sheet PA12)

- Medium density residential development on the northwest side of the site. 20 one and two bedroom apartments at first and second floor levels with dedicated secure apartment carparking and two commercial tenancies at ground floor.

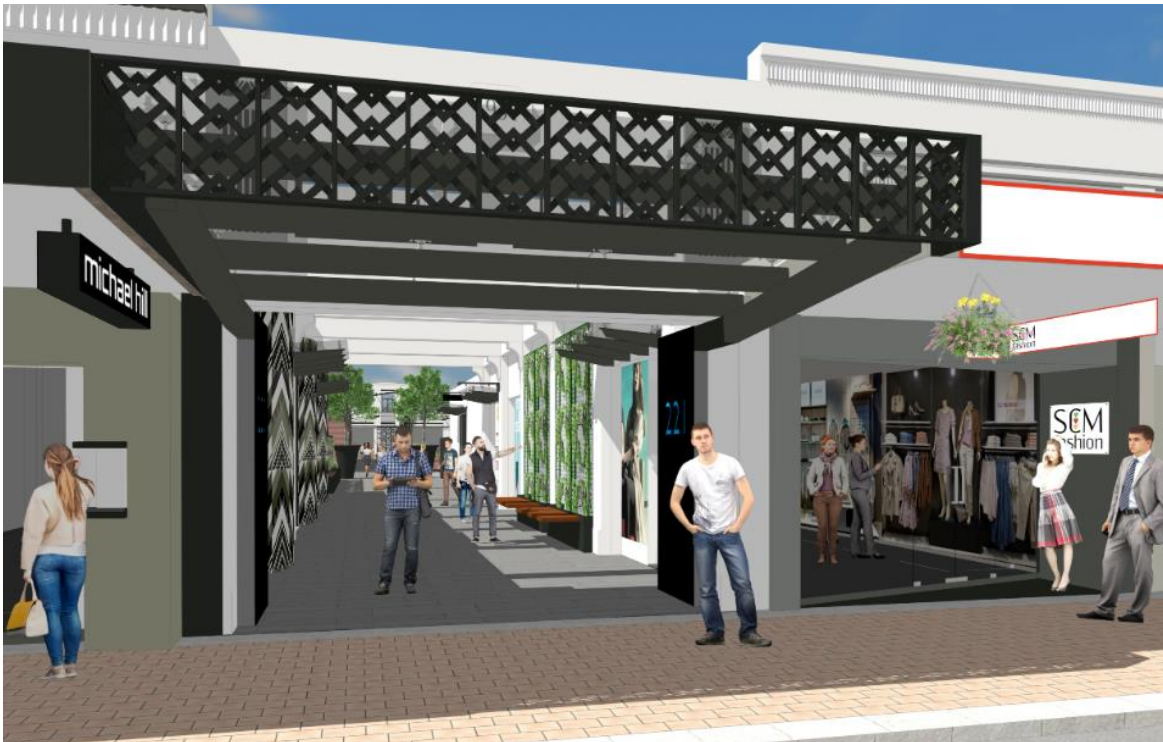
Figure 15: Laneway connections. (Source: Citrus Studio, Sheet PA13)

- Entry from Heretaunga Street is through the original shop front openings in the retained heritage facade.
- Existing solid veranda replaced by a glazed canopy to showcase the retained Art Deco facade above and create an entry point for the new laneway

- The linear nature of this pedestrian axis through the site is accentuated by retention of the existing corbeled concrete columns on the walls to both neighbouring buildings, as well as overhead concrete beams to provide a colonnaded walkway through to the public park beyond

- Paving pattern representative of the traditional pre-1867 footpaths through the wetlands, as opposed to an orthogonal design.
- New glazed canopy to 223 Heretaunga Street to align with the veranda height of adjacent buildings and match the projection of the existing veranda. Support frame to fit within the depth of the existing veranda fascia; new fascia to reflect materials and design motifs of the project (see Fig 15).

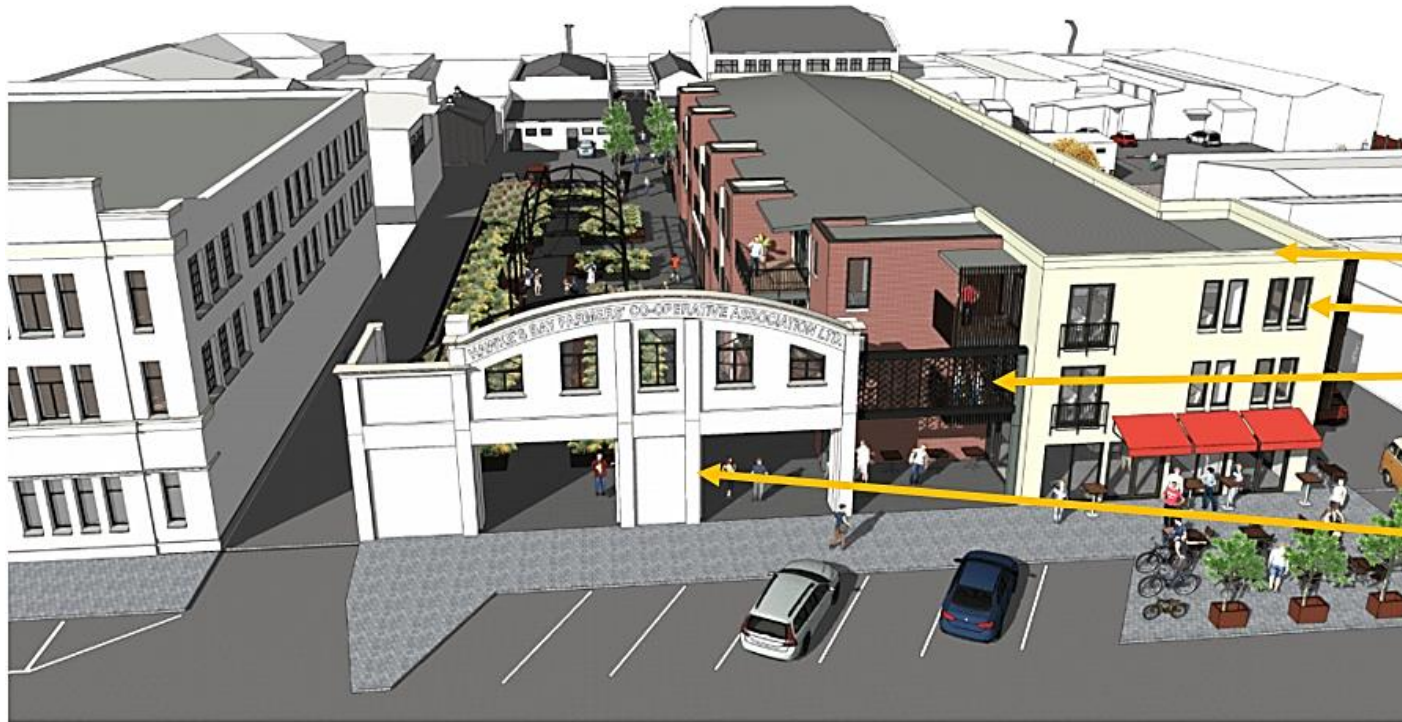
Heritage Elements in Redevelopment

Cornice detailing

Window configuration to reference IMS building
