Hastings CBD Heritage Inventory Project

A.F. REDGRAVE & CO.

A F Redgrave & Co, 337 Heretaunga Street West

Inventory Number: 28; Property ID: 93751; TRIM Reference: 93751#002#0002

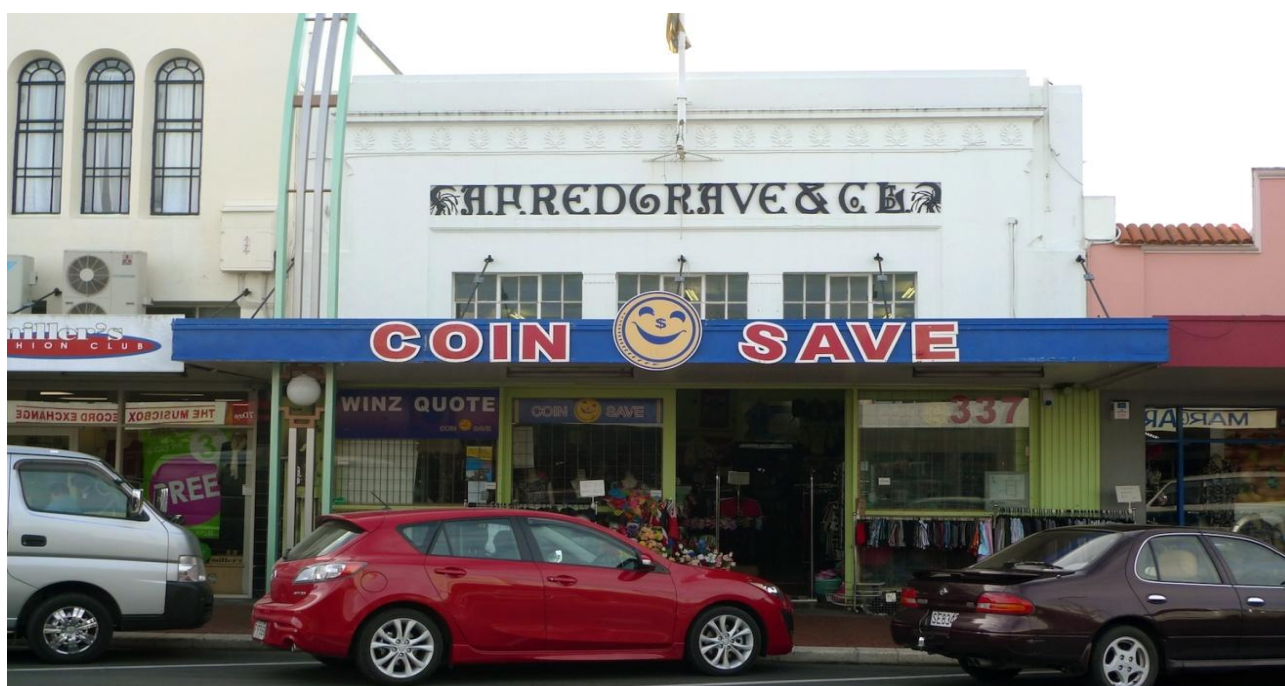
Photo: R Murray, 2012

Description: Redgrave's building is a compact single-storey structure set in the middle of a block of contemporaneous low-rise buildings. It has a tall stud height and high parapet that distinguishes it from the nearby single-storey buildings.

While nothing of the original building is visible below the stayed verandah (and the subdivision of the shop-front bears no resemblance to the pattern of the original), the upper façade remains in authentic condition. Sparely but effectively decorated, the main features are the three sets of steel windows just above the verandah, the beautifully rendered "A F Redgrave & Co. Ltd." in Art Nouveau relief in the centre of the façade, a small simple cornice above a palmette frieze and a central flagpole⁹.
