226-240 Heretaunga Street West (Commercial Group #2)

Hastings CBD Heritage Inventory Project

228-240 HERETAUNGA STREET WEST (COMMERCIAL GROUP #2)

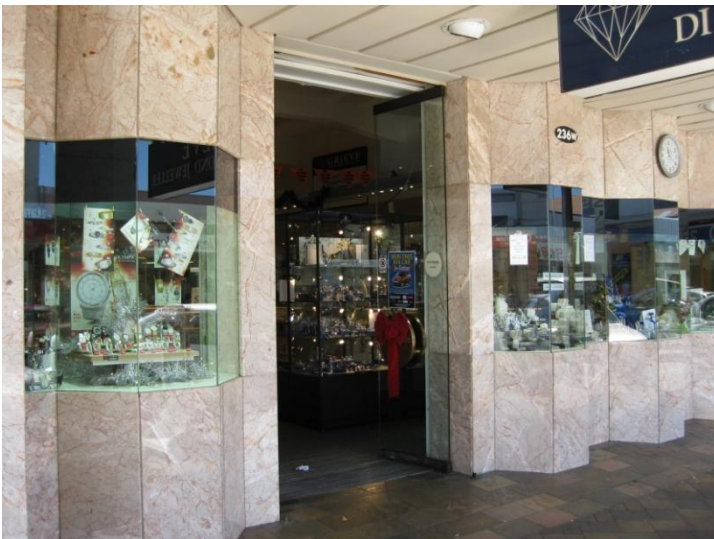
Example of a shop façade (Grieve Jewellers) in Commercial Group 2
(S. Akers, 2009).

Below the cantilevered verandahs, no evidence of the original shop-fronts survives; aside from Building 3, which has an elaborate 1980s frontage clad in pink marble, the rest have plain aluminium joinery.
