Carlsson House, 201/201A Warren Street North

Inventory Number: 61 Property ID: 25130, 25132; TRIM Reference: 25130#002#0003

Final Report: 18 April 2012

Hastings CBD Heritage Inventory Project

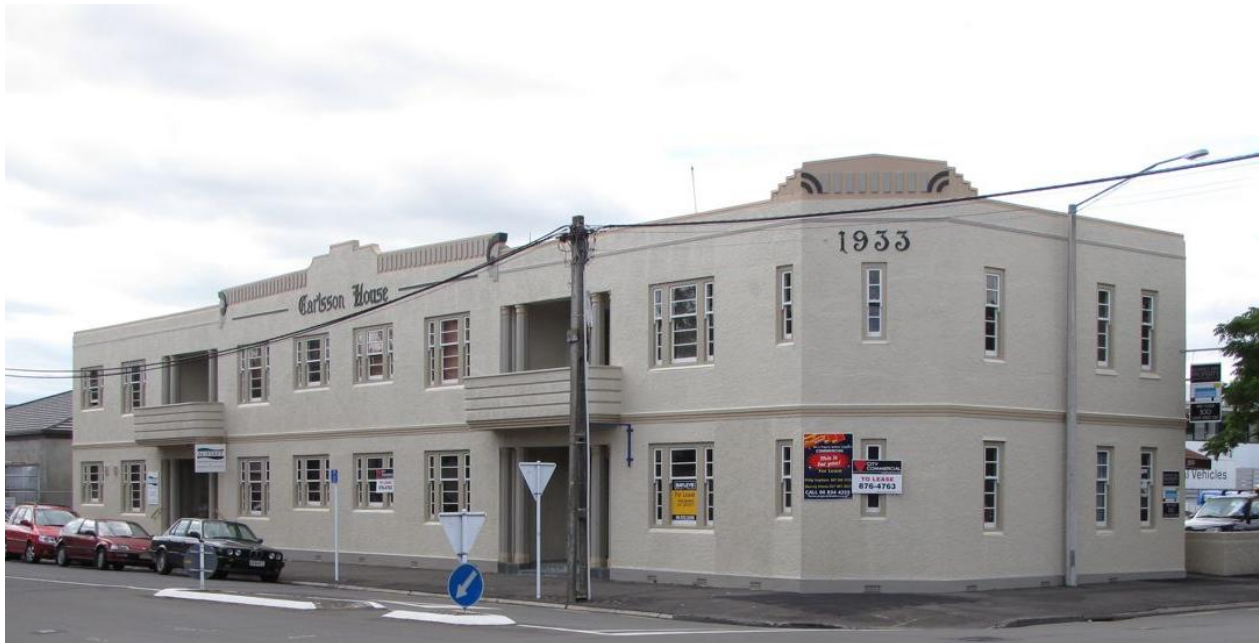
CARLSSON HOUSE

Description: Carlsson House stands firmly on the corner of Warren Street North and Queen Street East, two stories high and built right on the street edges. It is finished in rough cast solid plaster, plain but with horizontal bandings at first floor and parapet level. The Warren Street North elevation has two porches at ground floor level, matched by two small balconies with projecting balustrades to the flats above; centrally between them is a modest stepped parapet, and an unusual stepped motif marks the corner of the building. The long horizontal banding is reflected in the horizontal subdivision of the windows on the Warren Street elevation. Along with the inscribed name of the building, and its date, these features add visual interest to an otherwise plain form. Being on the edge of the CBD, and originally in residential use, the building does not have a verandah.

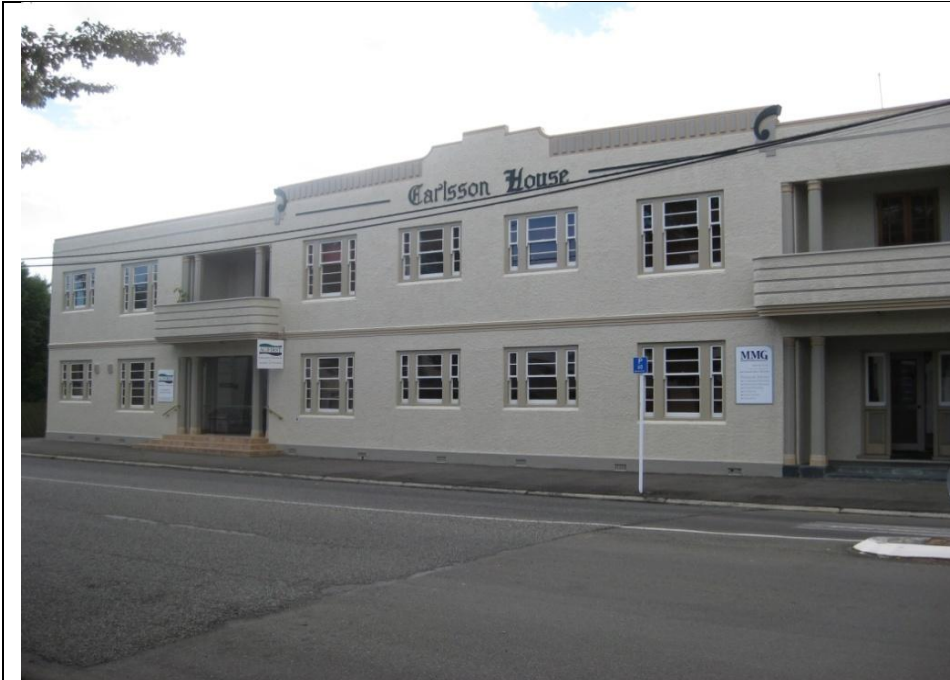
Warren Street North
Carlsson House
façade (S. Akers,
2009).
